# Shoreline Stabilization Using Wetland Plants and Bioengineering

*by Cathy J. Wendt & Hollis H. Allen*

This is a case study in which wetland plants and bioengineering treatments were used to protect an archeological site on an eroding reservoir shoreline and to stabilize the shoreline from further erosion. The site is called the Robinson Site and is located on Rice Reservoir in northern Wisconsin, 16 miles southeast of Rhineland.

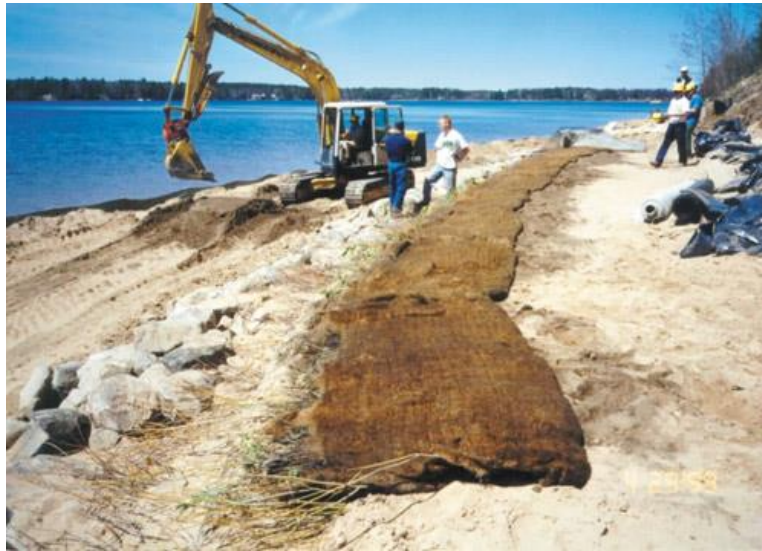
*Installing the pre-grown brush layer mats in the vegetated geogrid.*

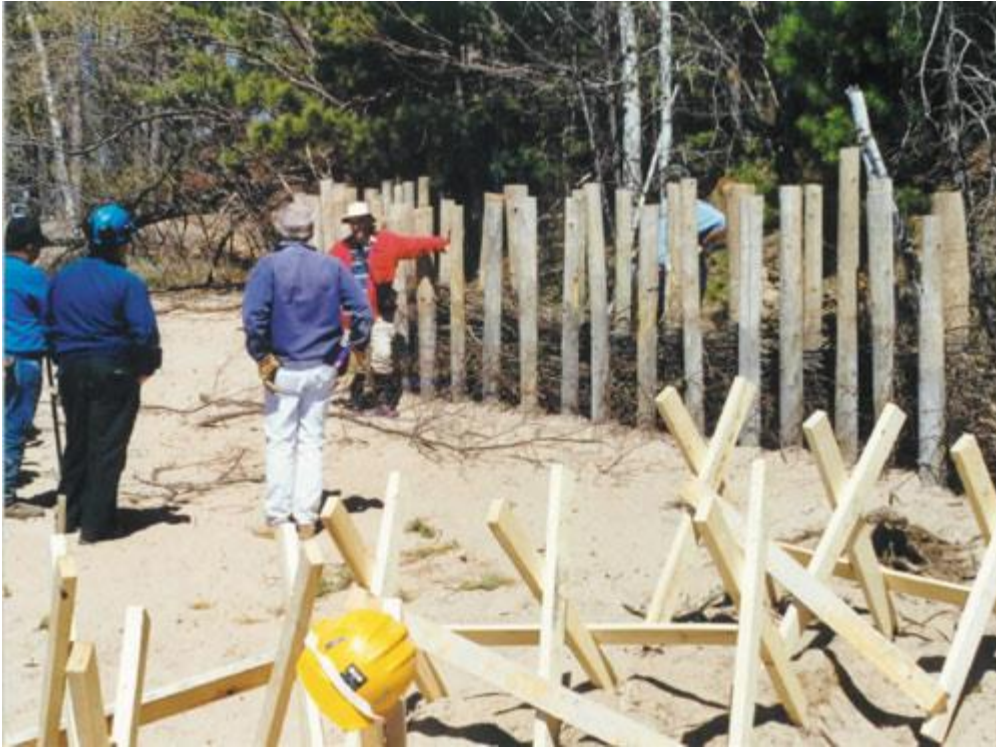
*Workshop participants learn how to construct a branchbox breakwater (above) and install an A-Jacks® toe (below).*

The branchbox breakwater is providing limited habitat for emergent plants. The habitat is limited because Wisconsin laws prohibit most structures from being more than a few feet away from the shore. The Wisconsin Department of Natural Resources did, however, allow this structure for demonstration purposes, but only allowed it to extend 15 ft. from the shore. This is still short of the more typical placement of 30 ft. or more. If it had been allowed to be placed further off shore, the breakwater could have protected more area and could have supported more emergent aquatic plants shoreward of it.

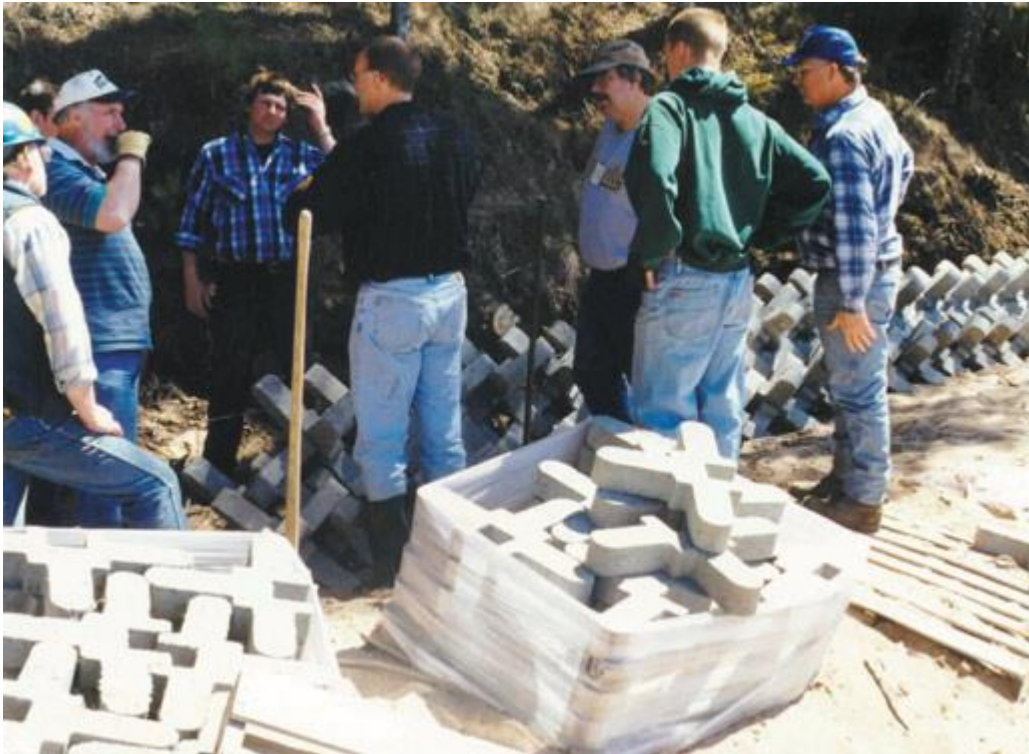
With the existing dense foliage, the A-Jacks are barely visible from the water. The reservoir was near full by April 2000, which provided the plants with moisture, producing the initial surge of growth indicated by the high stem count (391 stems) in May 2000. The total stem count decreased to 320 stems on August 28, 2001, however, the area covered increased based on photo comparisons. The stem count may have decreased for the following reasons. First, water levels remained atypically high for over 1 month in 2000 and over 2 months in 2001, and plants less tolerant to prolonged flooding may have drowned. Second, some plants died due to abrasion from the A-Jacks caused by wave action. Third, competition between plants would tend to shift more growth and foliage to the stronger plants with a corresponding reduction in stem count of less vigorous plants. The plants that did survive filled in the voids from the plants that were lost.

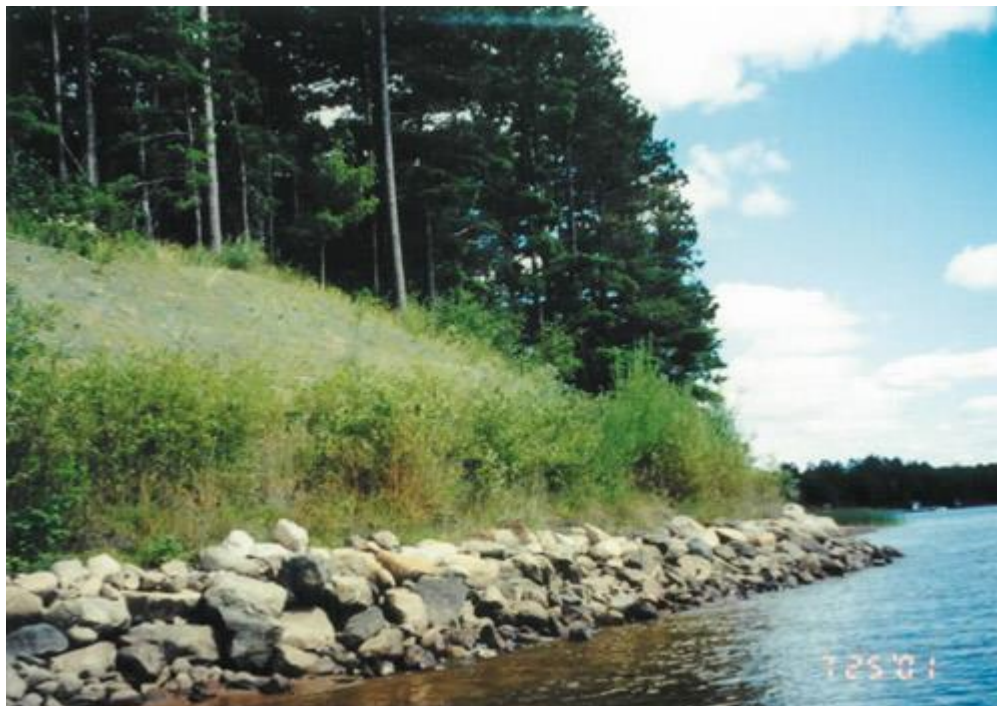
The rock toe has performed as expected for the majority of the zone. Soon after completion, however, the reservoir level rose and a void was created behind the large rocks, causing 5 lin. ft. of soil lifts to collapse. Filling this area with small rock repaired the void and no further erosion has occurred in this area.

Additional smaller areas have also washed out, but no major problems seem to have been created by these voids. As a preventative measure, these new voids could be filled, but the voids seem to have limited themselves and our intent is to monitor them to see if they will be "self-healing". All of the voids are located away from the mound. It appears that the reduced level of armoring in the fix away from the mound may be contributing to these minor failures. No failures have occurred in the mound fix area.

***Zone 2 - Two years after installation.***
