### Fiber Roll Toe

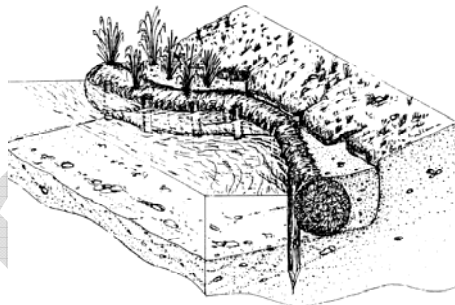
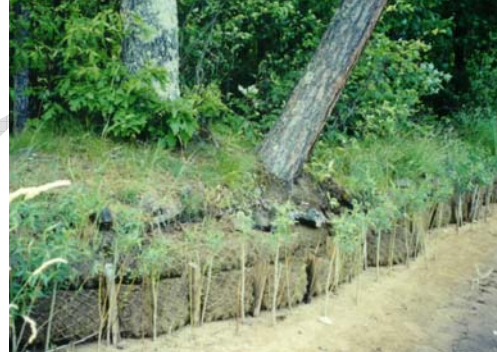
**Fiber Rolls Anchored with Wood Stakes:**

**1998** The site near the Hwy J Landing on Rainbow Reservoir was restored with a fiber roll toe. Over 800 linear feet of shoreline was covered with one or two tiered 12" diameter, 20' long fiber rolls depending on bank height and bottom slope. All fiber rolls were placed tightly against the bank and secured with wooden wedge shaped stakes. The fiber rolls were planted with several species of wetland plants that subsequently suffered high mortality. Willow cuttings were jetted in front of the rolls (36 cuttings in front of each 20' roll) and ones that did not survive were replaced annually. Besides replacing cuttings, the fiber rolls were reinforced with additional stakes where movement away from the bank was observed. An average of 12 stakes per 20-foot fiber roll was used. By 2002, the majority of the fiber roll toe had failed. The failure was probably caused by a combination of factors including: 1) the jute rope holding the coir together was destroyed by animals which caused the rolls to disintegrate faster than expected; 2) willow cuttings were not becoming established soon enough to dissipate wave energy; 3) the rolls had not been placed above the maximum water elevation in all areas allowing erosion to occur above them during high water conditions; and 4) the slope of the beach may have been too steep for this method in some areas. A 40' portion of the original installation is still intact and functioning. This portion has a gradual slope below the toe, already had some willow and grass established in front of the toe, and the rolls were not torn apart by animals.

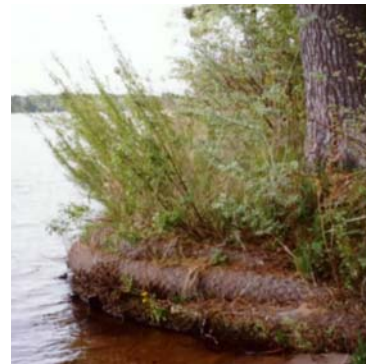
**1999** As part of the Robinson Site restoration on Rice Reservoir, 150' of fiber roll toe was installed on one end of the site with a very shallow beach. The fiber rolls were placed tightly against the bank, 1 to 3 tiers high depending on the bank height and secured with wedge shaped wooden stakes. Any voids between the bank and the rolls were backfilled with topsoil and planted with rooted willows. Although the fiber rolls have mostly decomposed, the willows that established behind them appear to be holding the bank intact. An anchored log wave deflector that was in place for the first few months after the fiber roll toe was installed may have played an important role in the success of this severely eroded, moderate energy site. Native willow and other wetland plants that already existed in front of the area may have also functioned as a natural wave break.

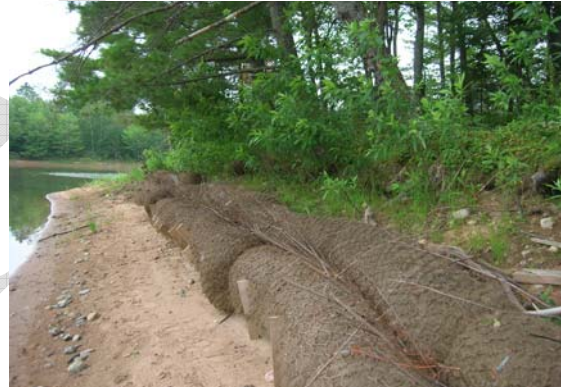
**2003** A trial fiber roll toe using an alternate anchoring system was installed in 2003 on a steep beach portion of the failed project near the Hwy J Landing on Rainbow Reservoir. It was determined that the original wood stakes may have played a part in the failure at this site since the stakes failed to hold the fiber rolls against the bank. A 100-foot section of the bank was selected and a double tiered fiber roll treatment was installed. The bottom tier consisted of 20" diameter fiber rolls and the top tier of 16" diameter rolls. The rolls were held in place with a combination of wooden stakes and pairs of Duckbill® anchors fastened together with Gripples®. Placement of the anchors varied with bank shape and bottom slope. Willow cuttings were placed between the fiber rolls and jetted in front of them. Any voids between the rolls and the bank were backfilled and planted with rooted willows. None of the cuttings placed between the rolls survived possibly due to an extremely dry late-summer and fall. After the reservoir filled in 2004, it became evident that the anchoring system was not functioning as expected. The rolls had pulled away from the bank allowing waves to overtop them and because of the steep bottom slope all of the jetted cuttings had drowned. In 2005, the anchoring system was modified. Cables were wrapped around both fiber rolls and anchored to a fence post driven in about 5' back on the shore. Also most of the Gripples® had failed leaving loose and disconnected cables. All were re-tightened and secured with cable clamps. Rooted willows that didn't survive behind the fiber rolls were replaced but no additional willow cuttings were jetted on the steep bottom slope. The technique is preventing further undercutting of the bank. Although some of the fiber rolls have settled, the root systems of the willows established behind the fiber rolls appear to be preventing displacement of the soil from waves during high water periods.

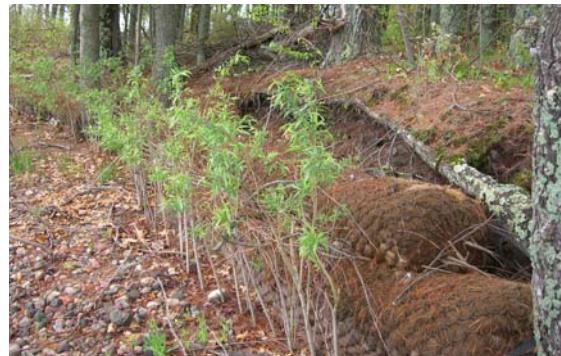
**2004** A portion of a large island on Rice Reservoir was restored using a variety of methods. A fiber roll toe was installed where the beach area was gradual and a natural wave break of native willows already existed on 100' of the shoreline. A combination of 16" and 20" diameter rolls was used. Depending on bank height, one or two tiers were installed. All were anchored in place with Duckbill anchors® and reinforced with cable clamps. All fiber rolls had willow cuttings jetted in front of them and two tiered installations had cuttings placed between the fiber rolls. Few of the cuttings placed between the rolls survived and they were not replaced. Almost 100% of the cuttings jetted in front of the toe survived and the site has required no maintenance.
