An Assessment of Urban Lakeshore Restorations in Minnesota

Dana A. Vanderbosch
Susan M. Galatowitsch

Ecological Restoration, Volume 28, Number 1, March 2010, pp.
71-80 (Article)

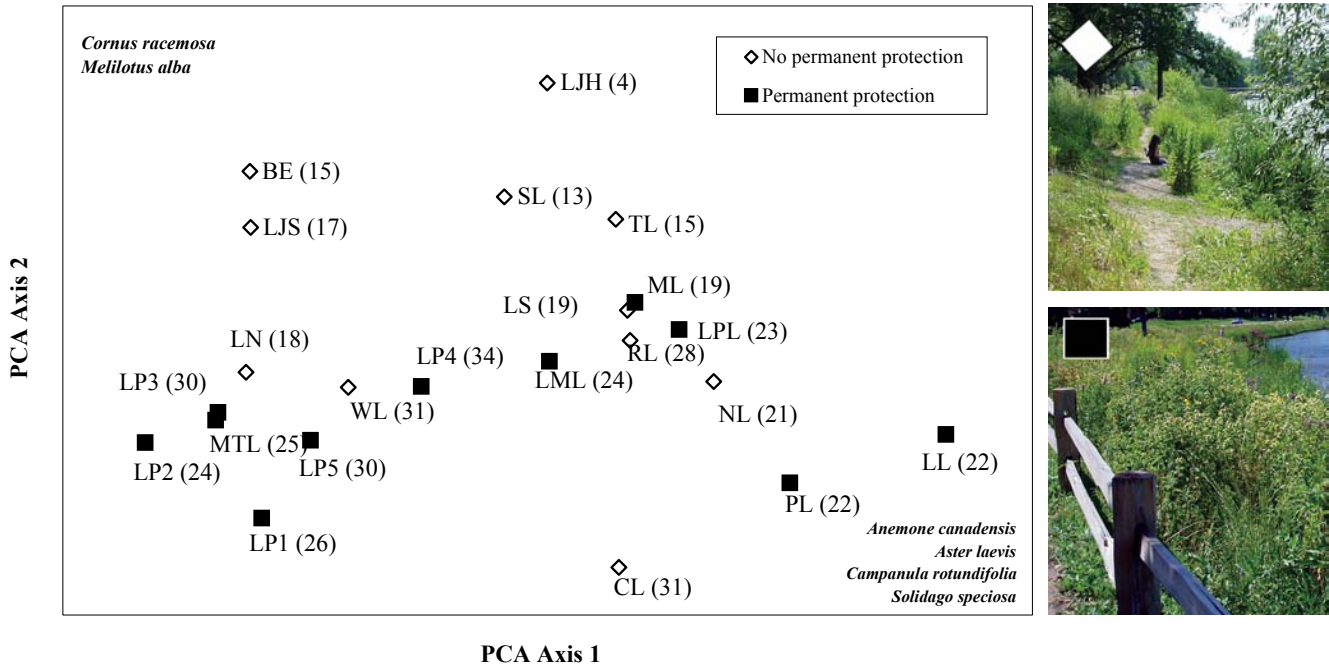
Figure 3. Similarities among lakeshore restorations based on their upland vegetation (Principal Components Analysis). Species richness indicated after the site name (Figure 1) suggests that well-protected sites support a greater number of species, whereas sites not permanently protected have lower species richness. Species shown have PCA Axis 2 eigenvalues > -0.2 or > 0.2 . Axes 1 and 2 explained a total of 24% of the variation in the data set.

Upland vegetation composition corresponded to the openness of sites and the extent to which they were protected after planting (Figure 3), as evidenced by the principal components analysis. Native perennials species of open meadows, boneset (*Eupatorium perfoliatum*), cup plant

(*Silphium perfoliatum*), fox sedge (*Carex vulpinoidea*), western ironweed (*Vernonia fasciculata*), and prairie cordgrass (*Spartina pectinata*), all had high values on Axis 1, whereas native perennial species of partial shade, columbine (*Aquilegia canadensis*) and harebells (*Campanula rotundifolia*), had low values. Upland areas that were not protected by fencing and sites that were not maintained through a routine watering or weeding program (high Axis 2 scores) had strikingly lower species richness than maintained sites with permanent fencing. Species that tolerate disturbance, such as white sweetclover (*Melilotus alba*) and Canada goldenrod (*Solidago canadensis*), had high values on Axis 2, whereas those typical of less disturbed habitats, such as smooth aster (*Aster laevis*), columbine (*Aquilegia canadensis*), showy goldenrod (*Solidago speciosa*), and harebells (*Campanula rotundifolia*), had low values on Axis 2. Fencing the boundary of restorations discourages mower encroachment and human foot traffic. Protective measures such as fencing are potentially useful for the lakeshore restorations included in this study because most are located within heavily used urban parks. Galbraith-Kent and Handel (2007) also found that failing to provide permanent protection and after-care to urban restorations contributed to diminished establishment of target vegetation; colonizing invasive species prevailed over time.
