An Assessment of Urban Lakeshore Restorations in Minnesota

Dana A. Vanderbosch
Susan M. Galatowitsch

Ecological Restoration, Volume 28, Number 1, March 2010, pp.
71-80 (Article)

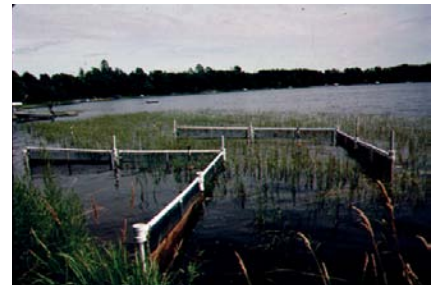
Figure 2. An effective wave break design provides protection from wave impacts to newly planted aquatic and transition zone vegetation during establishment. Transition and aquatic zone vegetation is planted in the sheltered area within each "V." Wave breaks are used until plants are well established, sometimes up to three or four years. They must be removed in autumn before lakes freeze and reinstalled the following spring after ice thaw.

Effective wave breaks have been designed that can protect new plantings during vegetative establishment (Clark et al. 1999). They consist of a V-shaped structure placed with the

point facing the lake and the two ends butted against the shoreline. A second V straddles the first, but is placed 1.5–3 m further out into the water (Figure 2). Transition and aquatic zone vegetation is planted in the sheltered area within each V. Such devices need to be removed in autumn before lakes freeze and reinstalled the following spring after ice thaw. Wave breaks must be used until plants are well established, sometimes up to three or four years. Although these wave-break structures have been successfully used elsewhere in the region (Clark et al. 1999), the nested V-configuration has not been used in our study area.

Provide support for aquatic/transition zone protection. Our research emphasizes the importance of wave-break protection for revegetation in the shallow water and shoreline areas. Restoration program managers need to commit funding for these structures along with guidance on how to construct and maintain them properly.

Provide protection to the aquatic and transition zones during the initial establishment phase. This study indicates that sites exposed to wave energy failed to support aquatic zone revegetation and had greater abundances of annuals and weedy perennials in the transition zone. Providing temporary protection from wave impacts will reduce the likelihood that newly planted vegetation will be uprooted and will minimize the potential for shoreline erosion.

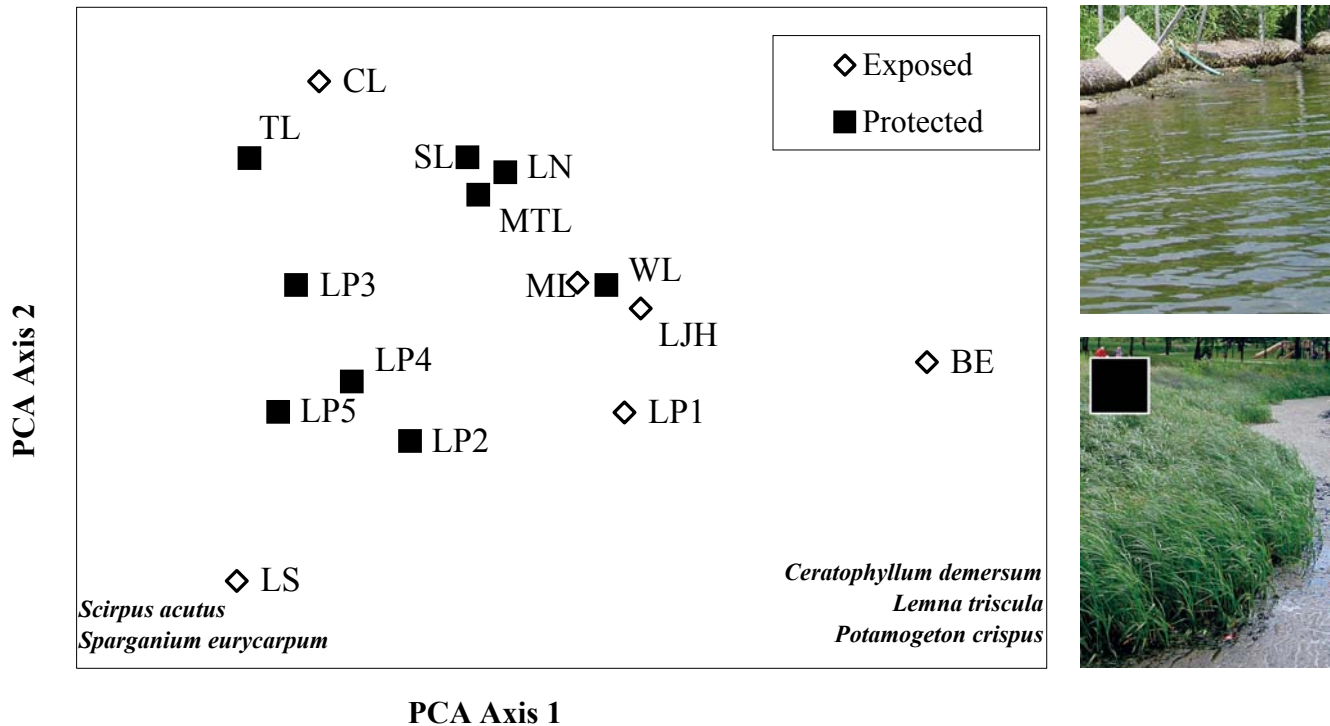
Figure 5. Similarities among lakeshore restorations based on their aquatic vegetation (Principal Components Analysis). Exposed sites lacked planted emergent vegetation and were dominated by submersed and floating vegetation, whereas more sheltered sites generally contained planted emergent vegetation. Species shown have PCA Axis 1 eigenvalues > 0.3 or < -0.3 . Axes 1 and 2 explained a total of 35% of the variation in the data set.

As with transition zone plant assemblages, patterns in aquatic vegetation reflected the extent to which sites were protected from exposure to wave impacts (Figure 5). Emergent macrophytes giant bur-reed (*Sparganium eurycarpum*) and hardstem bulrush had low values on Axis 1, whereas submersed/floating aquatics such as star duckweed (*Lemna trisulca*), curlyleaf

pondweed, and coontail (*Ceratophyllum demersum*) had high values on Axis 1. Most aquatic zones with high wave exposure had high Axis 1 scores; these lacked planted emergent vegetation. Aquatic zones sheltered from wind had low scores on Axis 1 and contained planted emergent vegetation. The observed presence or absence of emergent vegetation suggests that selecting sites protected from wind and wave energy increases the likelihood of emergent macrophyte planting success. These results agree with Wilson and Keddy (1988), who found that biomass accumulation was significantly related to site exposure to wave action and tended to be greatest on sheltered shores. The use of wave-breaking technologies, such as those described earlier, would provide protection to the aquatic zones of more exposed sites during the establishment phase of restoration.
