**Site Assessment Summary of Diver Hand Removal and
Chemical Application to Eliminate Eurasian Water Milfoil
(*Myriophyllum spicatum*) from the St. Croix Flowage at the Gordon
Dam County Park Boat Launch -August and September, 2007**

Dive Removal/Site Assessment Conducted by and Report Prepared by:
Endangered Resource Services
Matthew S. Berg, Biologist
St. Croix Falls, Wisconsin
August - September 2007

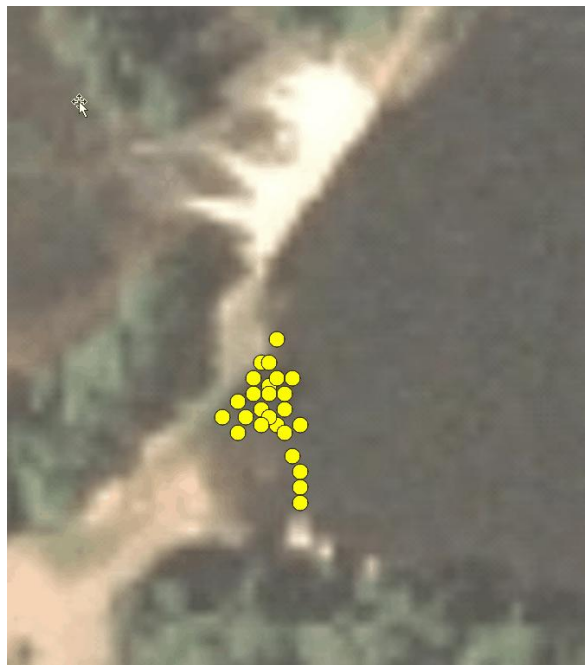
Figure 2: Approximate Location of Initial Hand Removal Effort.

We removed between 25 and 30 cloth bags full of EWM (1 bag = Yellow Dot) at roughly the locations indicated in Figure 2. Densities varied from only a single plant/10m transect to total infestation with all native species excluded. In general, plant density increased from south and east (near dock) to north and west (at the rock wall) where a dense stand covered an area approximately 10m X 10m in 6-14ft of water. Most plants exhibited multiple stems and were close to canopying. With the exception of the dense area near the rock wall, plants were primarily located in a line along the drop off in 8-10ft of water.

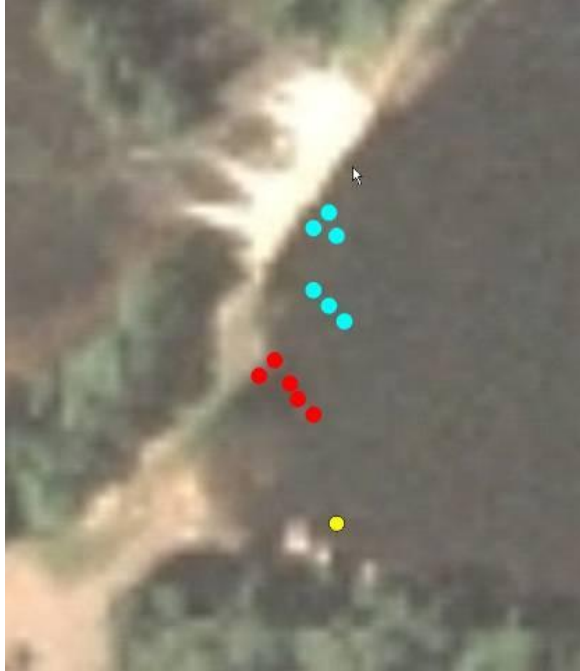
Figure 3: Approximate Location of EWM in Follow-Up Assessment.

During our follow-up swim over, we located an additional 11 total plants that were still alive despite both control methods (Figure 3). Of those, six individual plants were directly in front of the dam (blue points) in areas where the herbicide would not have made contact, and poor visibility had prevented us from locating them during the initial dive. Five additional plants were easily located in the prior areas of heaviest infestation (red points). Whether the herbicide knocked all other species down or natural fall senescence was occurring, the EWM was the only plant still standing tall. Although the plants showed evidence of herbicide burn, they had recovered, and some new growth was evident on two of the plants. Roots on these plants were partially white, while roots on the other plants in the treatment zone were mostly black. We also located an additional single plant (yellow point) approximately 40m to the south/southeast along the edge of the littoral zone in an area with native northern water milfoil (*Myriophyllum sibiricum*). This was of concern because it was further away from the landing than any other plant yet located.

We feel the diver hand removal and Aquathol provided acceptable control where visibility was good and the current didn't interfere with contact time. Plants showed evidence of being knocked back and killed throughout the treatment zone with the exception of at the marker buoy near the rock wall (area with the most current/nearest the dam). The single plant found growing outside the treatment zone to the east was a concern. A spring survey and/or treatment should consider following the "milfoil zone" in 8-10 feet of water for some distance up the shoreline to ensure other pioneer plants aren't taking hold.

3. In spring, a diver should inspect the treatment area to determine the impact of the 2,4-D application in the original known infestation area.
4. Inspection should continue for at least several hundred meters upstream of the area based on the one EWM plant found near the upstream boundary of the original control zone.
