Lake Puckaway's
Vanishing Act.....

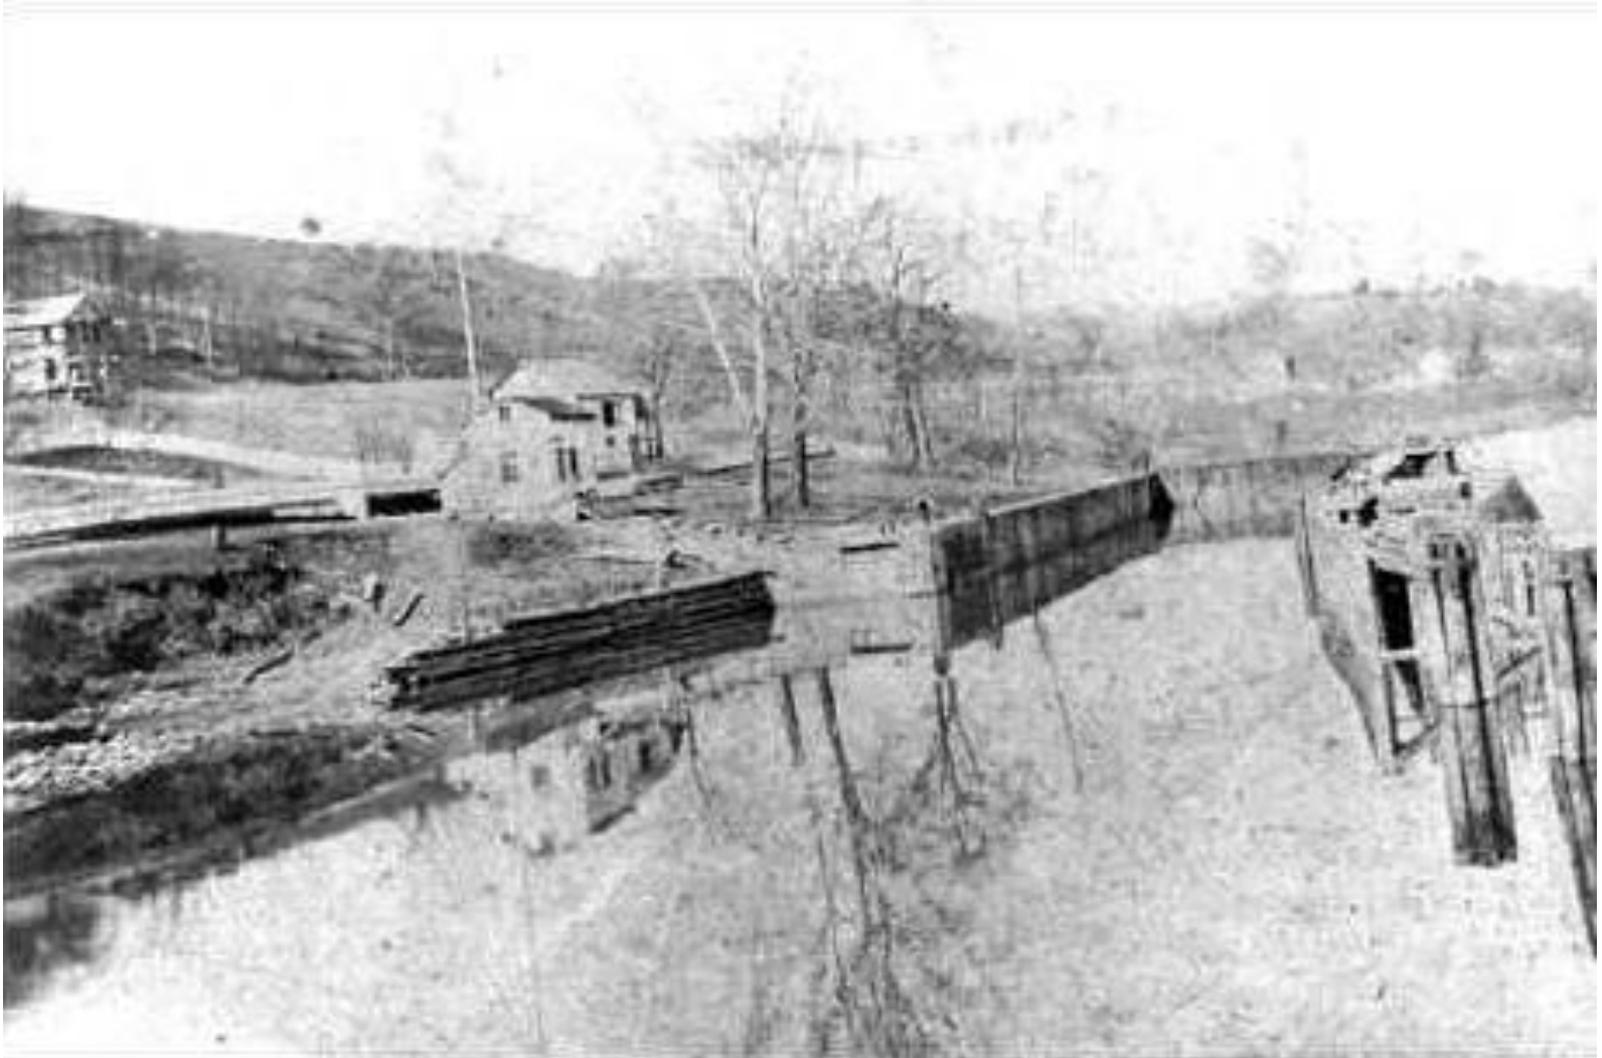
Original Lock and Dam built around 1860 soon fell into disrepair

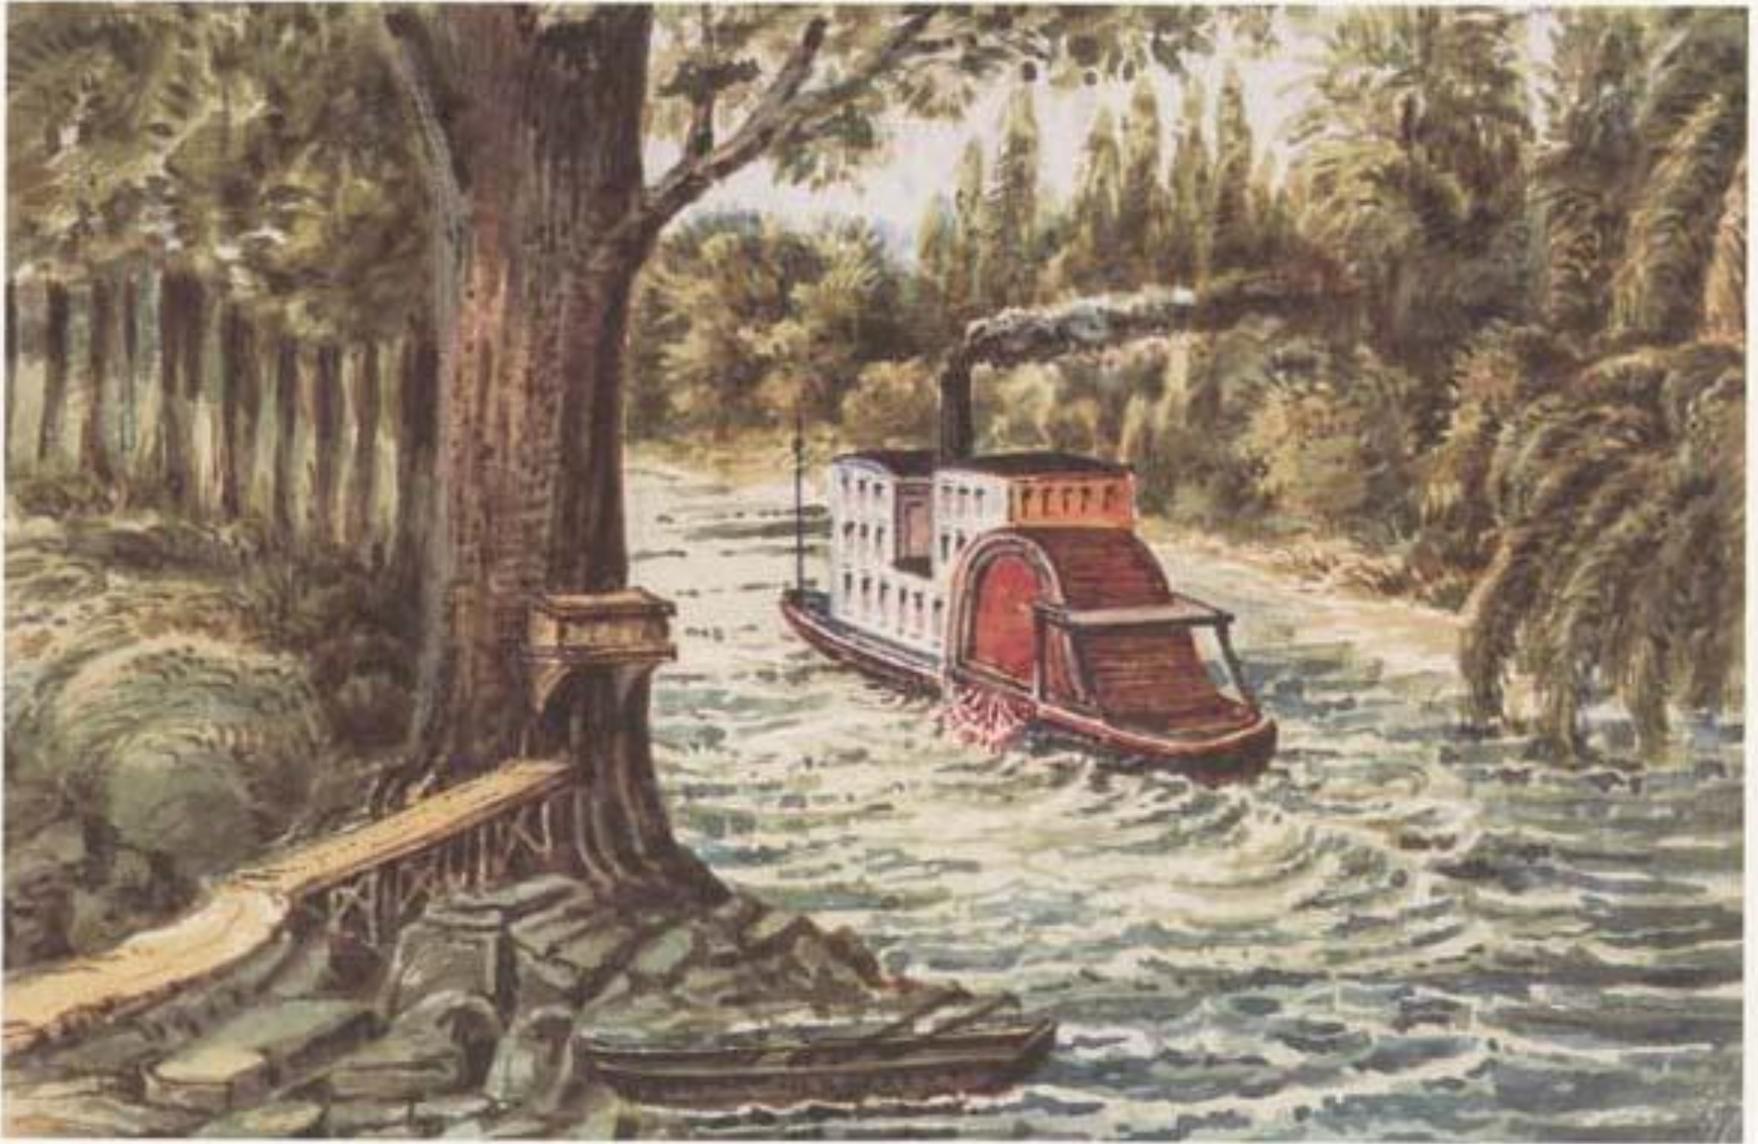
The Princeton Dam was built by the Army Corps of Engineers in 1897 in an effort to provide water deep enough for commercial freight steamers.

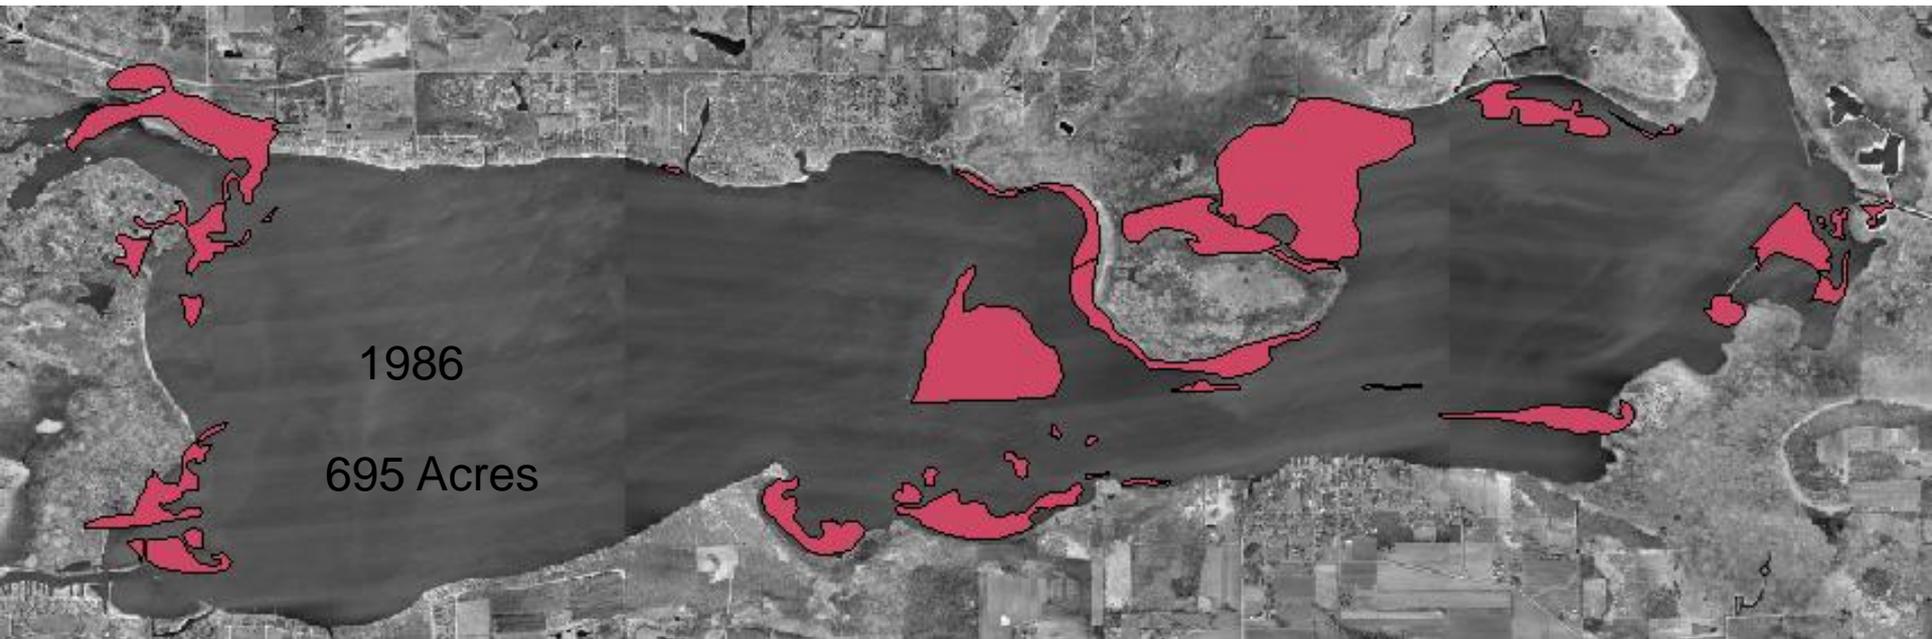
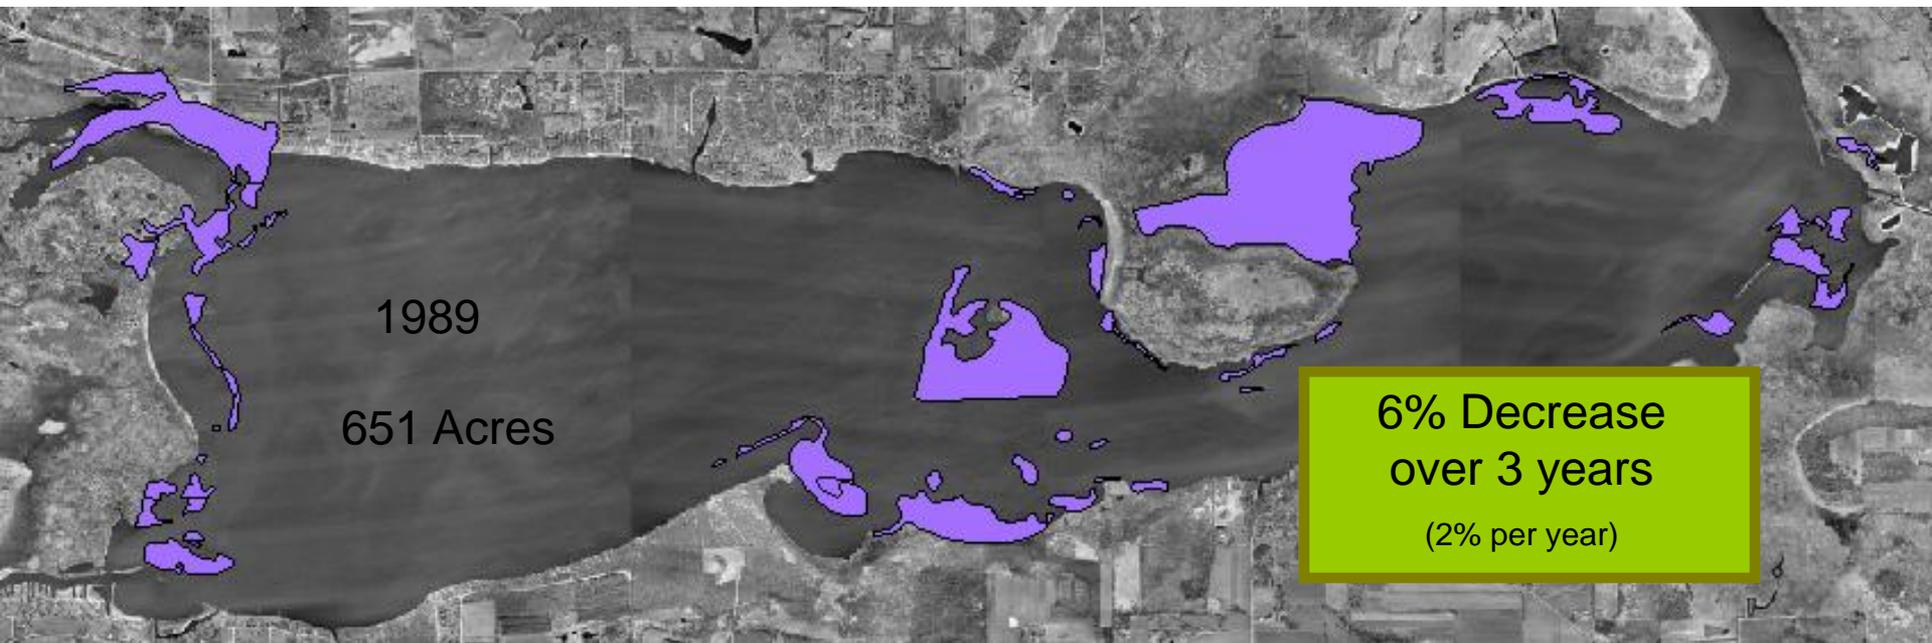
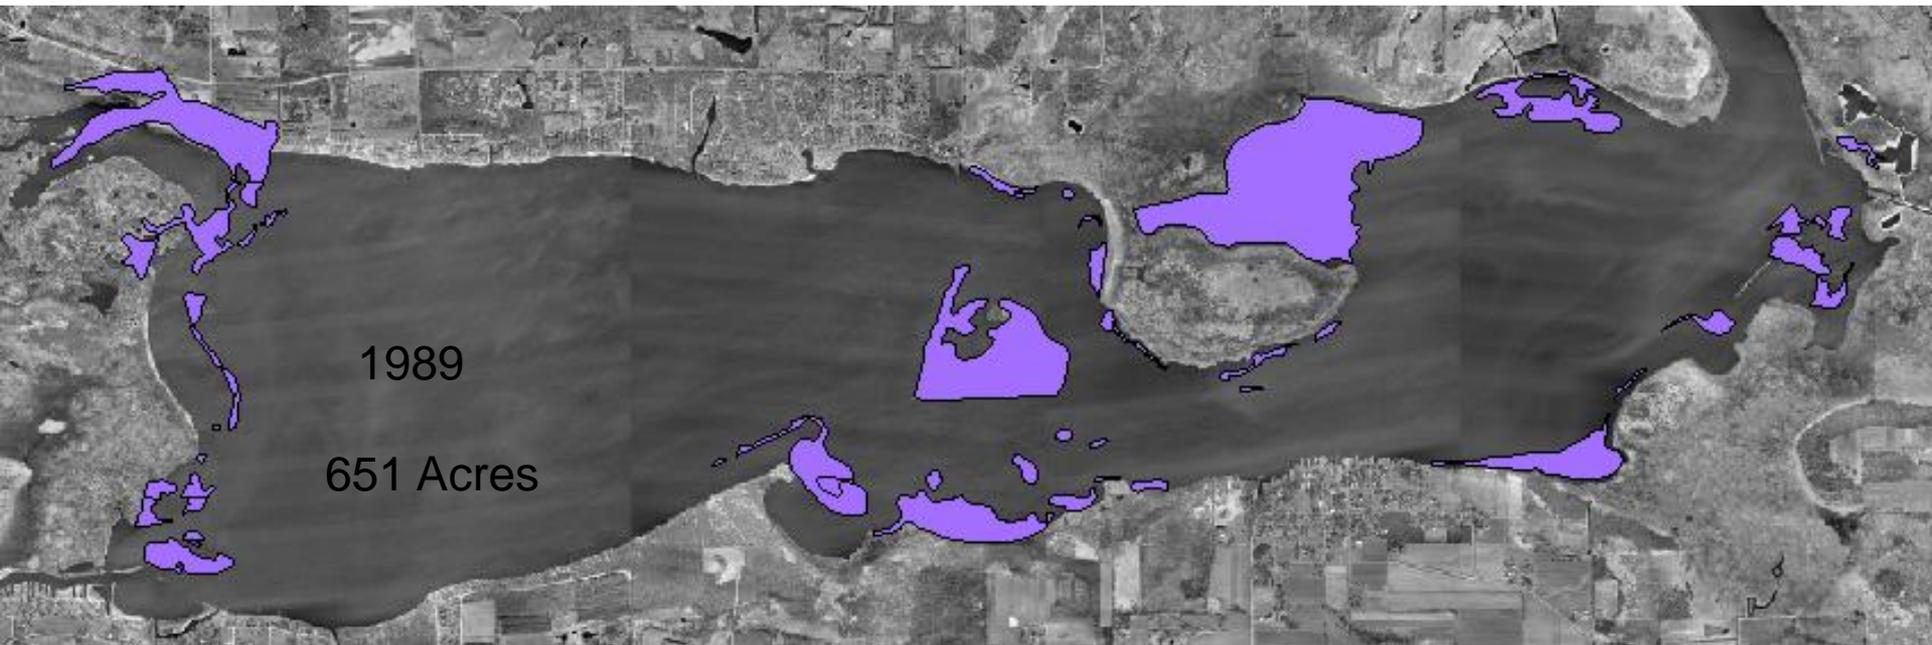
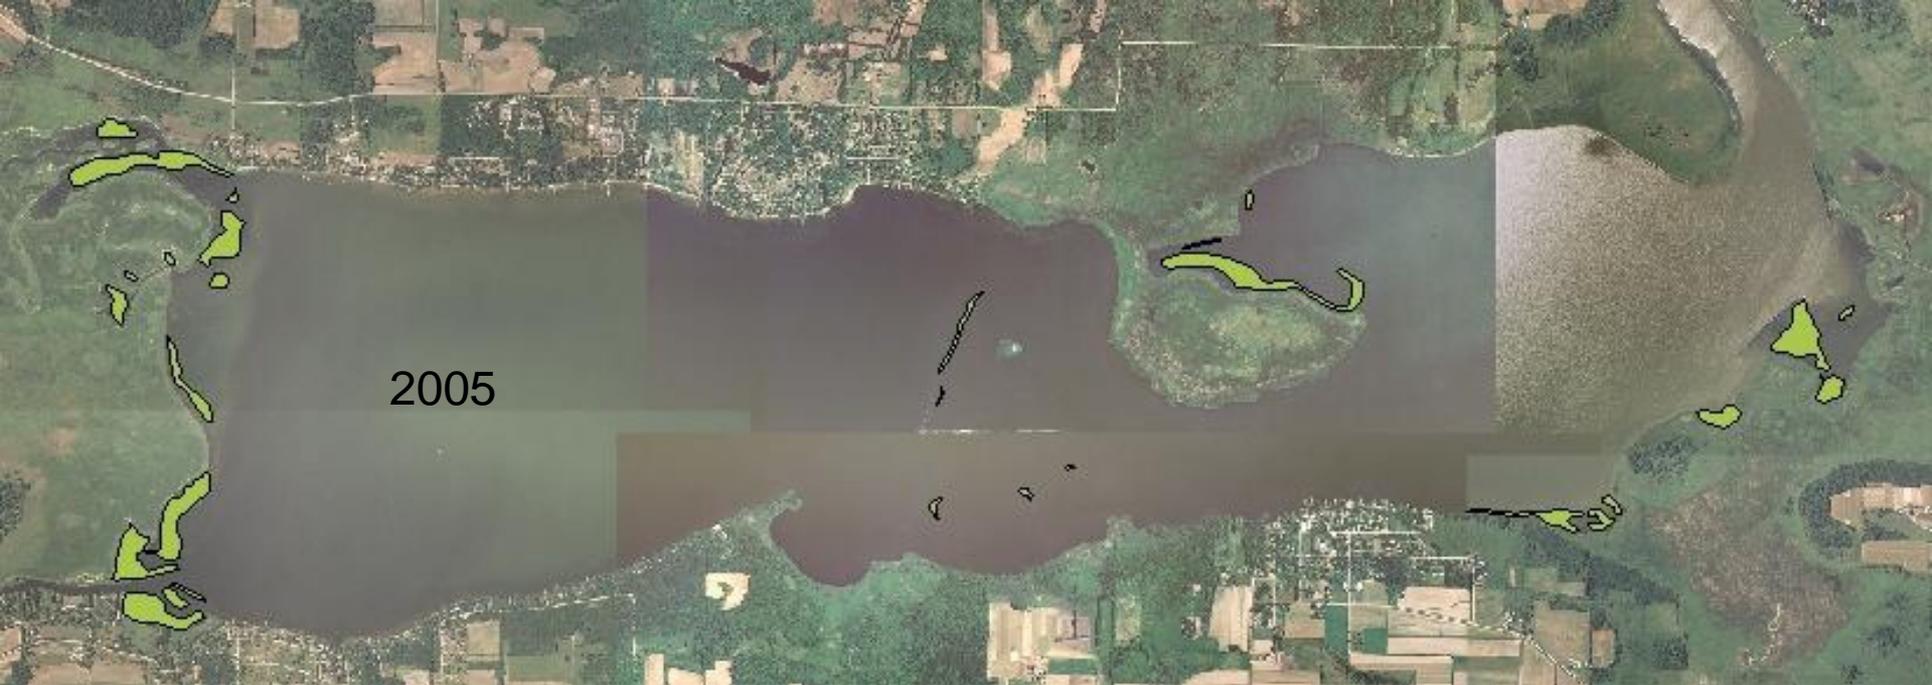
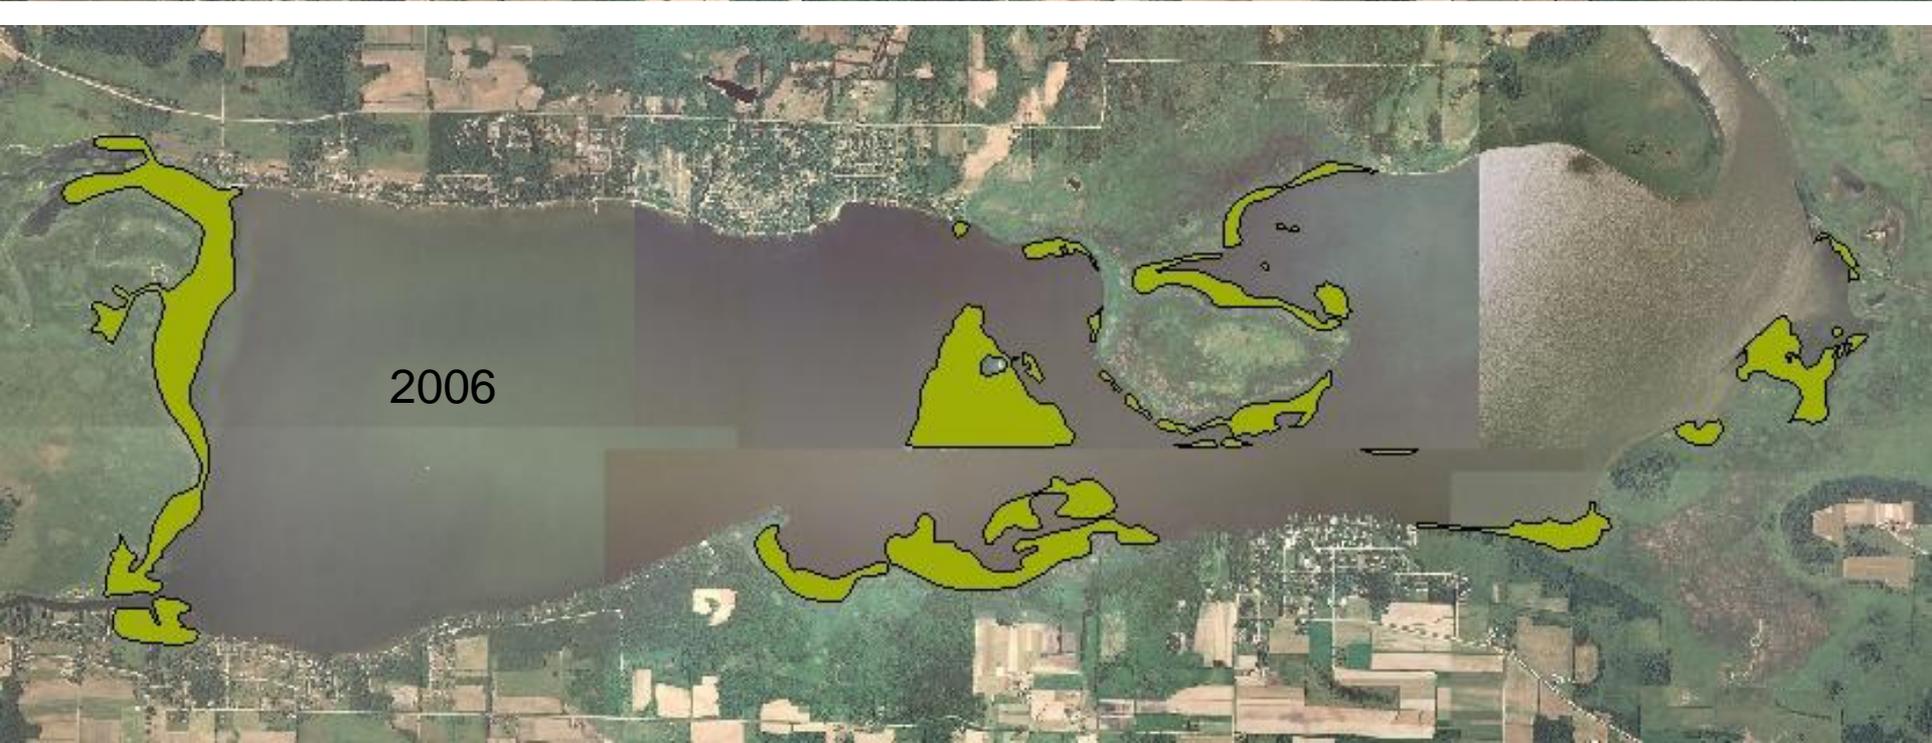
Approx. 651 acres

1989 Photographic
Analysis of visible
emergent and/or floating
leaf aquatic plant beds

- Scanned and GeoReferenced 7000 Aerial Images
- Created a Composite Image for Each Year
- Used Mapping Software to define each visible plant bed
- Software measures exact acreage of the plant beds

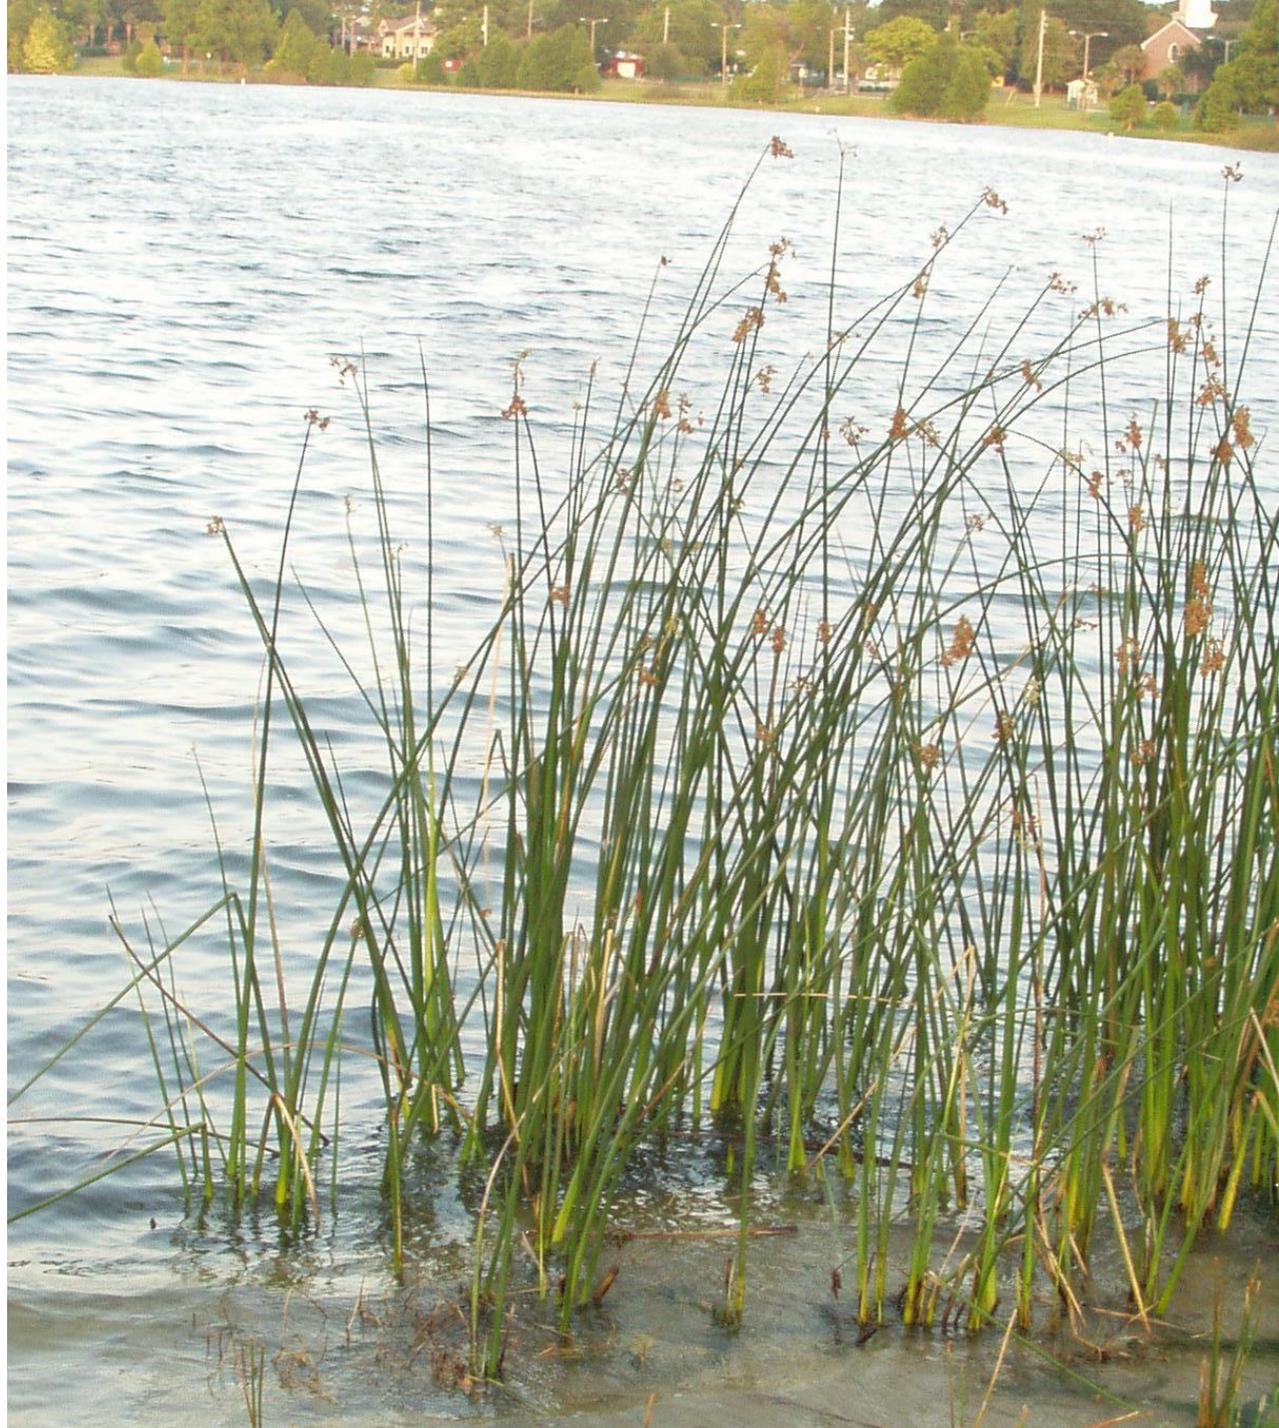
Micro-Scale Analysis:

Establish set sample points throughout the lake and conduct a plant survey annually at the same location.

Use GPS to delineate edge of emergent plant beds for comparison over time.

Begin monitoring in 2010.

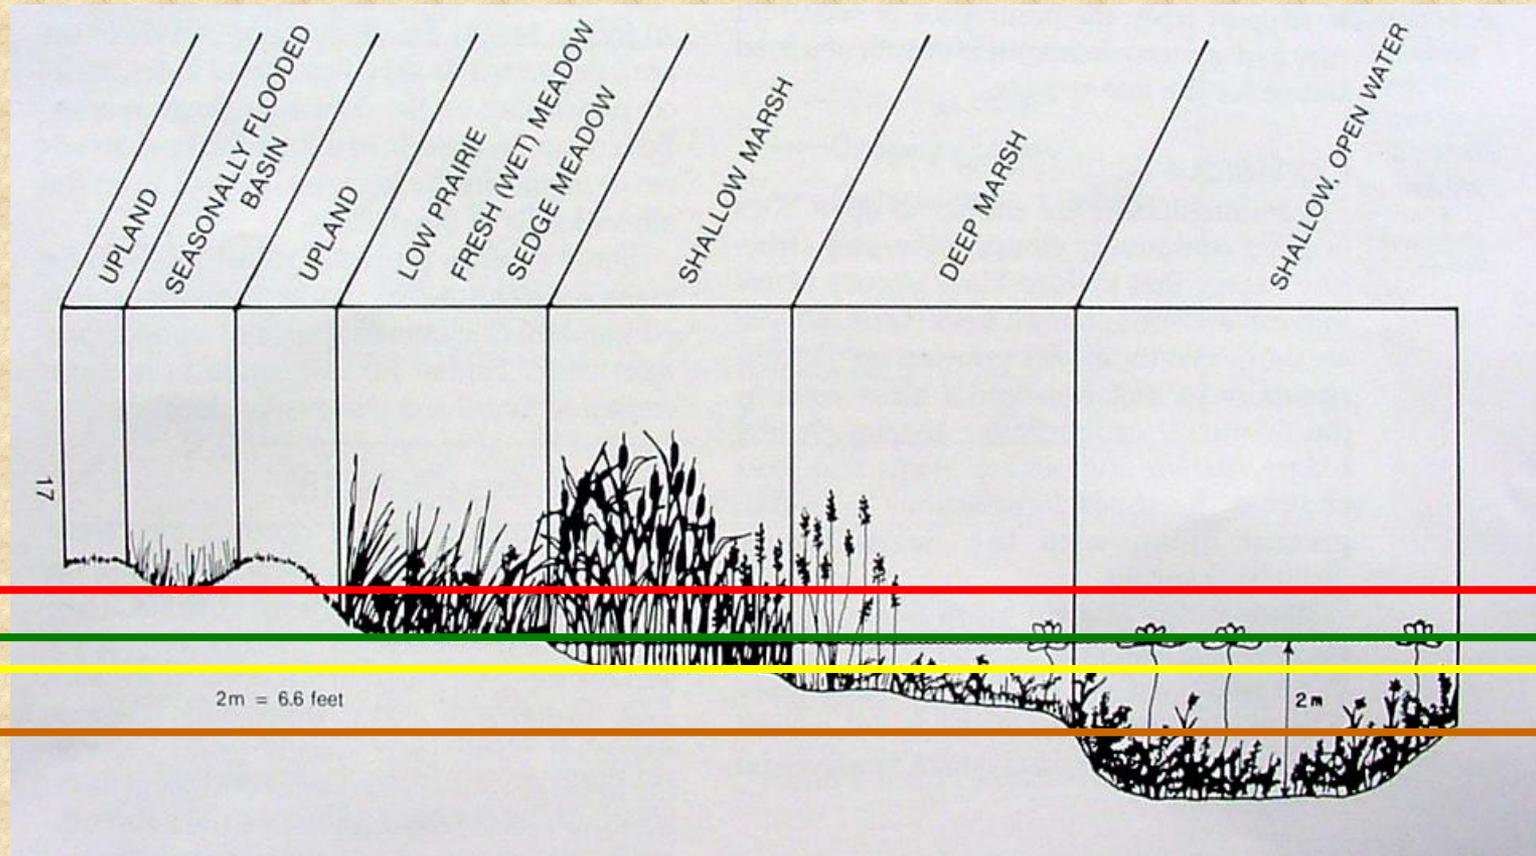
Green = Normal

Red = Flooding

Yellow = Drought

Brown = Extended Drought
