Quantifying the Ecological Benefits of Lakeshore Restoration in Wisconsin

Project Goal – Quantify the benefits of shoreland restoration by comparing habitat and wildlife endpoints at "restored" vs. "unrestored" shorelines on developed lakes. Endpoints are measured before and for 10 years after restorations.

Measuring the value of wildlife habitat restoration on northern Wisconsin lakes—the Wisconsin Lakeshore Restoration Project

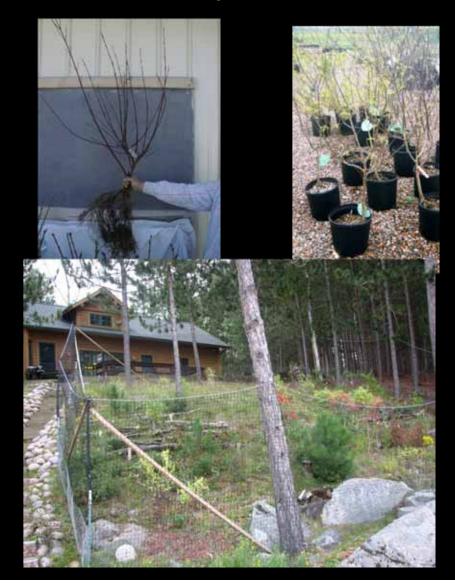
Shrub comparison study > bare root gravel culture plants versus 3-5 gallon containers

Bare root is grown in an experimental gravel culture medium that is well-watered

- Aronia melanocarpa, Cornus racemosa, Sambucus canadensis, Symphoricarpos alba, Physocarpus virginanum, Viburnum lentago
- Paired with container stock of same species
- Planted in same shoreland area
- Marked/tagged for long-term monitoring

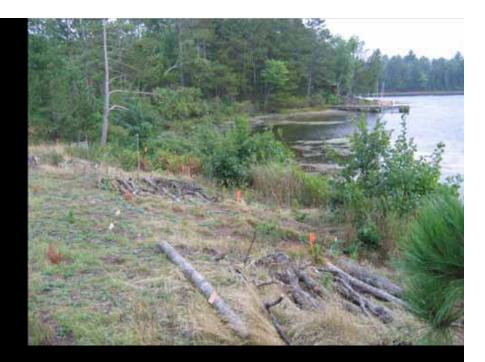
Woody habitat comparison > 10' X 10' sites

- The project is examining the use of woody habitat on restored plantings
- Monitoring changes in soil temperature and moisture between sites with no wood on the ground, 25% woody cover, and 50% woody cover
- Perhaps woody habitat can lessen plant mortality
