**PRELIMINARY WETLAND
MITIGATION PLAN**
MOSES CREEK MITIGATION SITE
WISDOT PROJECT I.D. 6351-01-04/74
City of Stevens Point
Portage County, Wisconsin

NRC Project No. 008-0099-02
October 2009

**PRELIMINARY WETLAND MITIGATION PLAN
MOSES CREEK MITIGATION SITE
WISDOT PROJECT I.D. 6351-01-04/74**

**UWSP, SCHMEEKLE RESERVE, CITY OF STEVENS POINT
PORTAGE COUNTY, WISCONSIN**

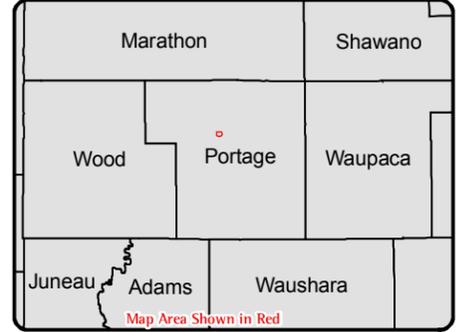
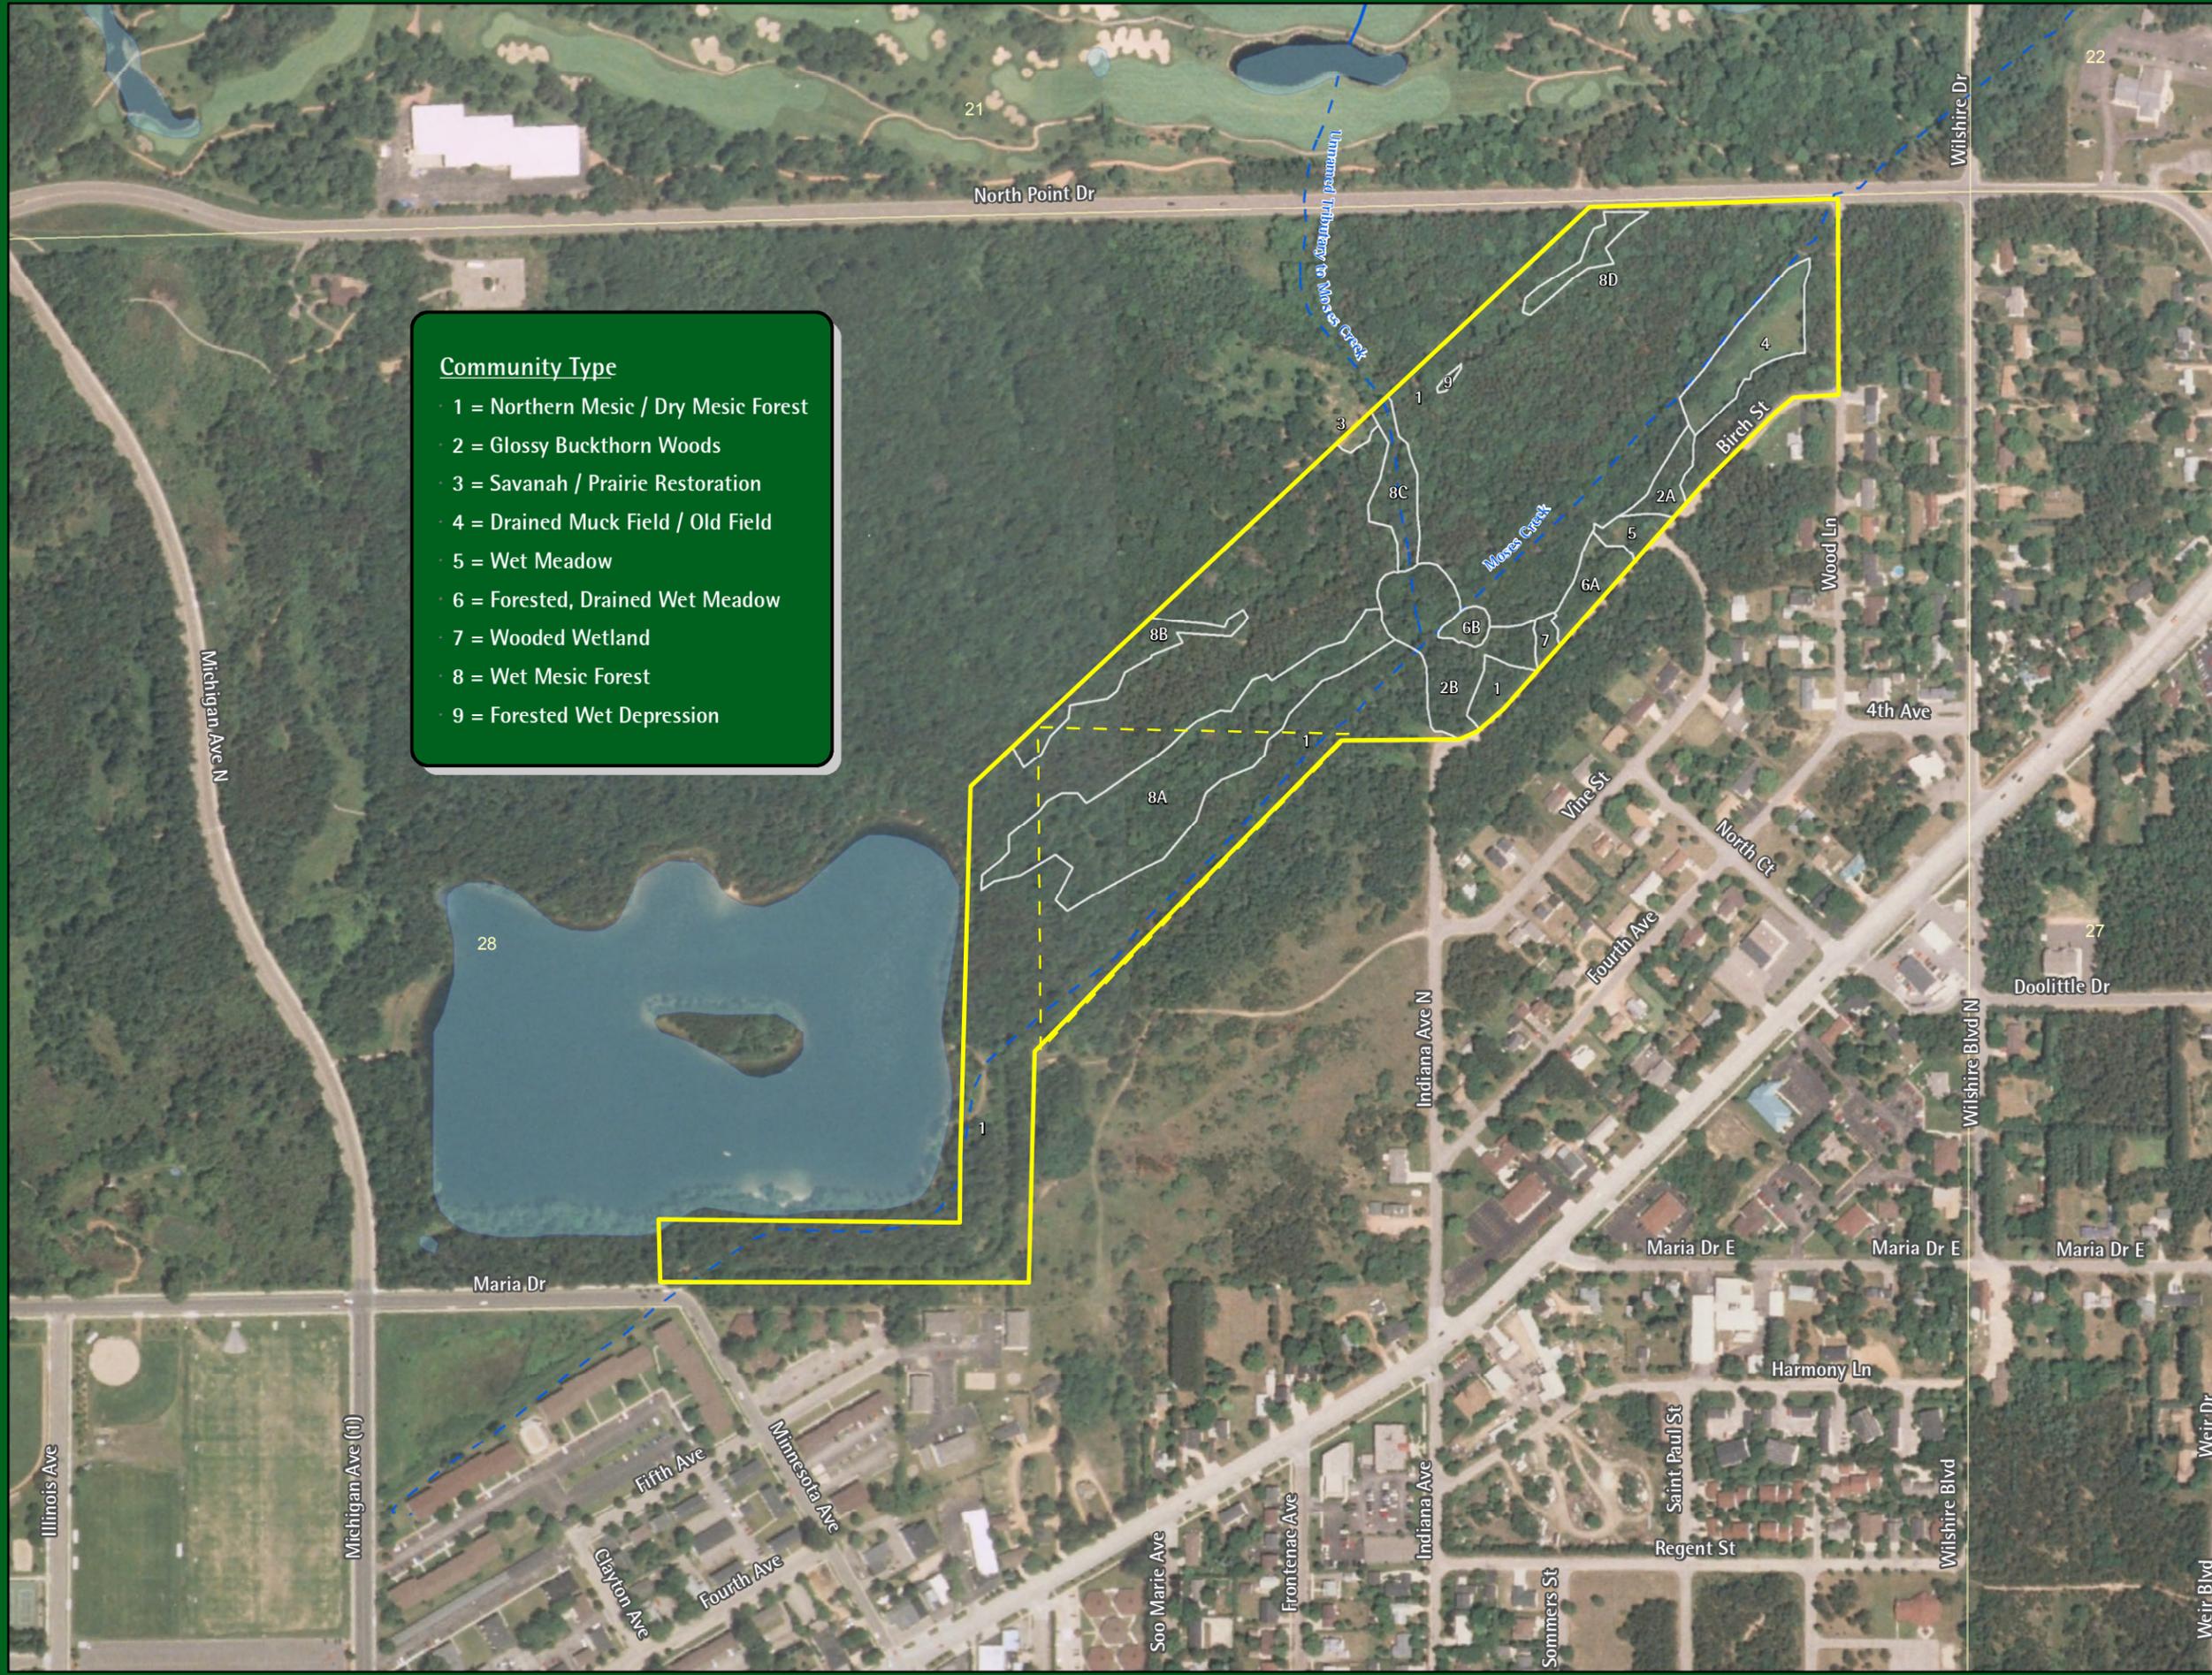
On-Site Plant Communities Moses Creek

- 1 = Northern Mesic / Dry Mesic Forest
- 2 = Glossy Buckthorn Woods
- 3 = Savannah / Prairie Restoration
- 4 = Drained Muck Field / Old Field
- 5 = Wet Meadow
- 6 = Forested, Drained Wet Meadow
- 7 = Wooded Wetland
- 8 = Wet Mesic Forest
- 9 = Forested Wet Depression

Community 2B is a woodland stand dominated by glossy buckthorn that is located in the central portion of the project area. A total of 25 species were identified within this community, 16% of which are exotic. Tree species such as quaking aspen and paper birch cover approximately 60% of the stand. Glossy buckthorn is the dominant plant in the shrub and herbaceous layers, with areal coverages of 80% and 100%, respectively. This community was considered ecologically degraded due to the prevalence of glossy buckthorn.

Community 4 is an old field community with drained muck soil that is located in the northeast portion of the project. A total of 52 species were identified within this community, 35% of which are exotic. This community is dominated by Canada thistle (*Cirsium arvense*), Morrow's honeysuckle (*Lonicera morrowii*), reed canary grass, Kentucky blue grass, and common goldenrod. This community was considered ecologically degraded due to the amount of exotic species and the prevalence of Canada thistle, Morrow's honeysuckle, reed canary grass, and Kentucky blue grass.

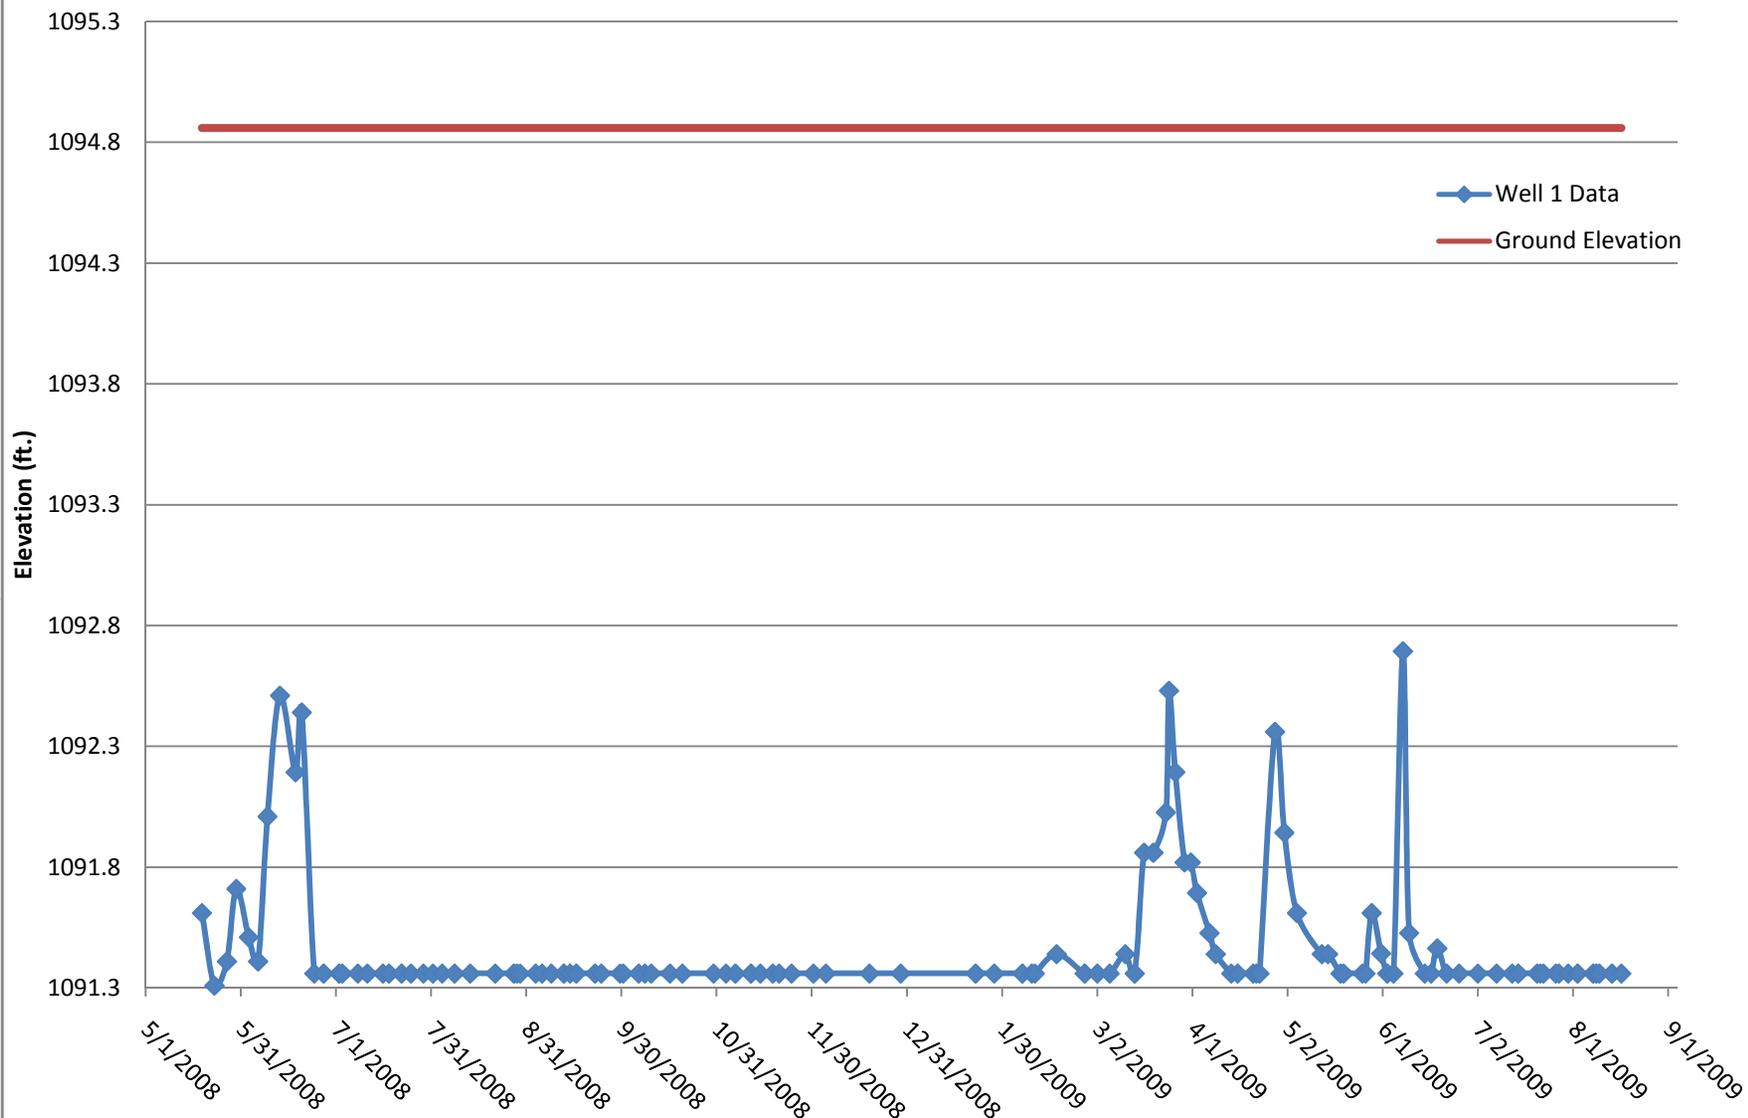
Monitoring Well 1 Hydrograph

Install Date: 5/19/2008
 Soils: 0-6 10YR 3/2, Sandy Loam
 6-19 10YR 3/4 Loamy Sand
 19-35 7.5YR 4/6 Sand
 35-43+ 10YR 5/3 Sand
 *Popper Correlation = 0.25 feet

These data have provided a representation of groundwater elevations across the site, and provide information related to seasonal groundwater fluctuations (see Monitoring Well Data, Appendix B). The groundwater elevation is highest in the north portion of the site. Highest water table elevations observed at monitoring Wells 1, 2, and 3 were approximately 1092.3, with Well 1 having slightly higher elevations and Well 3 slightly lower. Median water elevations from the beginning of May through the end of June over the two year monitoring period was 1091.2 at Well 2 and 1090.7 at Well 3. Well 4 had a high ground water elevation of 1090.7, with a median May through June value of 1089.5.

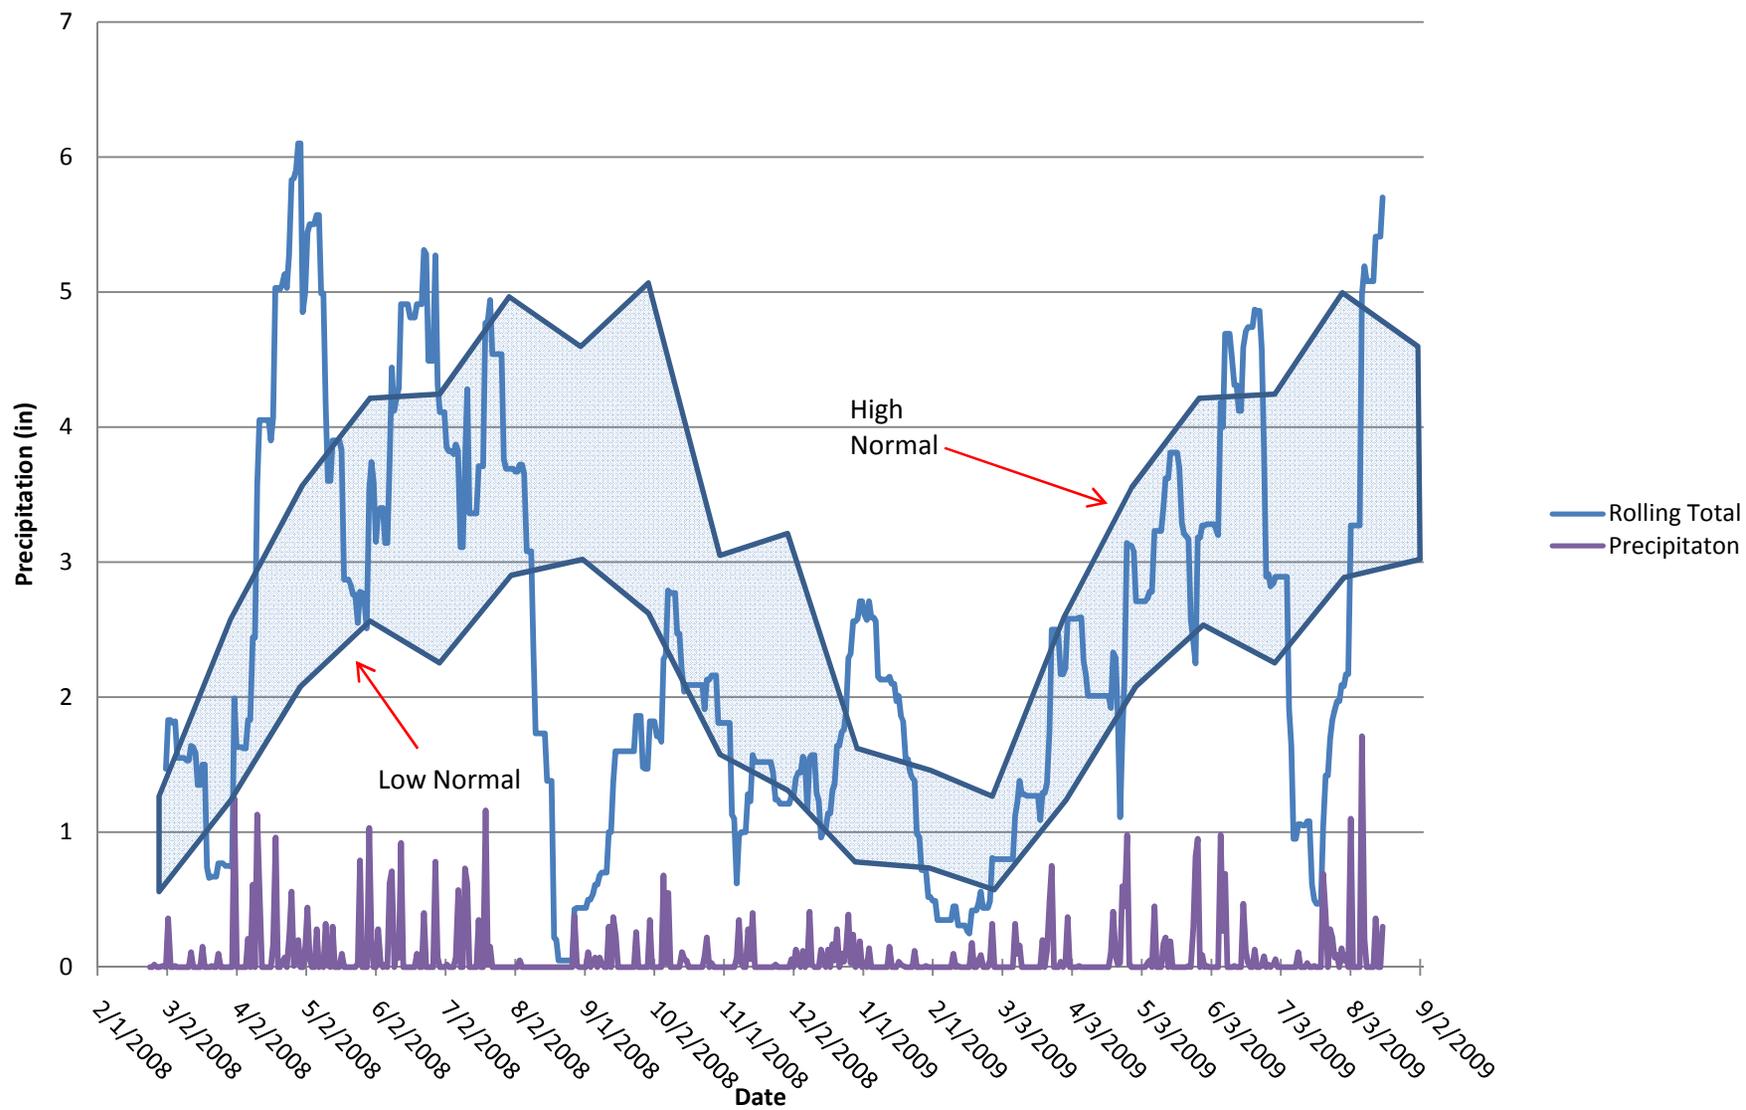
Figure 7. 30 Day Rolling Total Analysis Using Stevens Point NWS Station and WETS Data

Climatic conditions varied over the 2008 growing season (see Precipitation Analysis, Appendix B). A 30 Day Rolling Total Analysis indicates that abnormally high amounts of rainfall were recorded for all of April and most of June, but abnormally low amounts of rainfall were recorded from the end of July until the start of October. In 2009 rainfall values were mostly in the normal range from the beginning of March through the end of June, with an abnormally dry period occurring during July.

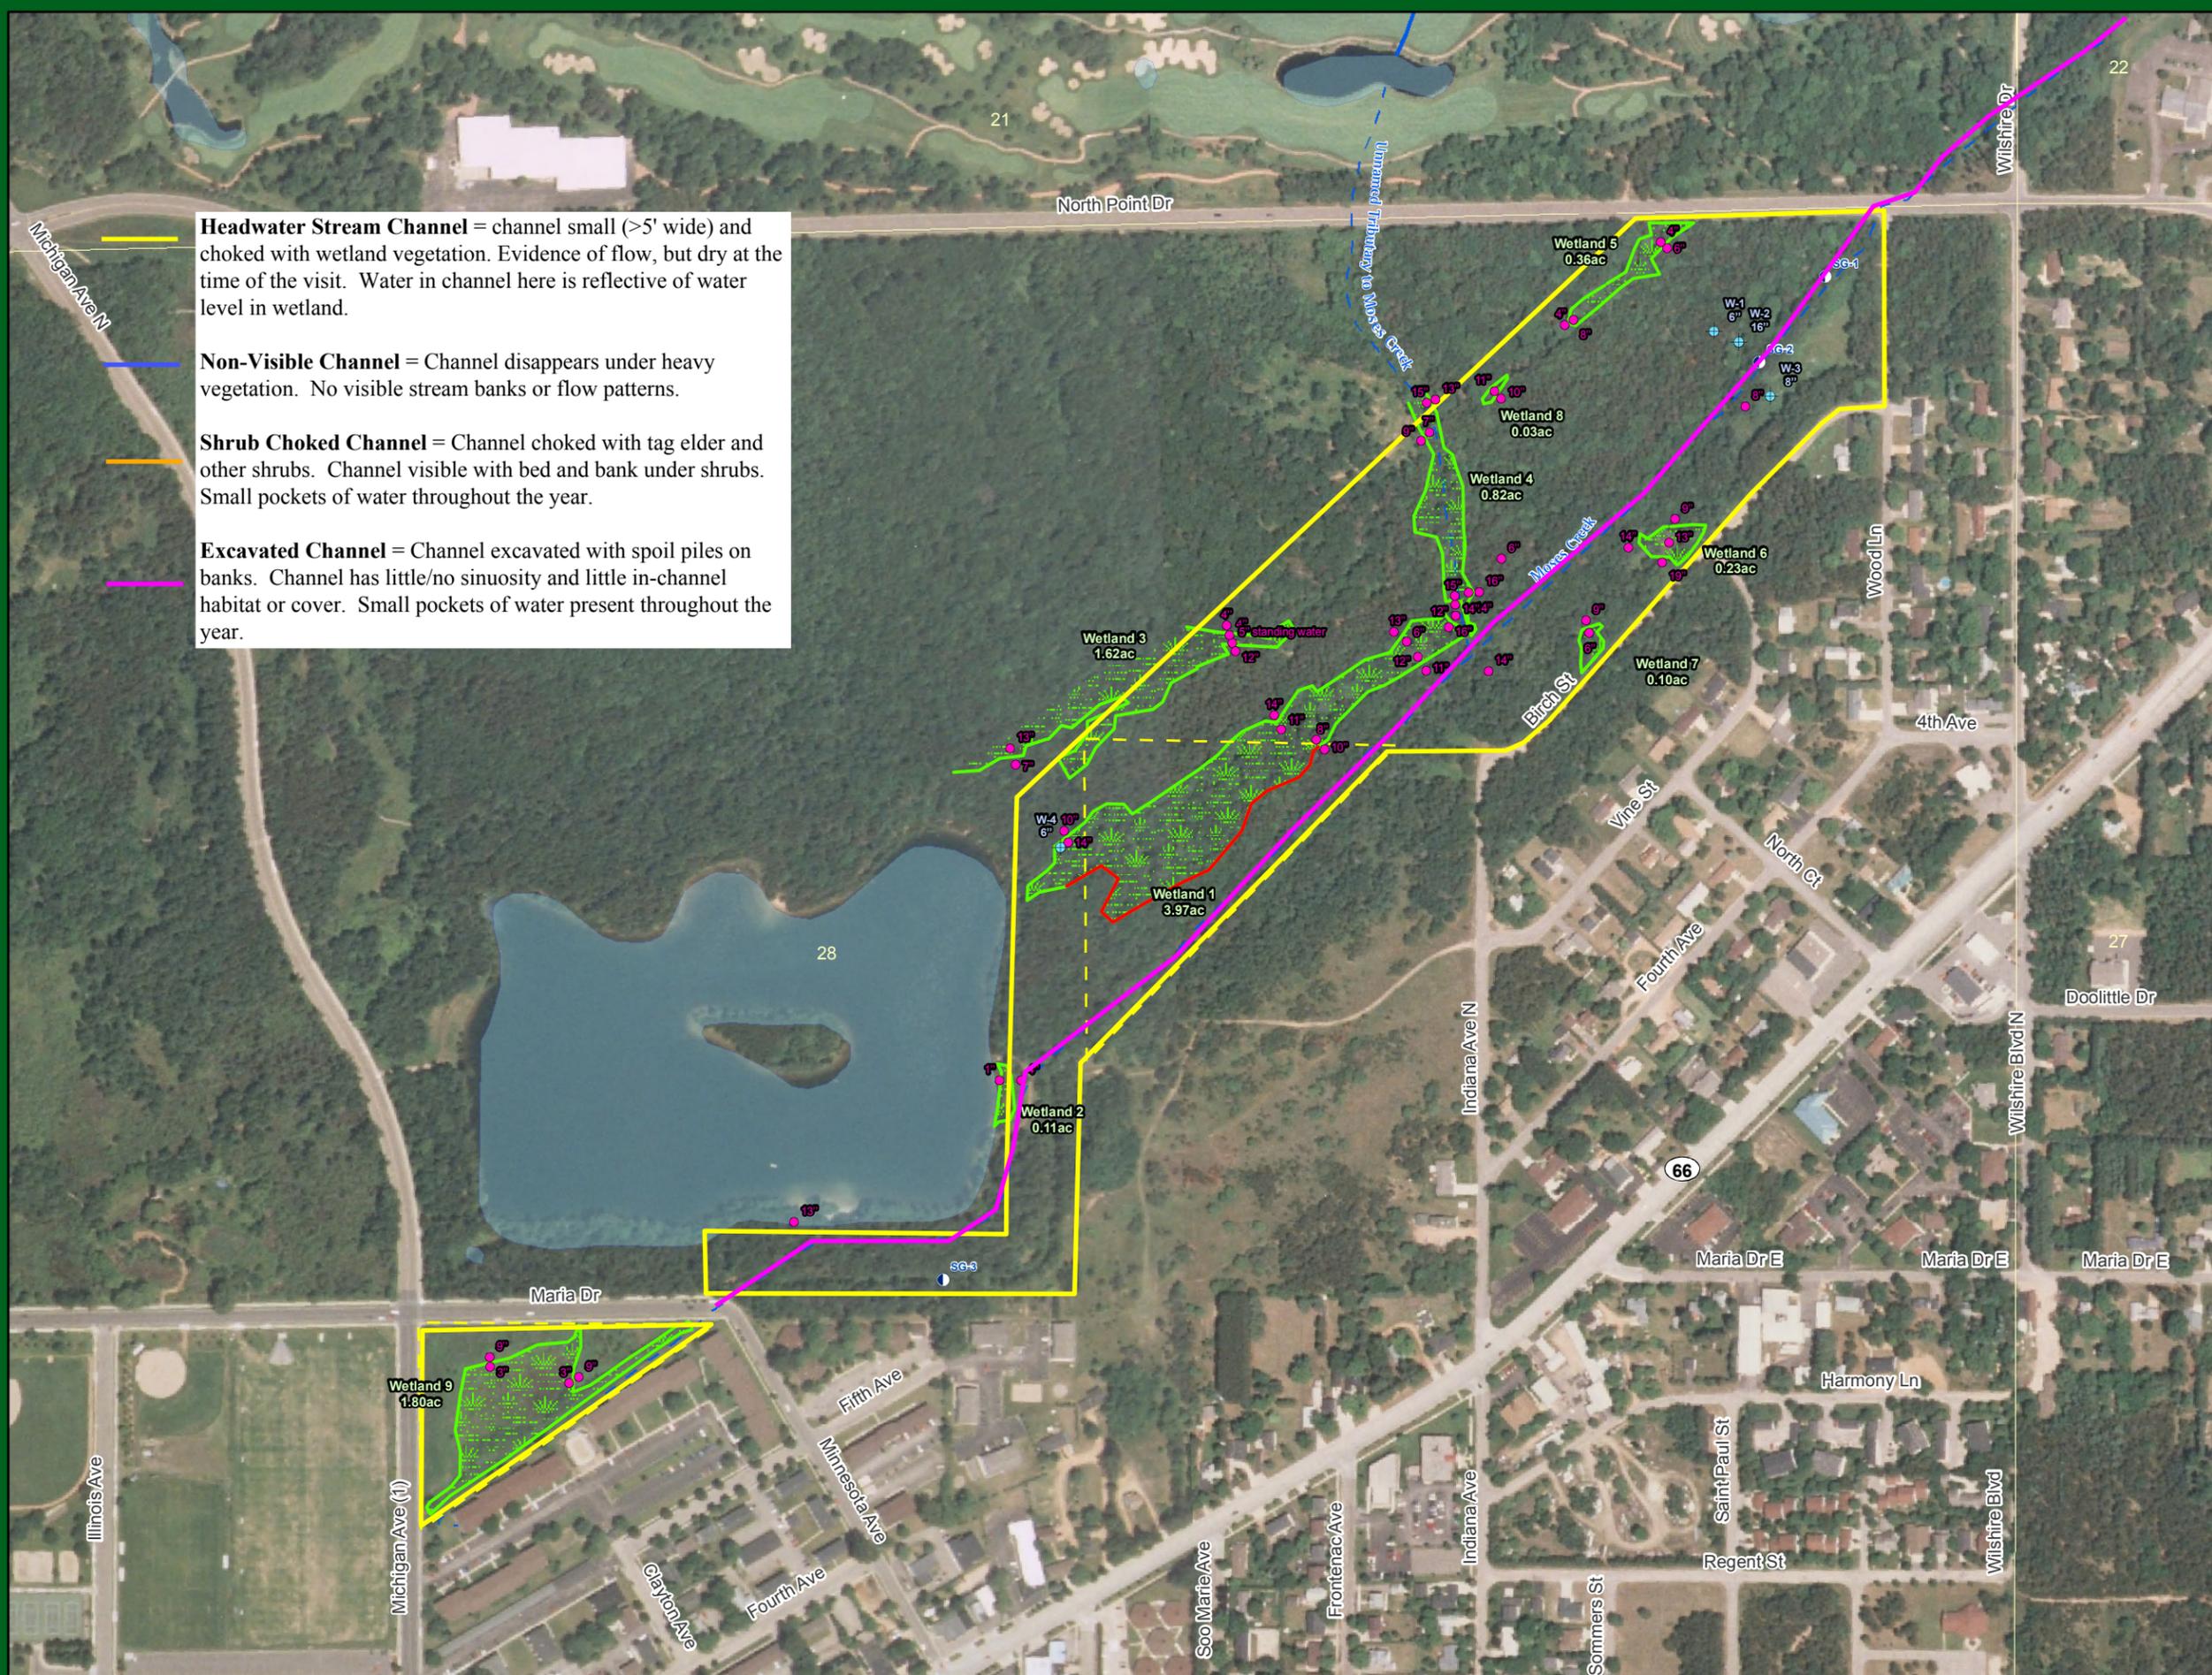
Shrub Choked Channel = Channel choked with tag elder and other shrubs. Channel visible with bed and bank under shrubs. Small pockets of water throughout the year.

Excavated Channel = Channel excavated with spoil piles on banks. Channel has little/no sinuosity and little in-channel habitat or cover. Small pockets of water present throughout the year.

Roughly 2,500 linear feet of the lower Moses Creek channel has been excavated and straightened. The channelization begins at the road embankment of INT 39 and continues in a mainly northeast direction. Spoils piles were observed on the banks of the stream at all locations surveyed during the site visit. At the time of the visit, minimal water was observed in the channel with no flow, and several large debris dams were noted. In-stream habitat in the excavated areas is minimal with deeper pools and detritus making up the majority of potential habitat. The channel is roughly 15 feet wide with banks averaging 3-4 feet high. Substrate in this area is comprised of sand, mud and some areas of larger gravel. Upstream from the channelized portion, the stream disappears into an alder thicket and is not readily visible until roughly 1,000 feet south of reference reach.

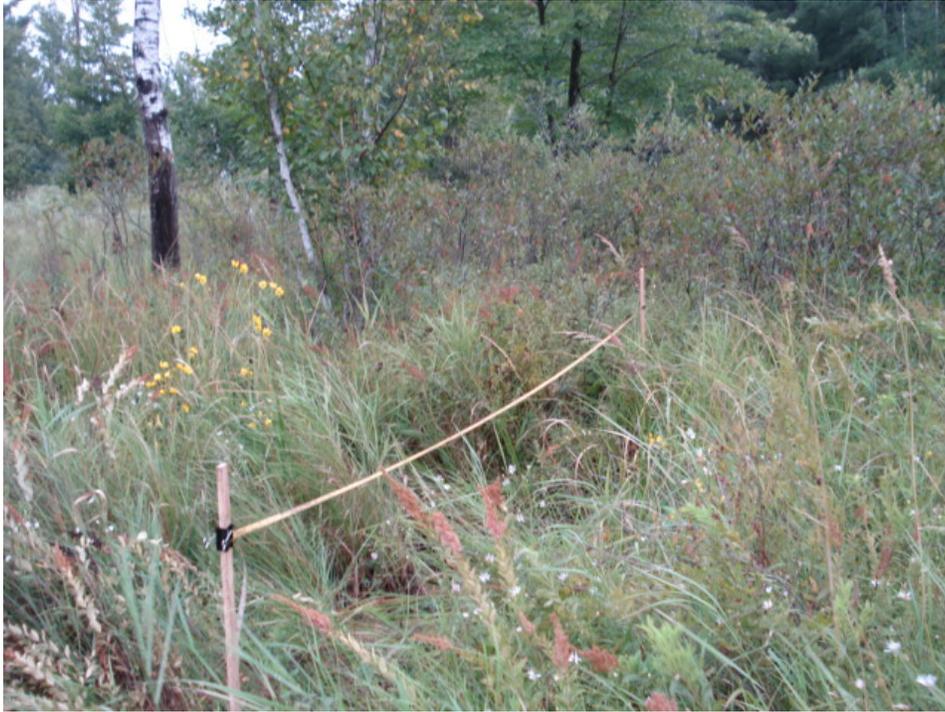
Reference site MC-RR-1 and channel cross section

At the time of the visit, Reference Reach 1 (MC-RR-1) was dry and considerable native vegetation was growing in the stream channel. There were obvious signs of prior flow in the form of debris dams and sediment deposits. The banks are well vegetated with a mixture of sedges and brush species as well as an intermittent wetland tree species. Substrate in this reach appeared to be comprised mainly of a highly organic muck, but areas of well sorted sand were observed throughout the reach. Because there was no baseflow at the time of the visit, no macroinvertebrate or fish observations were made, however, several species of adult dragonflies, damselflies, caddis flies and mayflies were observed flying throughout the site. The channel cross section and longitudinal profile was surveyed using a laser level set at an arbitrary elevation of 100 feet. A figure showing the location of MC-RR-1 is presented in attachment A.

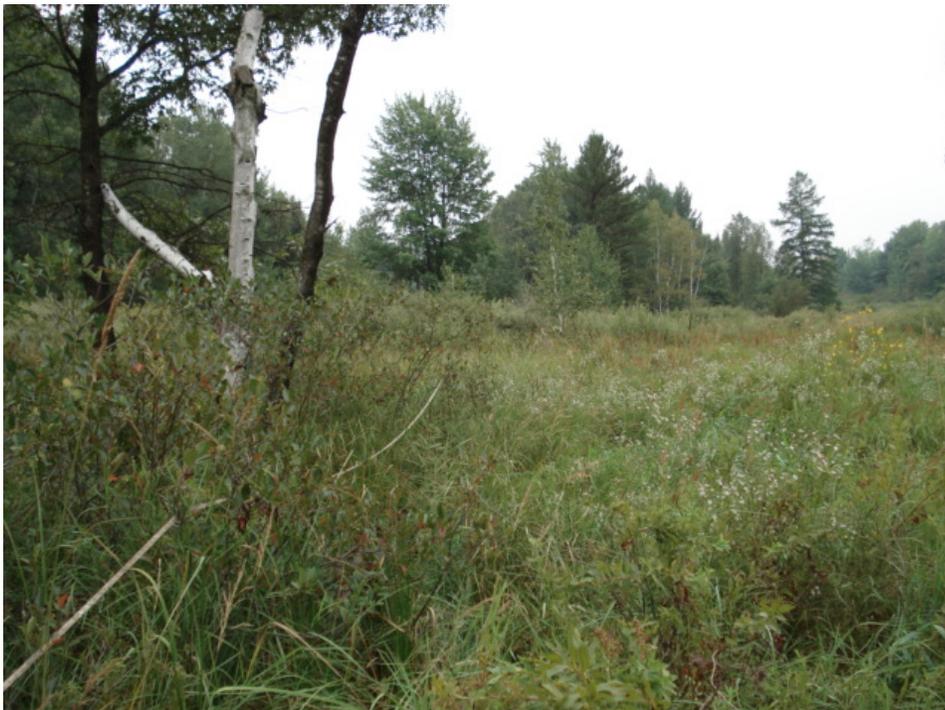
Longitudinal profile looking south

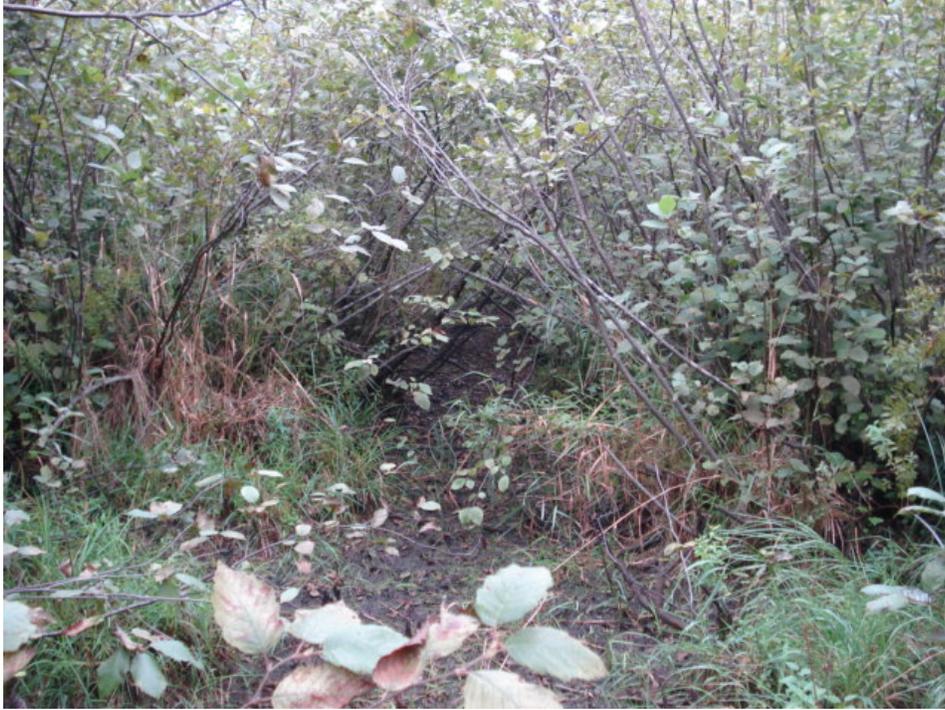
Moses Creek channel choked with tag elder. Photo taken looking north roughly 3,000 feet north of INT 39.
