2008-09 EWM Management on McDill Pond, Stevens Point, WI

Paul Skawinski – Portage Co. AIS Coordinator
Scott Provost, DNR Water Resources Specialist
Krista and Greg Olson, McDill Lake P&R District

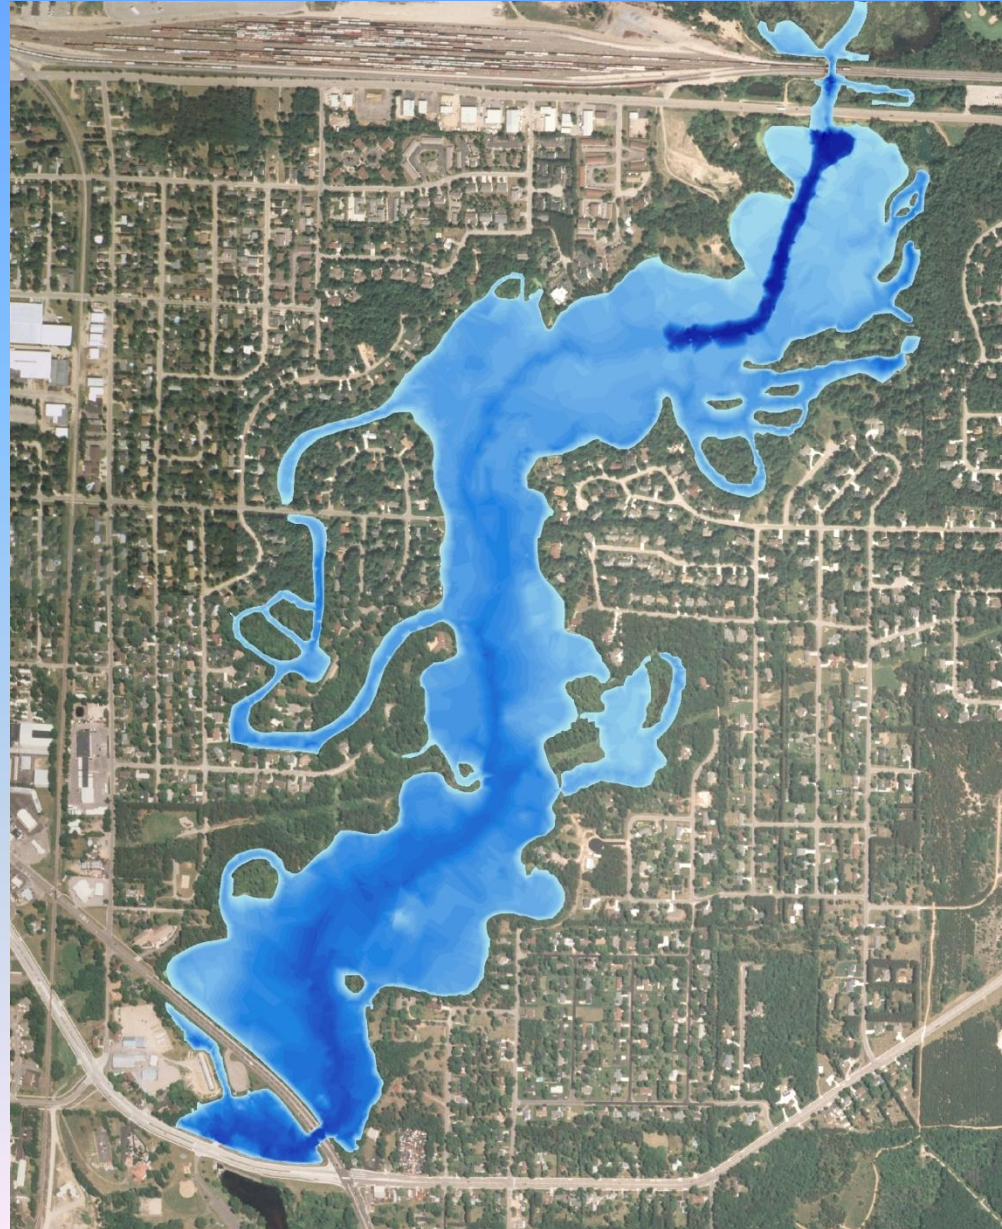
261 acres

Max depth 15ft
(excluding dredged area).

Impoundment of the
Plover River in Stevens
Point, WI.

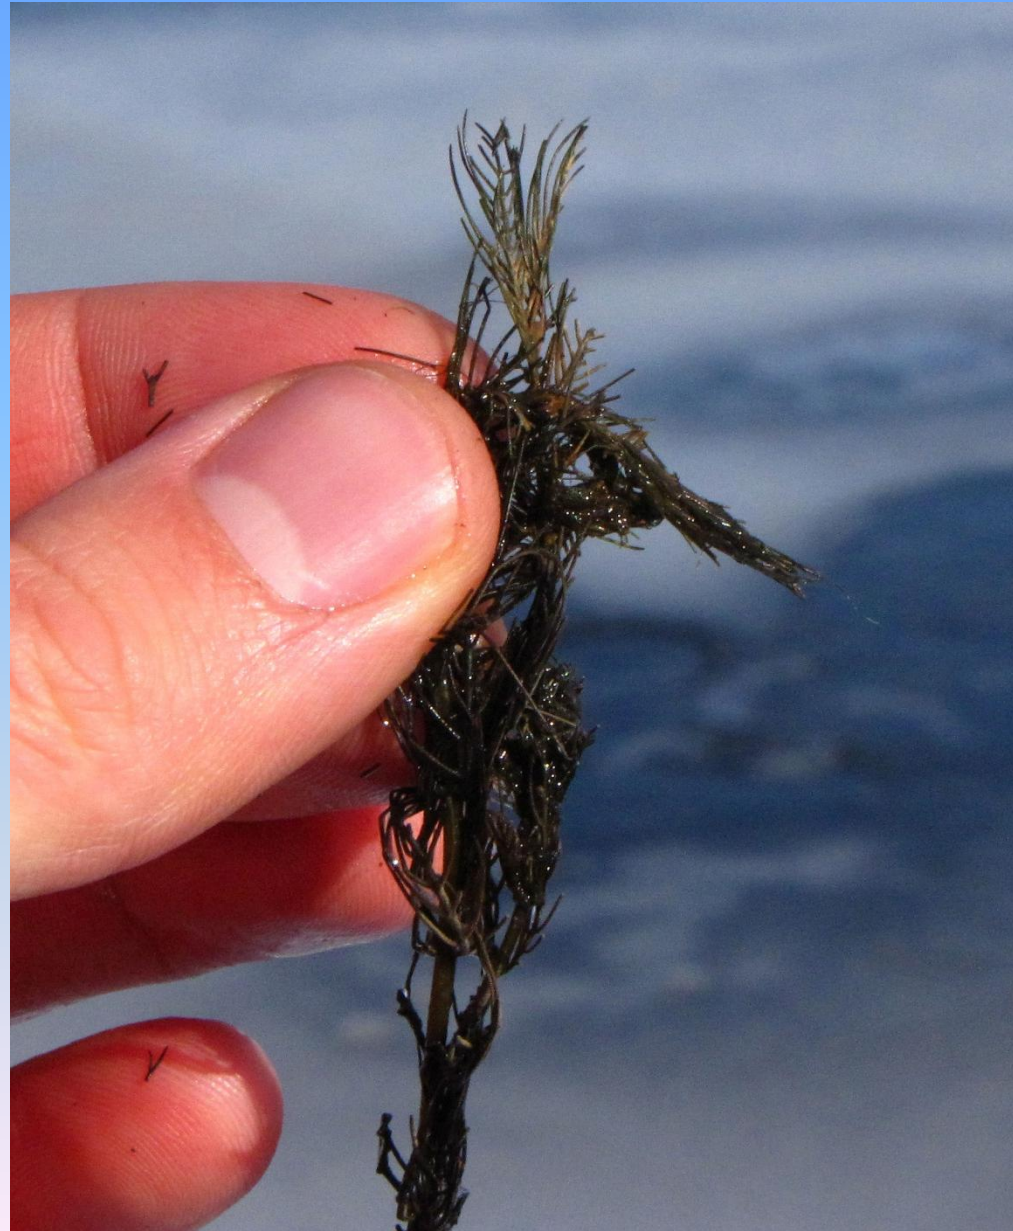
EWM Survey Jan. 29, 2009

Channel open, surveyed
by kayak with GPS unit.

Spotty EWM found.
Often hard to identify.

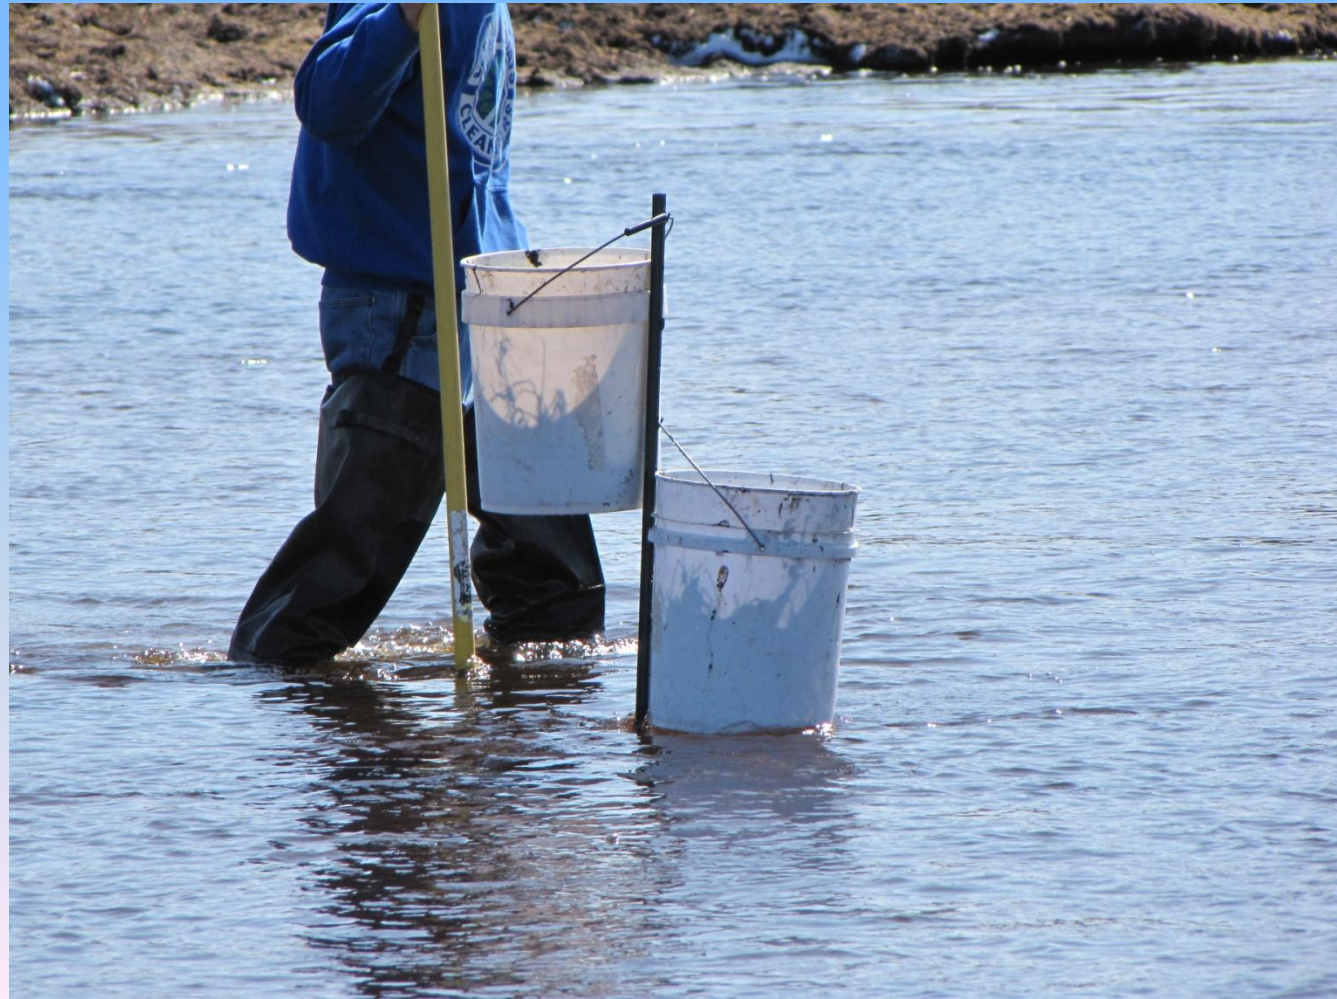
Problem #1: Buckets risk being pushed over by current.

Solution: Hang buckets on steel fence post.

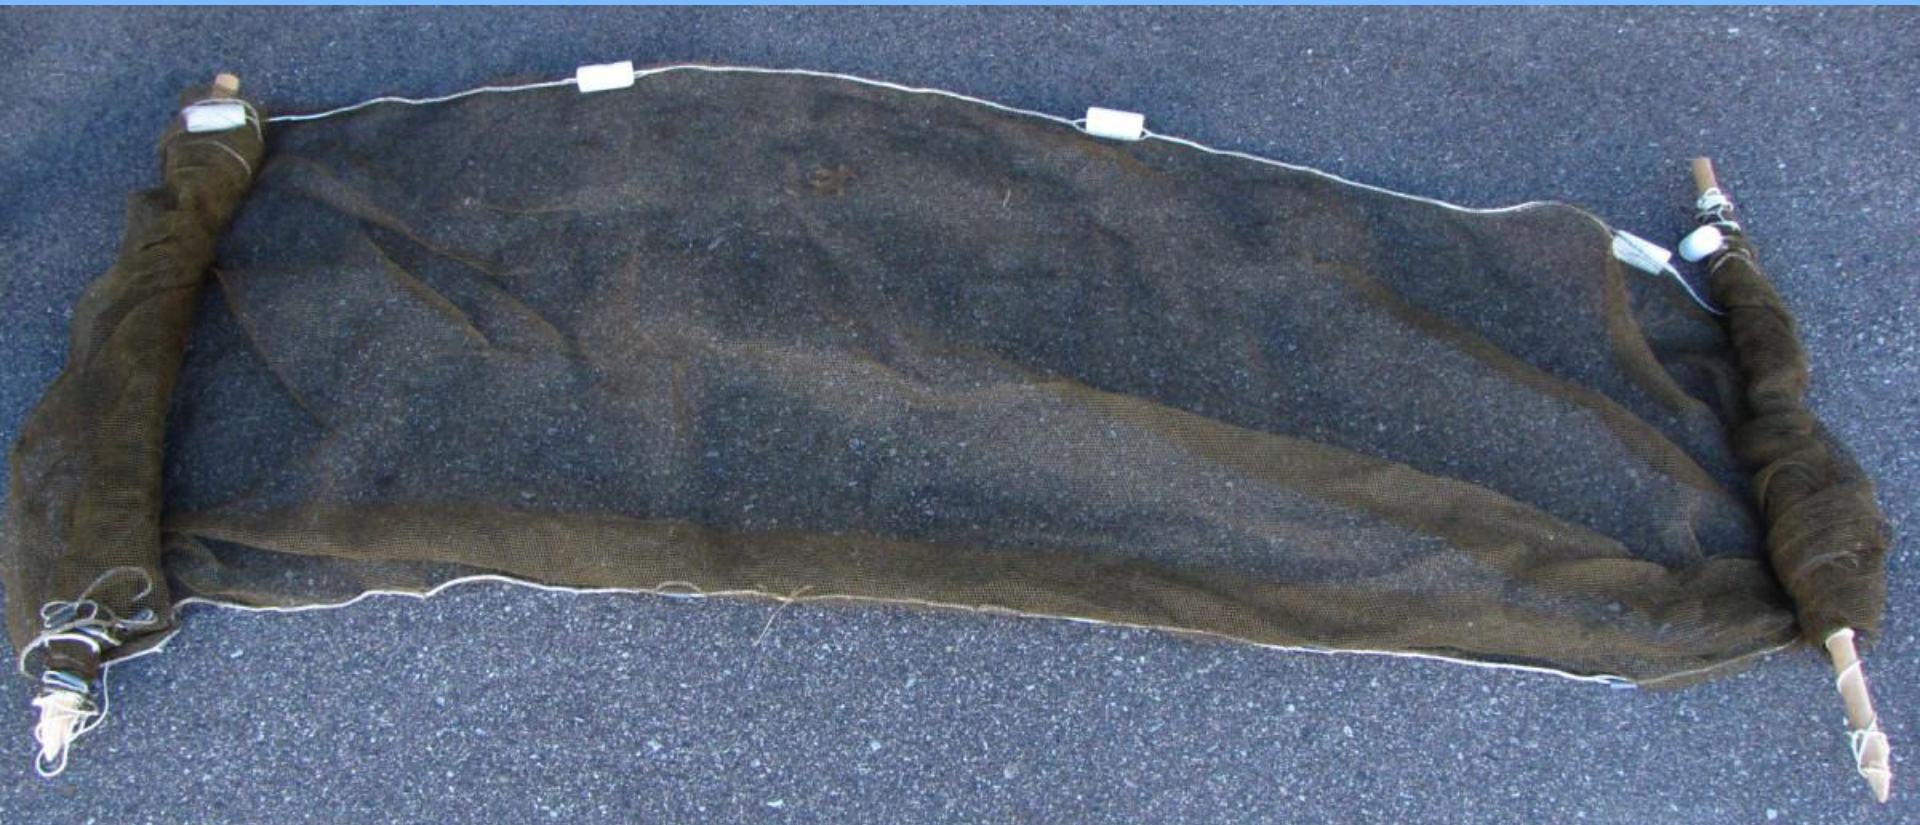
Problem #2: Fragments may get carried away.

Solution: Set up minnow seine downstream?

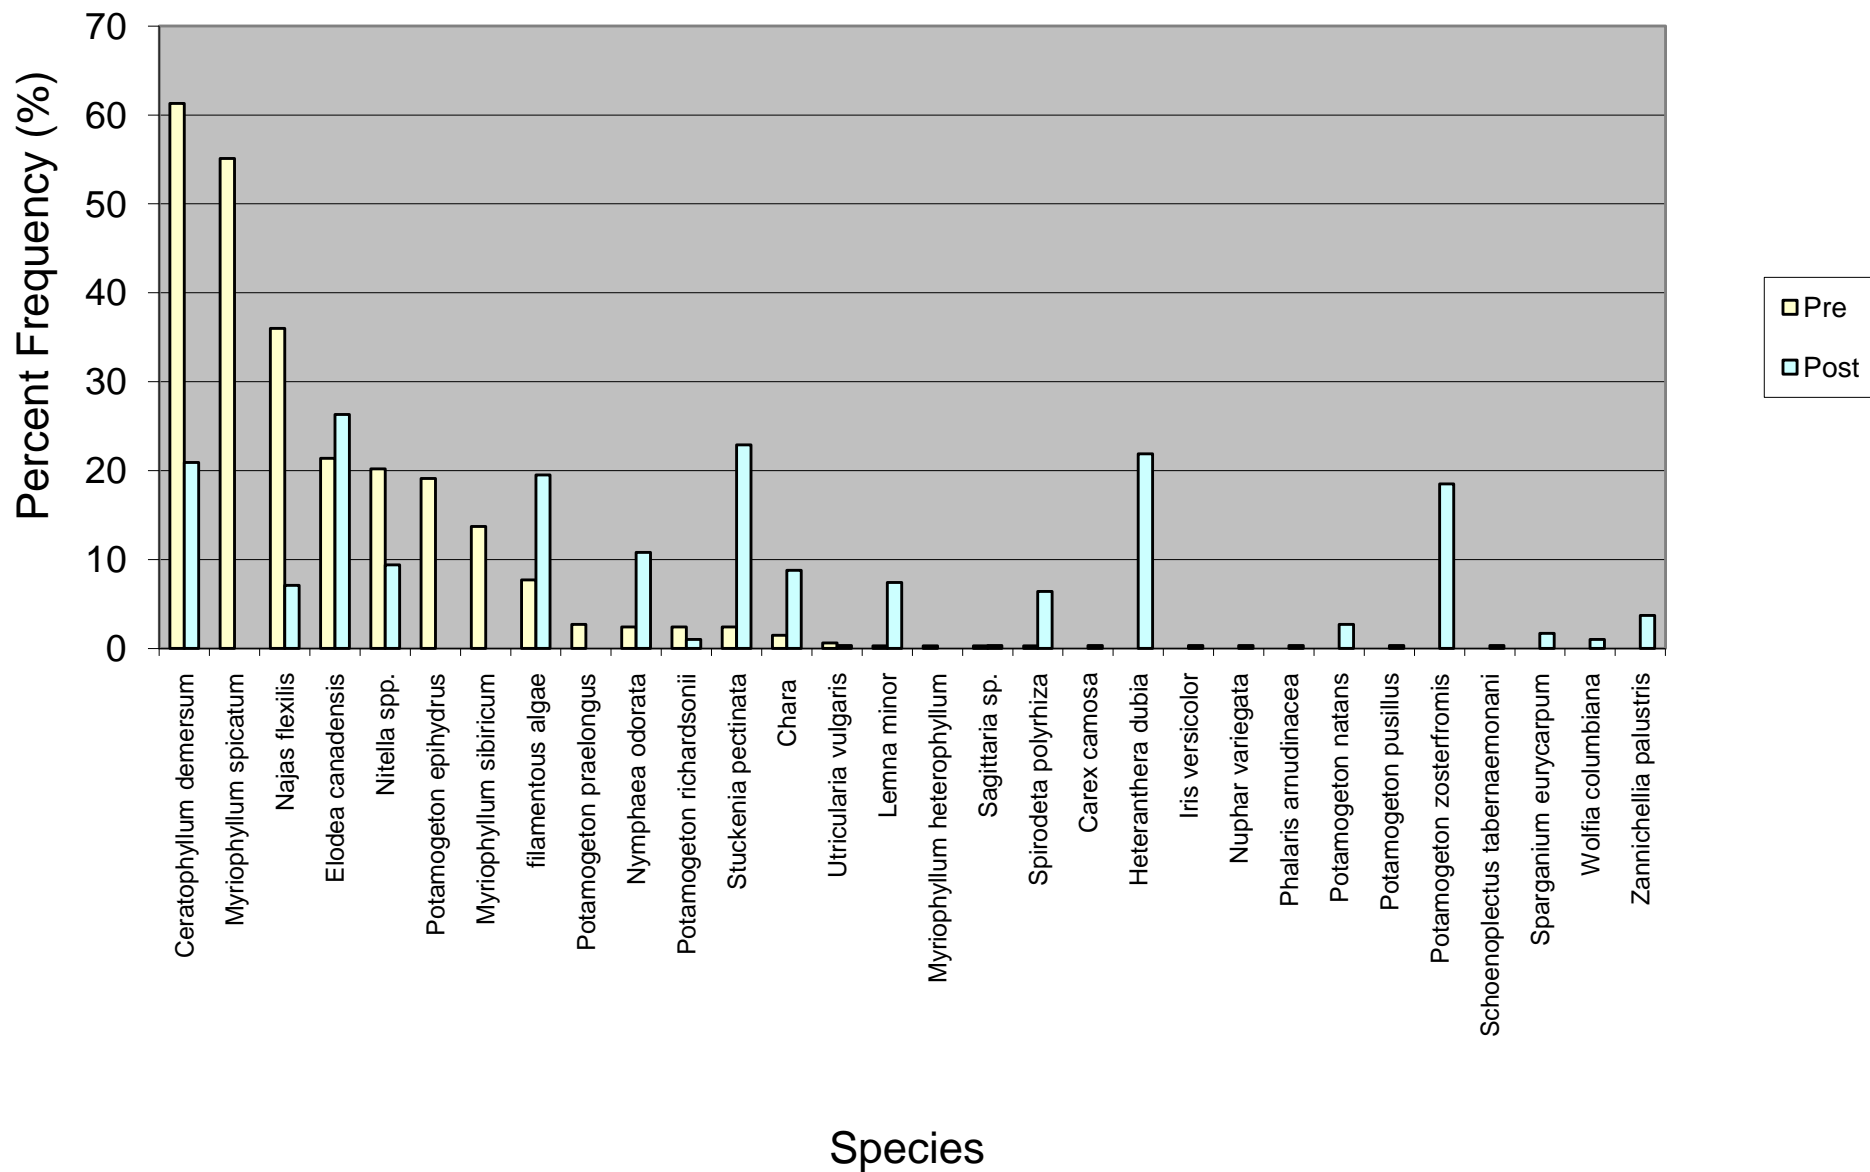
Pre and Post Drawdown Aquatic Plant Frequency, McDill Pond

- Pre FQI = 28.0; Post FQI = 36.7
- Pre n = 26; Post n = 39
- EWM in September

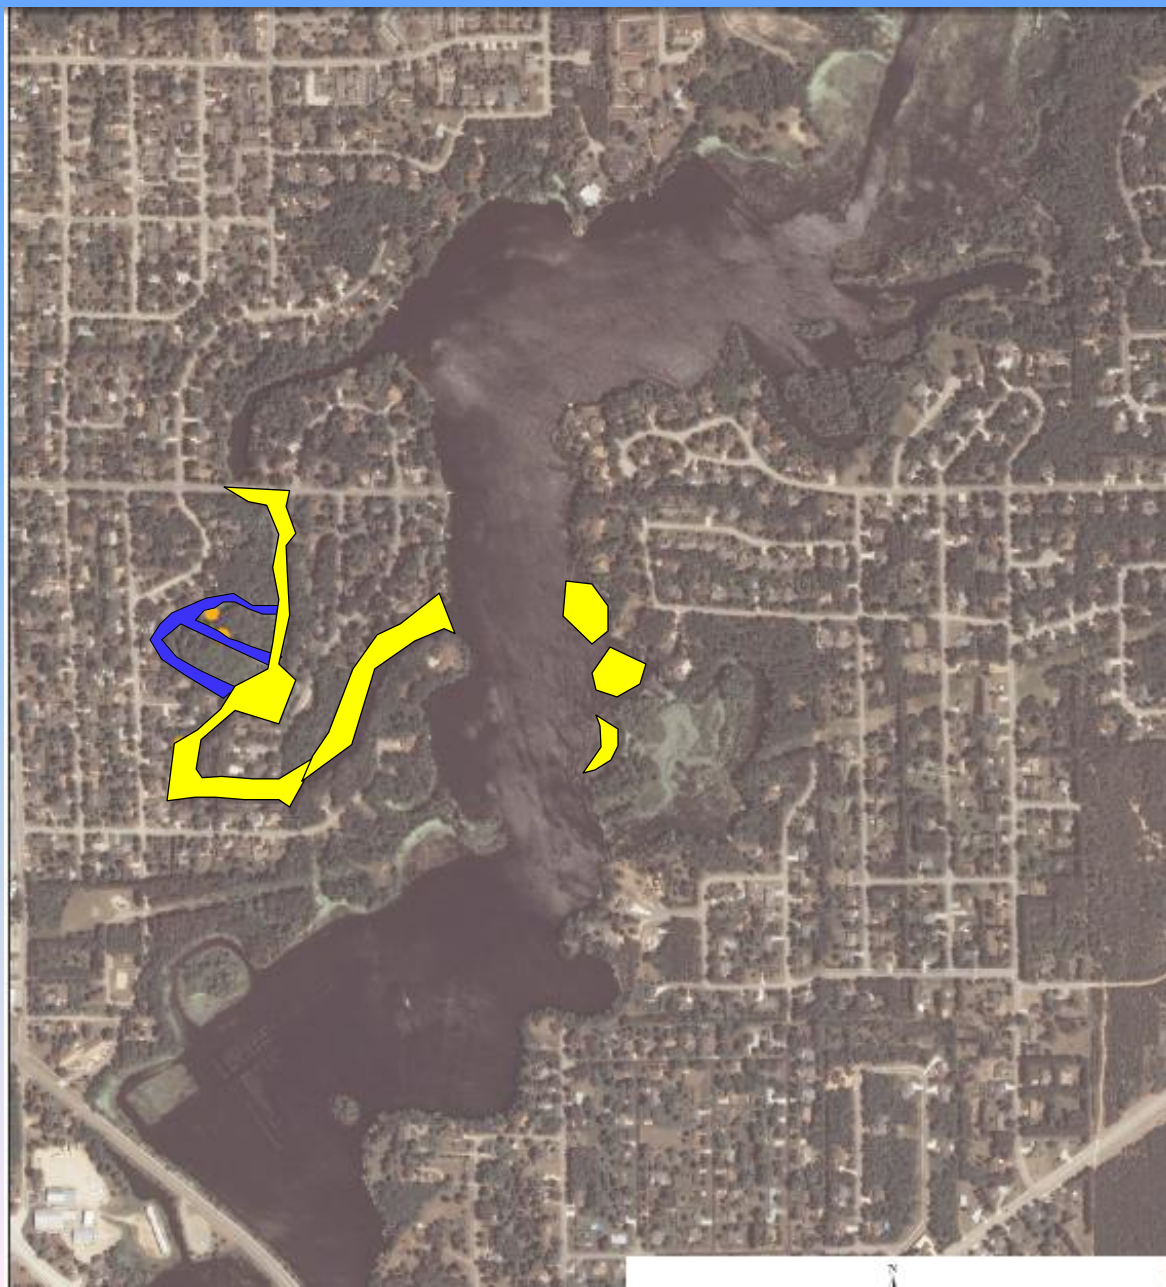
Herbicide Application Aug. '09

Liquid 2,4-D in channel.

Granular 2,4-D in main body.

Blue area (high FQI) was not chemically treated. Hand-pulled to preserve area of high FQI.

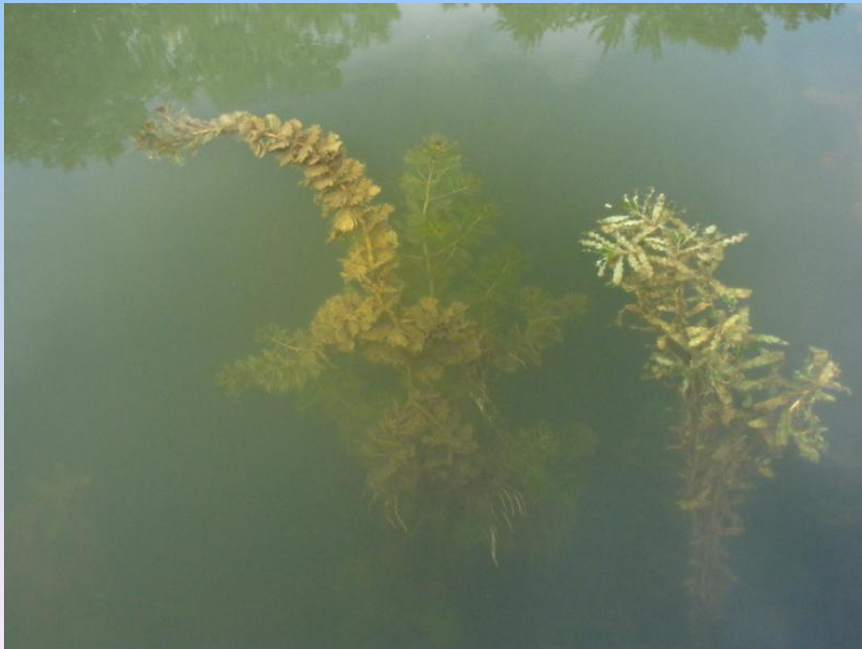
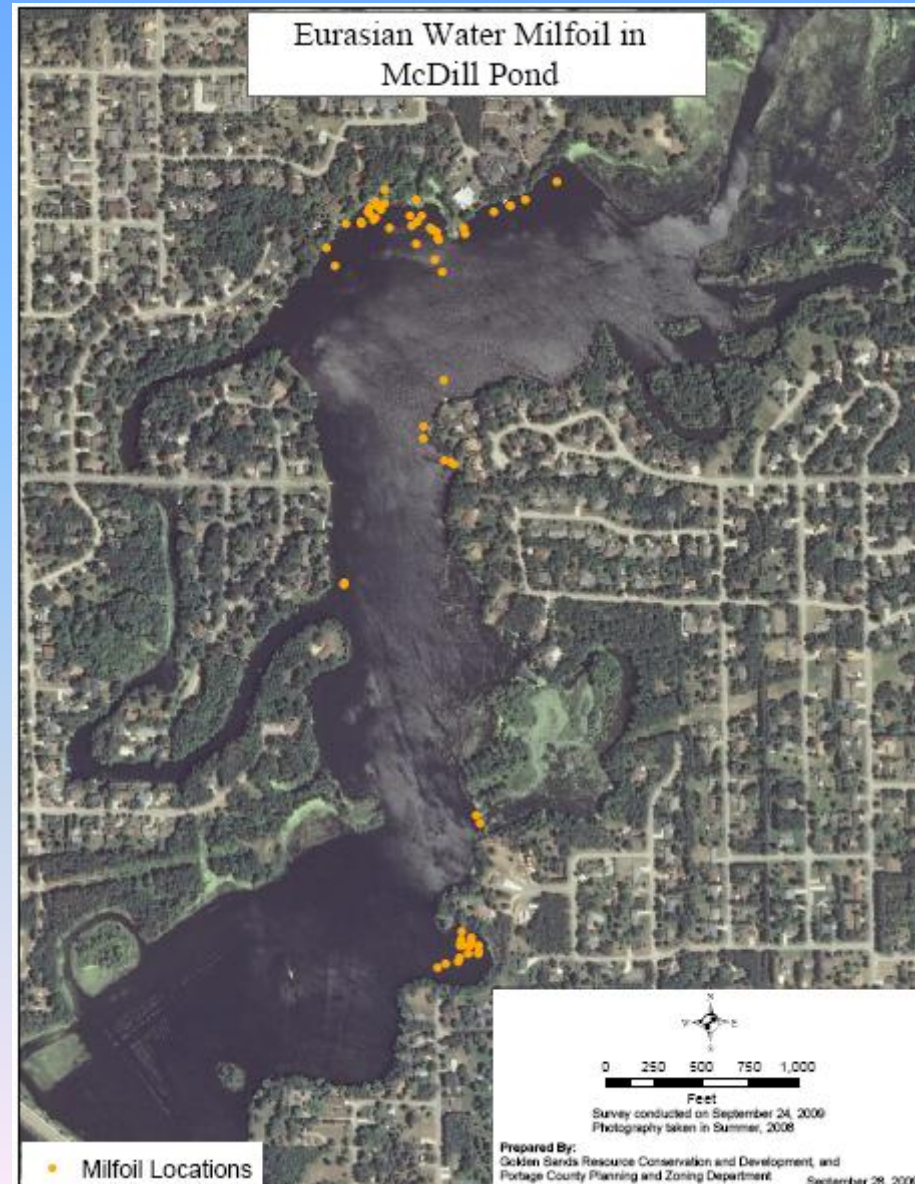
September 24th Mapping

- Some additional EWM found.

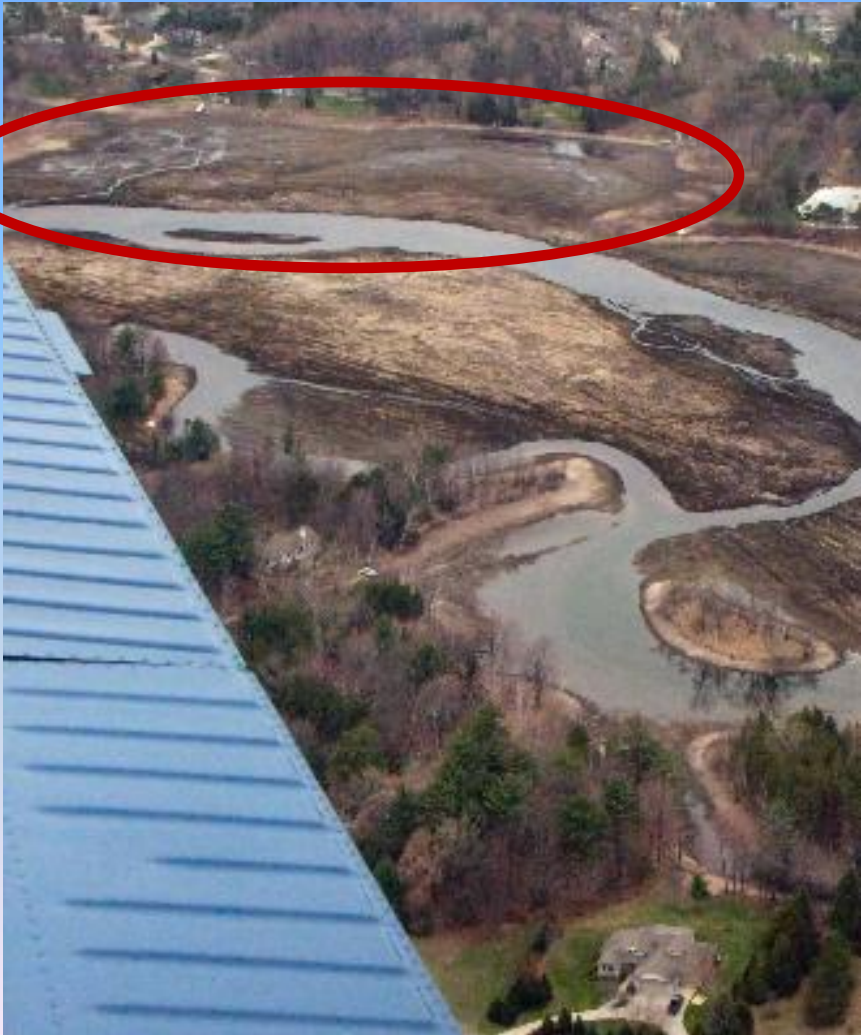
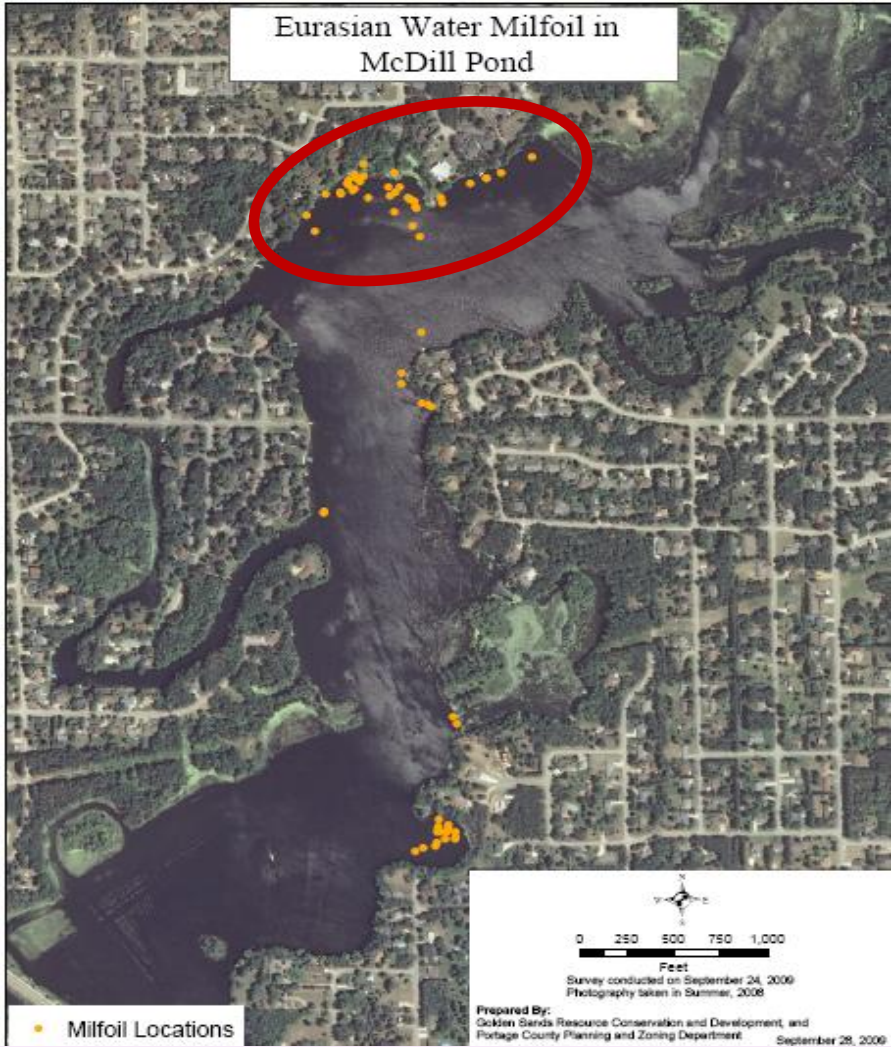
Unaffected Areas from the Drawdown Harbored EWM
