RESERVOIR DRAWDOWNS AND AIS MANAGEMENT

Two Case Studies: Lac Sault Dore and Musser Flowages
Price County

Lakes Convention – April 24, 2015

Jim Kreitlow-Lake Biologist, WDNR, Rhinelander
Tim Plude-AIS Coordinator, WDNR, Plymouth

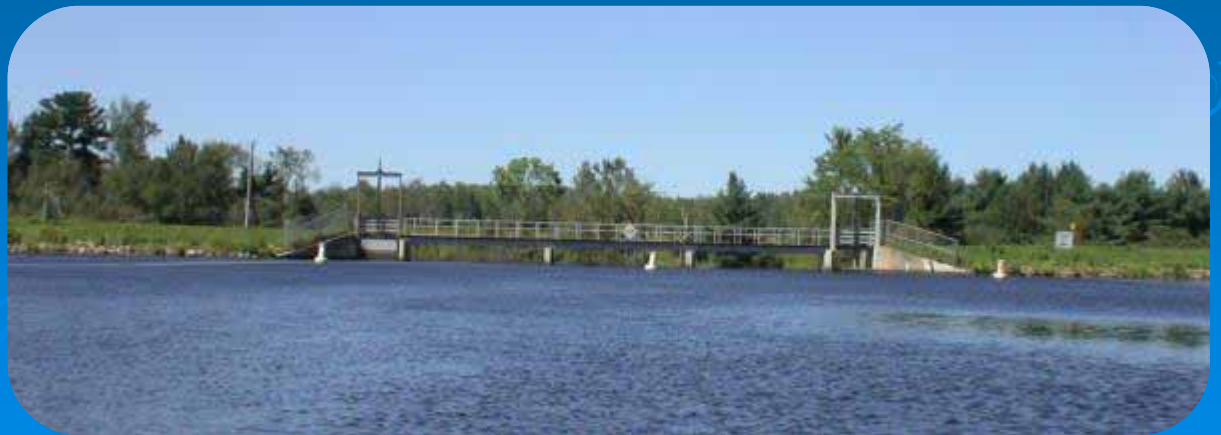
- Winter drawdown required for maintenance on Weimer Dam
 - Limited to **6 feet**, per specs of the dam
 - Start water drawdown after Labor Day 2010
 - Refill by May 1, 2011
 - Secondary benefit to possible control EWM population

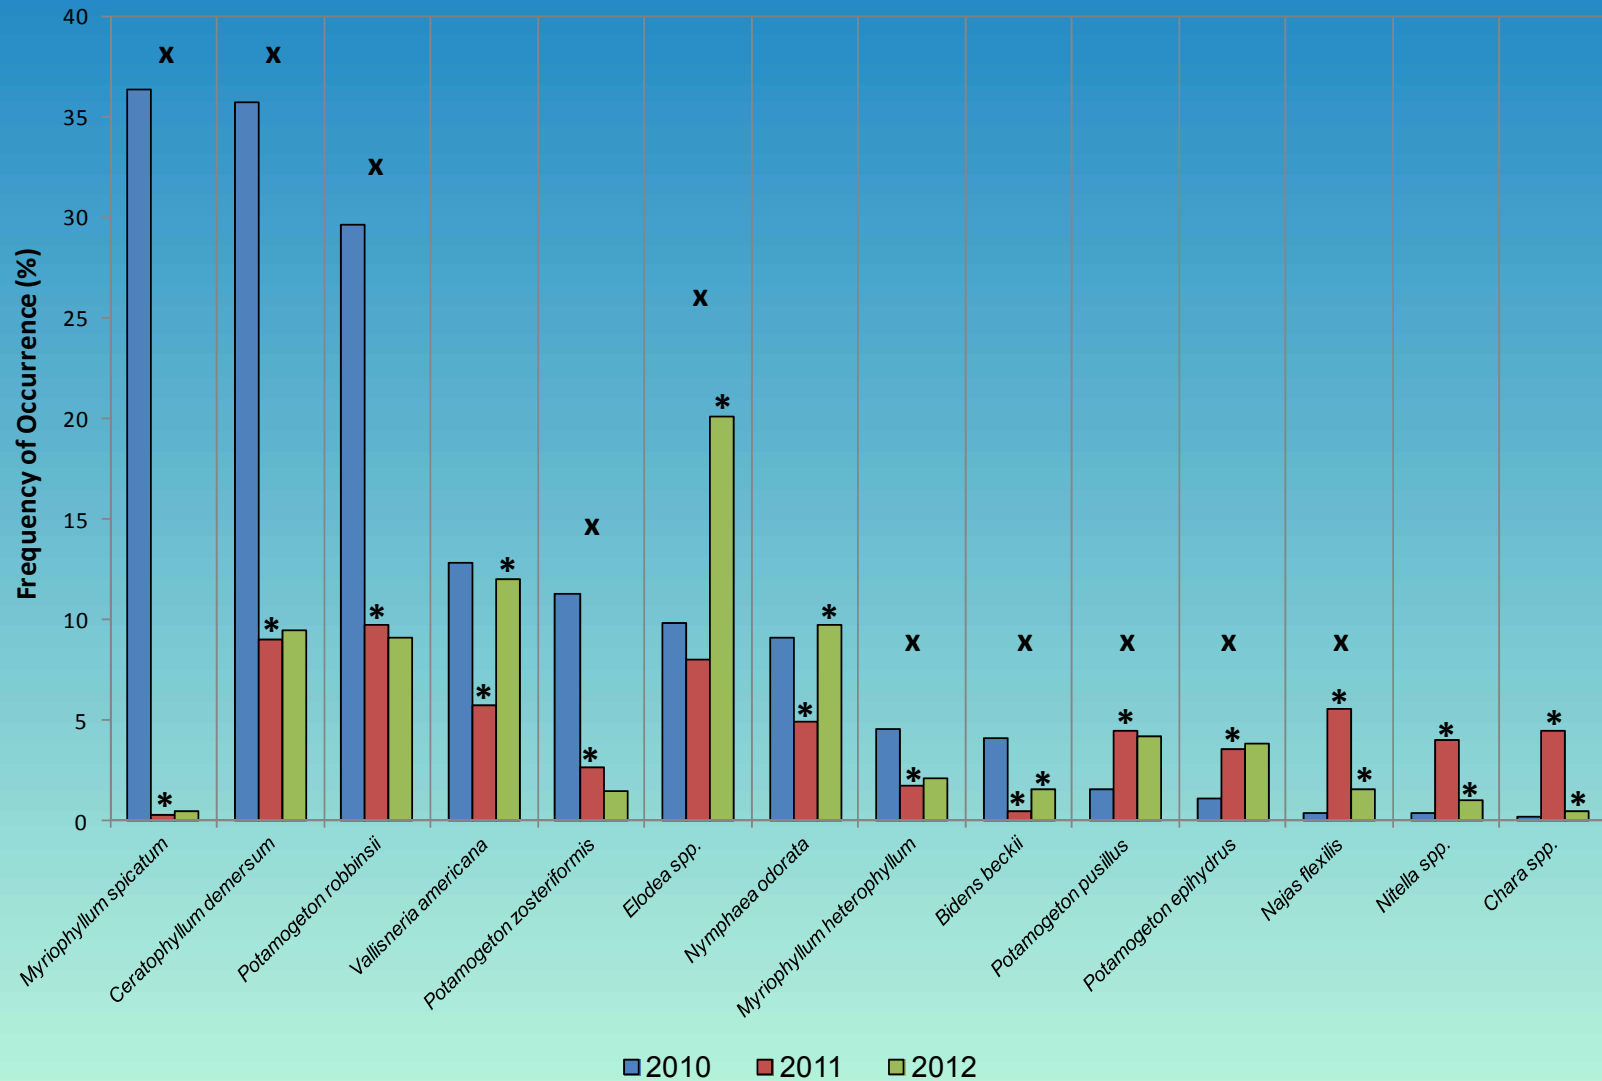
PI Survey Results – changes in frequency of occurrence

* Statistically valid change in occurrence from previous year (Chi-square $\alpha = 0.05$)

X Statistically valid change in occurrence from 2010 to 2012 (Chi-square $\alpha = 0.05$)

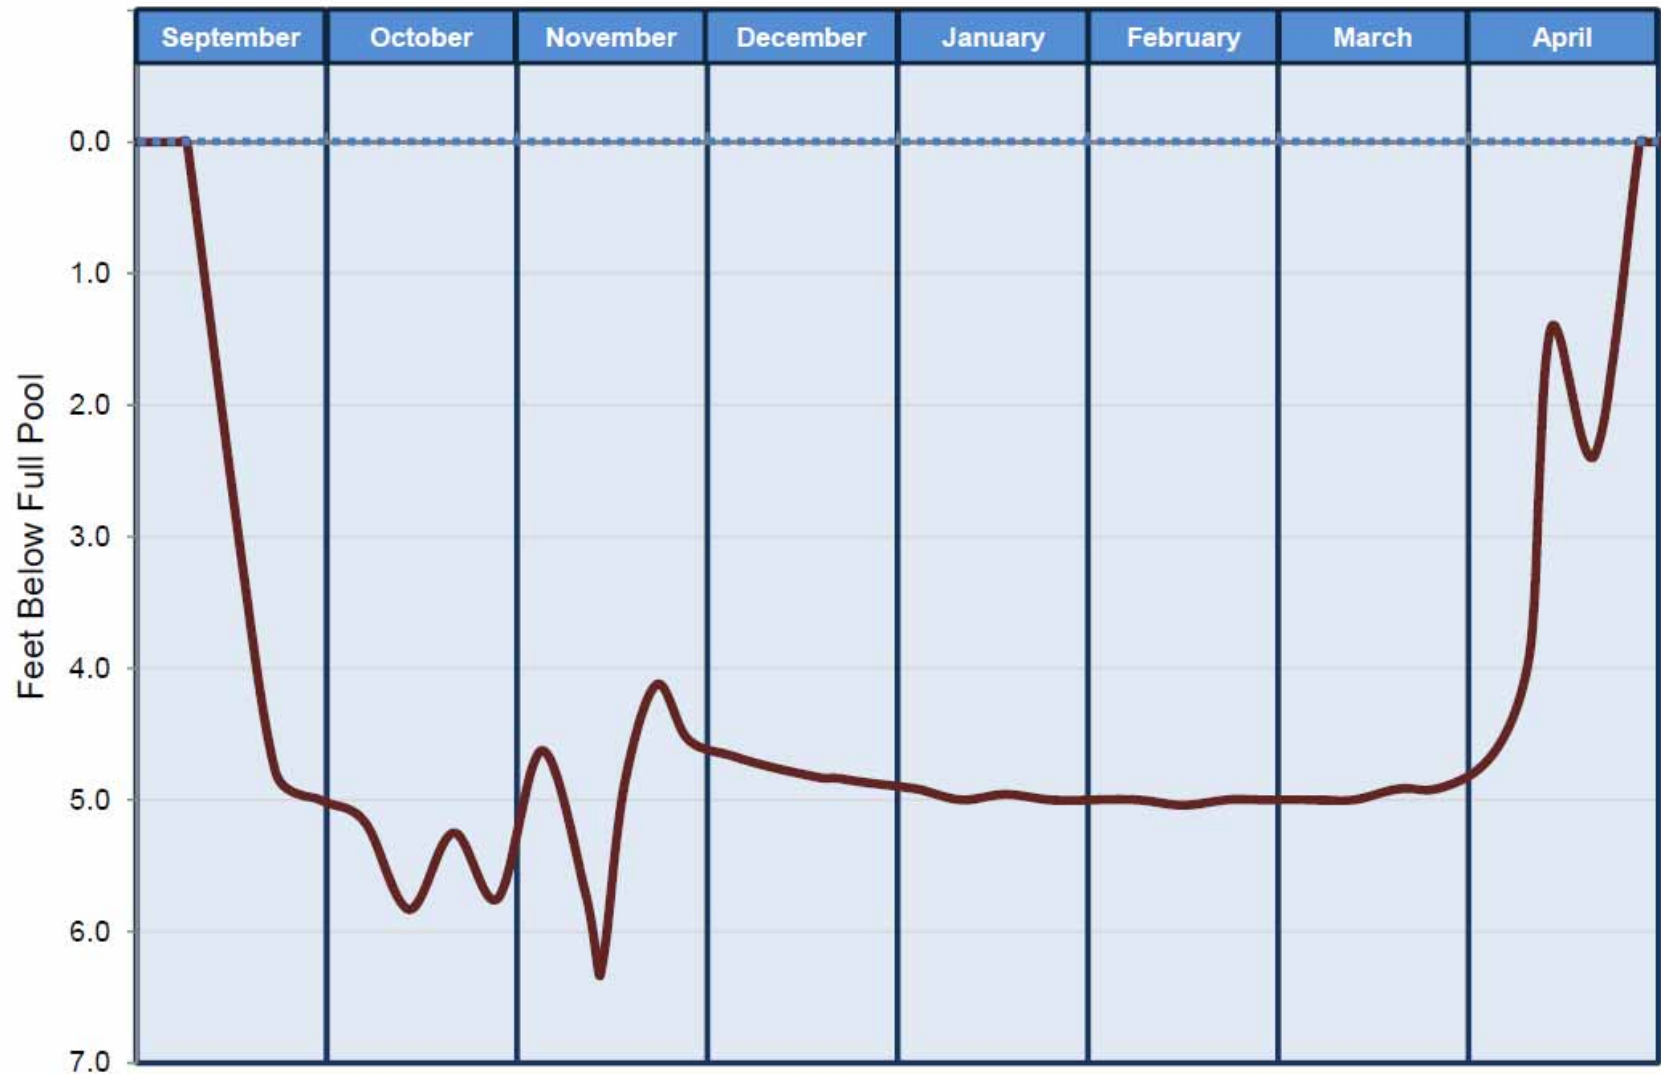
Winter Water Levels

- Drawdown starts after Labor Day- September 9, 2013
- No more than 6" per day
- 5-6 foot drawdown planned

- Drawdown completed by September 21, 2013
- Refill by May 1, 2014

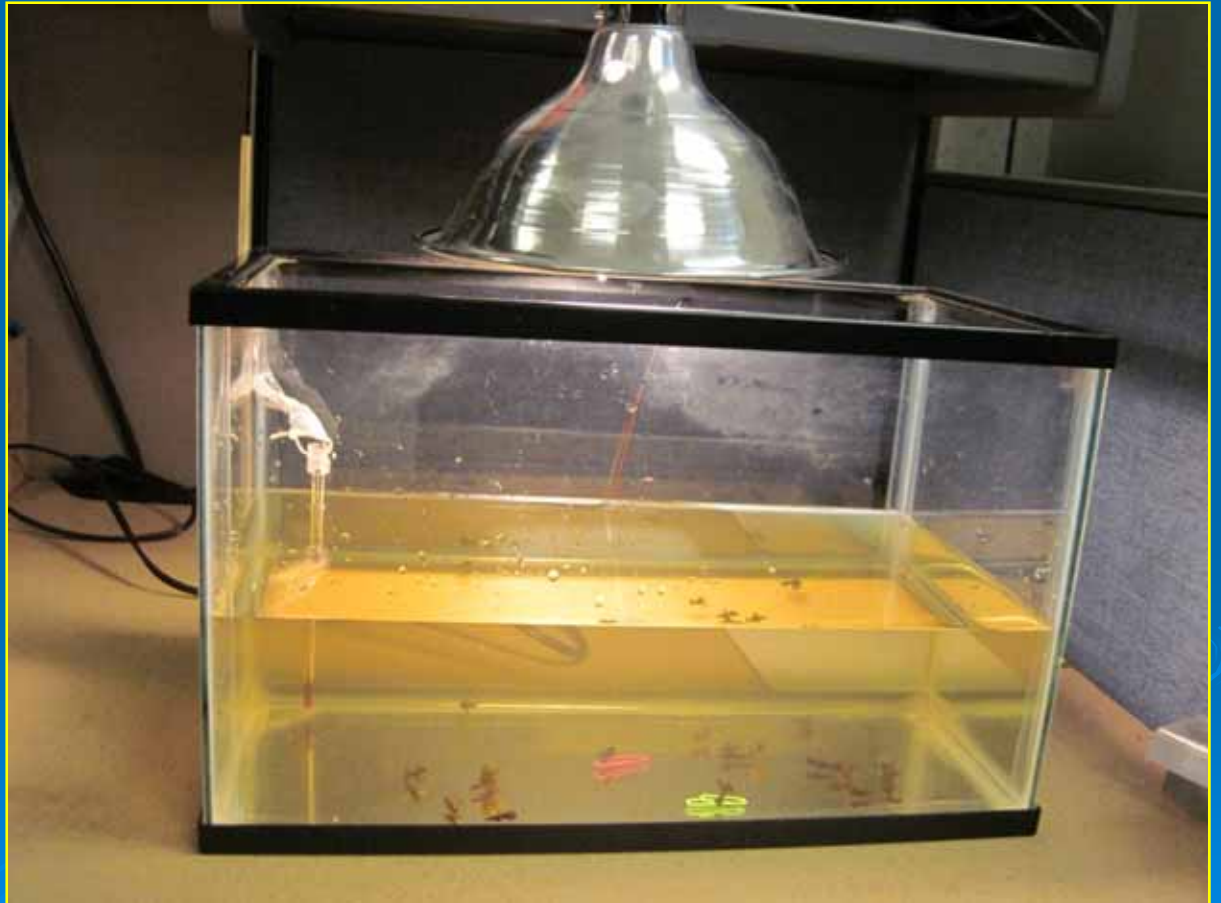
Turion Germination Method - Lab

1. Chill turions in a refrigerator for 1 week

2. Place turions in aquarium

*some turions floated and after a day I placed plastic paper clips on the floaters to sink them

3. incubate at daily average temp of 81-85°F for 2 weeks

*10 light hours/ 14 dark hours

*nightly average temperature water=65-70°F
air=70-72°F

4. note any sprouting and remove sprouted individuals

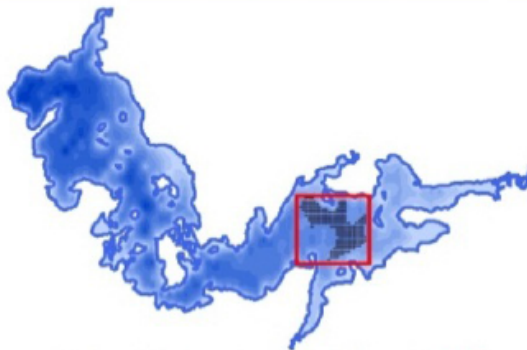
Extent of above images shown in red
