*Hypothesized Changes in Littoral Habitat with
Continued Water Level Decline in a Central
Wisconsin Seepage Lake*

2015 Wisconsin Lakes Partnership Convention
April 24, 2015

Onterra LLC
Lake Management Planning

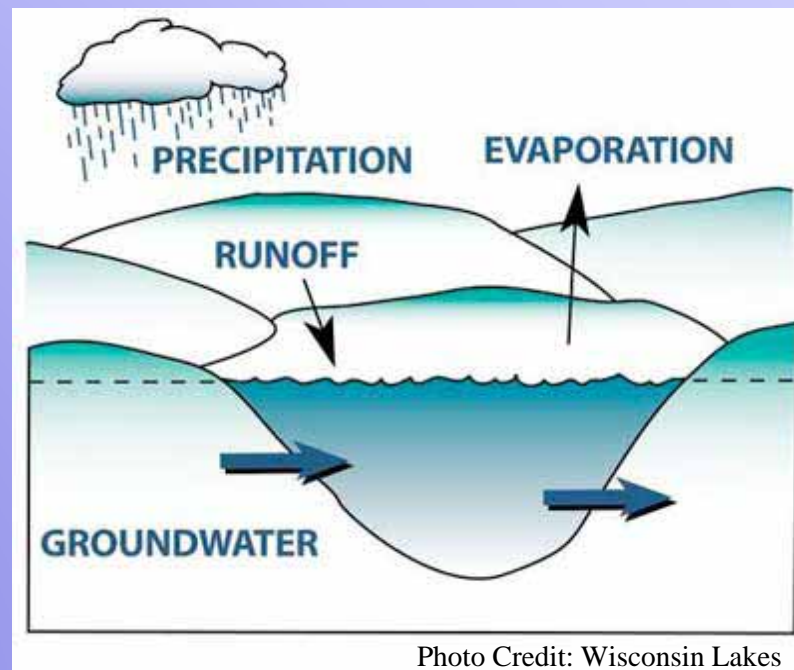
- **What is a seepage lake?**
 - No tributary inlet or outlet (landlocked)
 - Relatively small drainage basin; lower nutrients
 - Occur when groundwater table meets land depression
 - Water levels are strongly tied to groundwater table

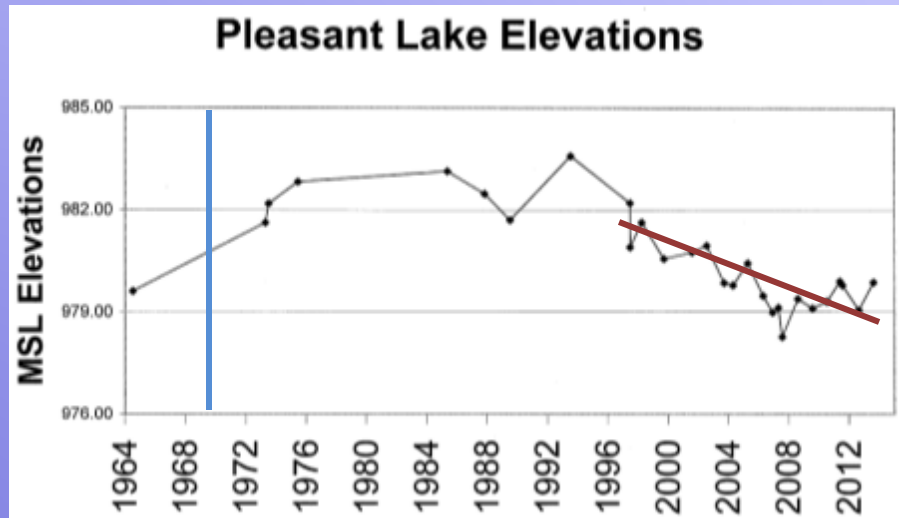
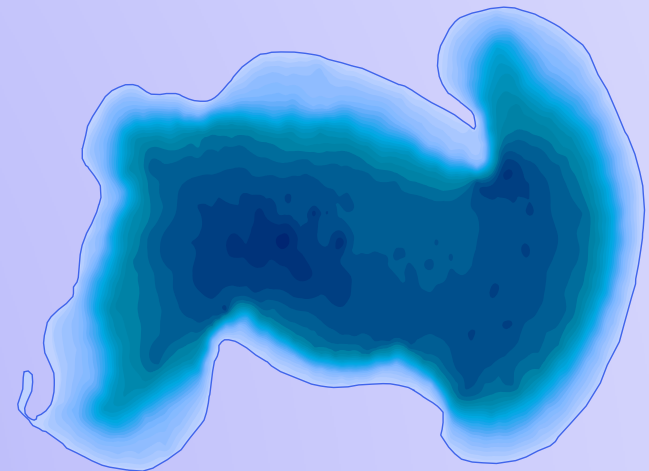
- Deep Seepage Lake
 - ~131 surface acres; Max Z: 26'; Mean Z: 15' (2013)
- Mesotrophic, Hard Water Lake
- Water Levels
 - Measured intermittently since 1964
 - Maximum in 1994; Minimum in 2007 (difference of 5.5 feet)
 - Levels in a general decline since mid-1990s
 - 1.6 feet of decline attributed to pumping in 2013 (Kraft et al. 2014)

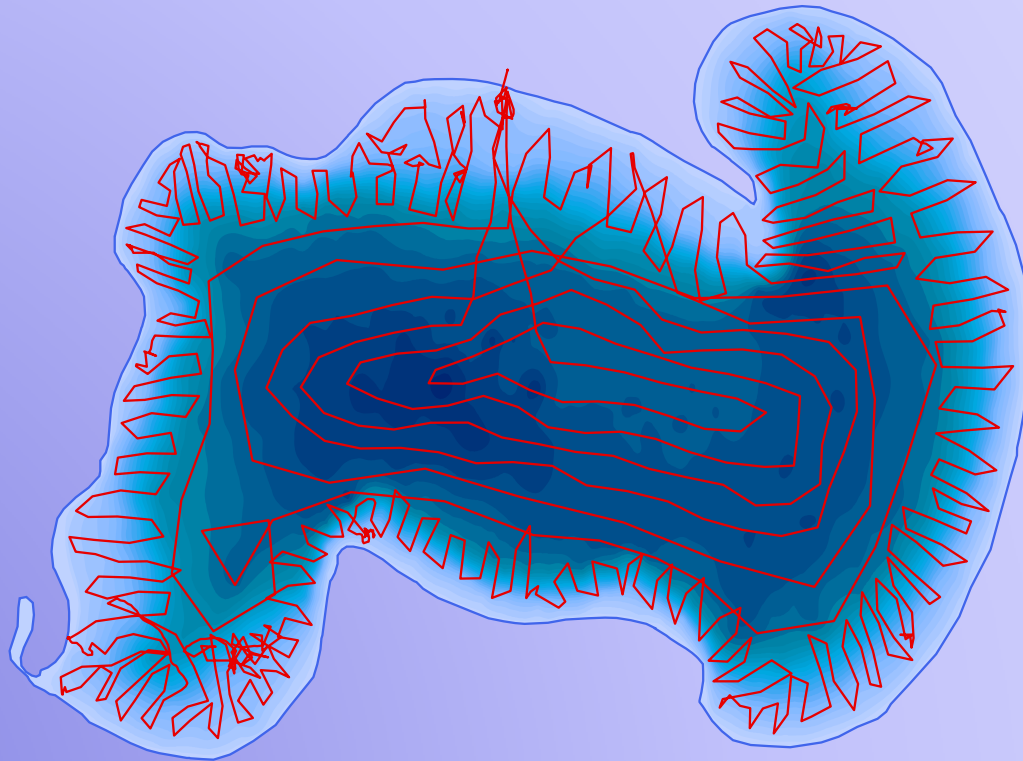
- **Acoustic Survey (2013)**
 - Accurate bathymetry
 - Aquatic Plant Bio-Volume/Height
 - Substrate Hardness

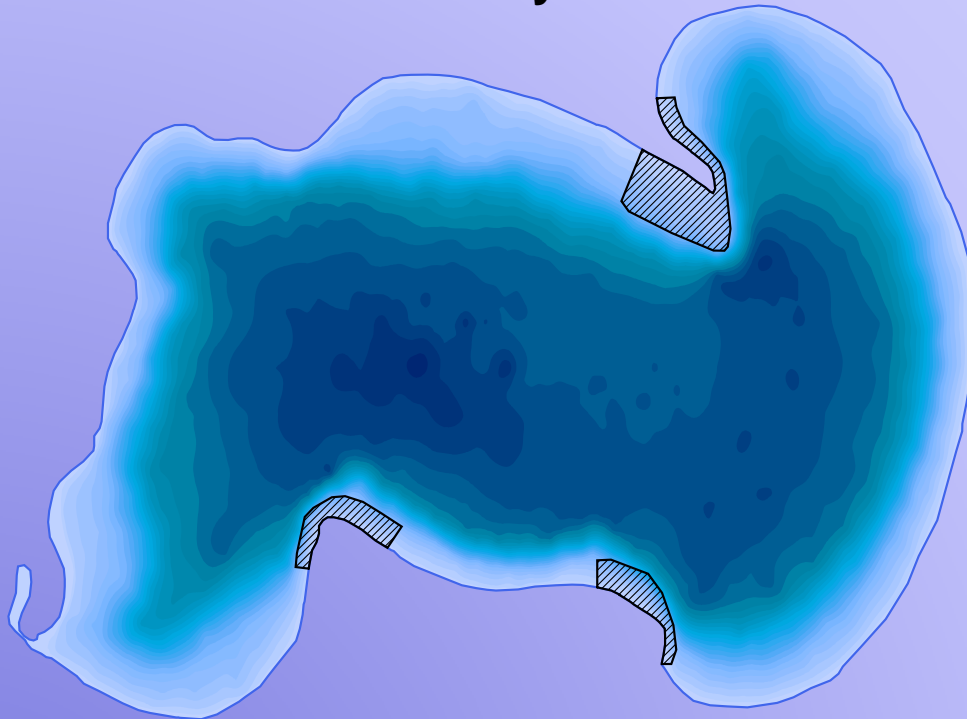
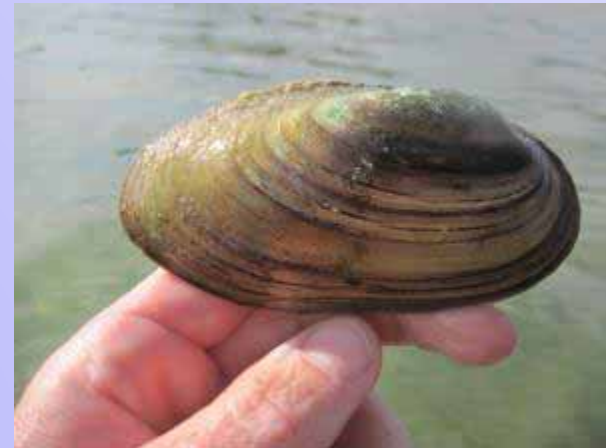
Mussel Survey Areas

- **Freshwater Mussel (*Unionidae*) Survey (2013)**
 - Snorkel Transects

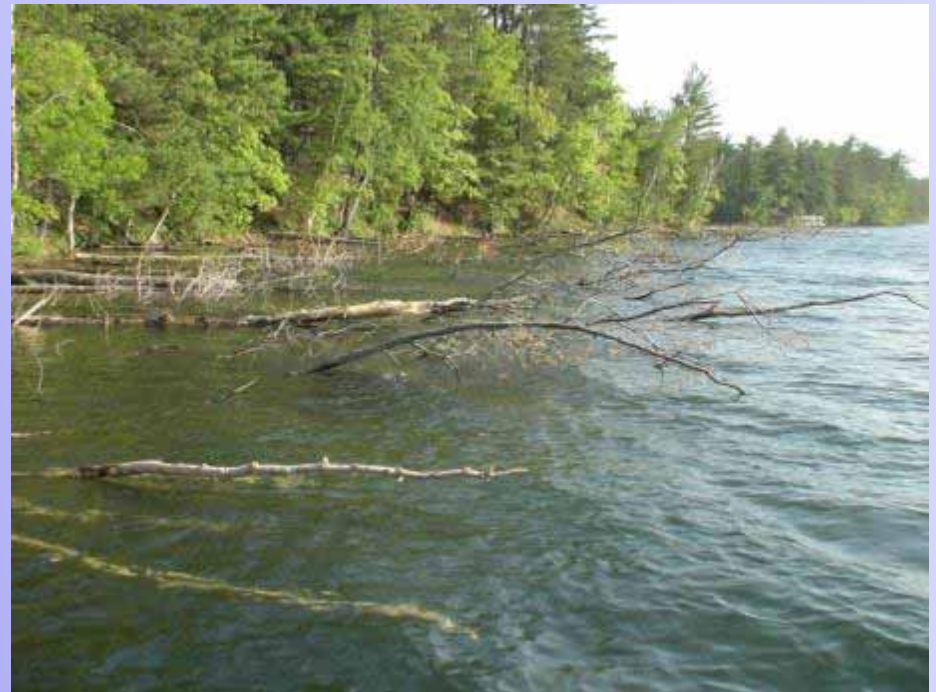
- **Coarse Woody Habitat Survey**
 - Classified Based on Size
 - 2-8 Inches in Diameter
 - >8 Inches in Diameter
 - Classified Based on Branching Complexity
 - No Branches
 - Minimal Branches
 - Moderate Branches
 - Full Canopy

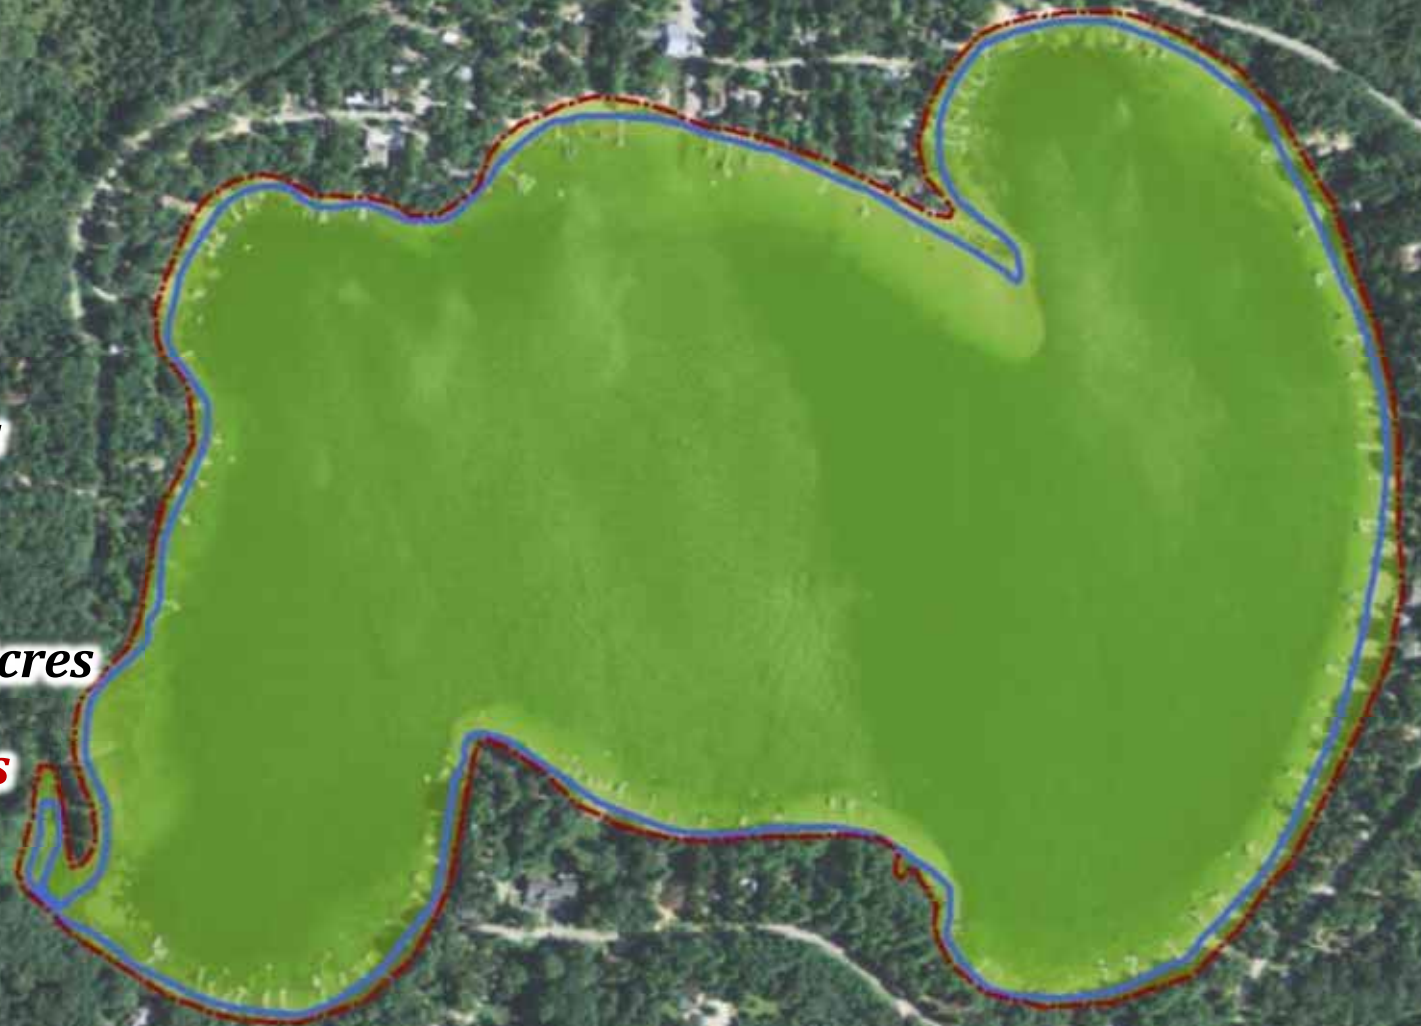
***2013 Littoral Area:
~131 Acres***

***1993 Estimated
Littoral Area: 140 Acres***

Reduction of 9 Acres

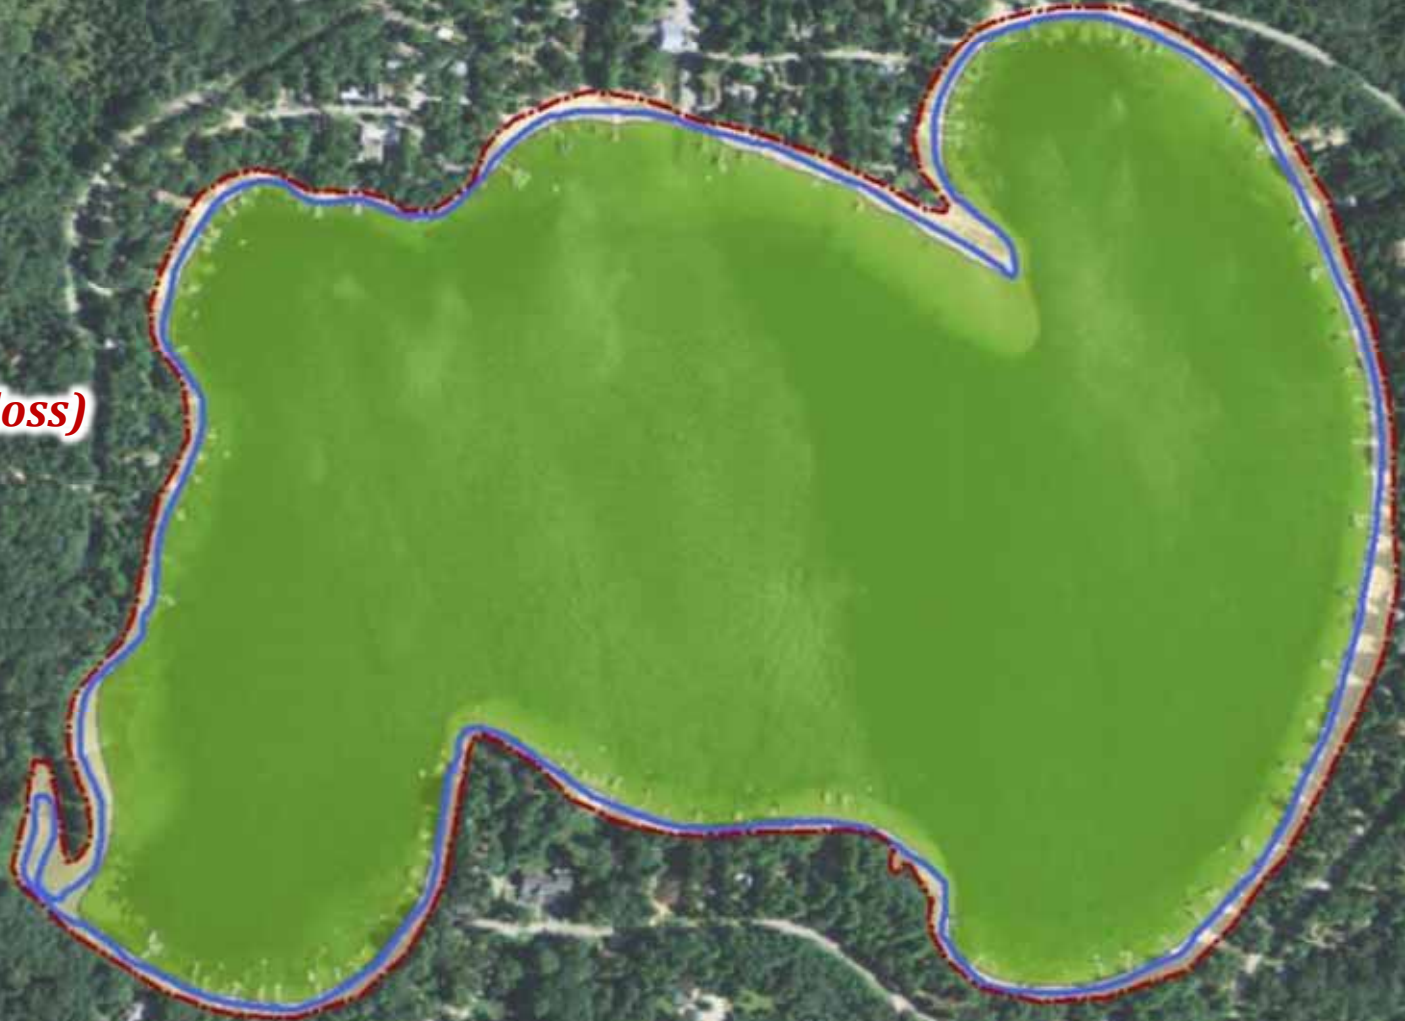
*1' Below 2013 Water Line
(5.4 feet Below 1993 Water Line)*

2013 LA: 131 Acres
1' Decline: 127 (4 net loss)

- Hypothesized Changes to Littoral Habitat
 - Littoral area (lake area) will decline ~4-6 acres with every 1' of water level decline
 - ~25 acres of littoral area (19% of 2013 lake area) would be exposed with 5' decline
 - Course substrate habitat & associated communities may be impacted with continued decline
 - Area with highest plant diversity in terms of species and structural complexity would expand by ~7 acres with 5' decline
 - Likely expansion of hybrid watermilfoil and curly-leaf pondweed
 - Turtle Bay Wetland would likely disappear with >2' decline
- Every lake is going to respond differently

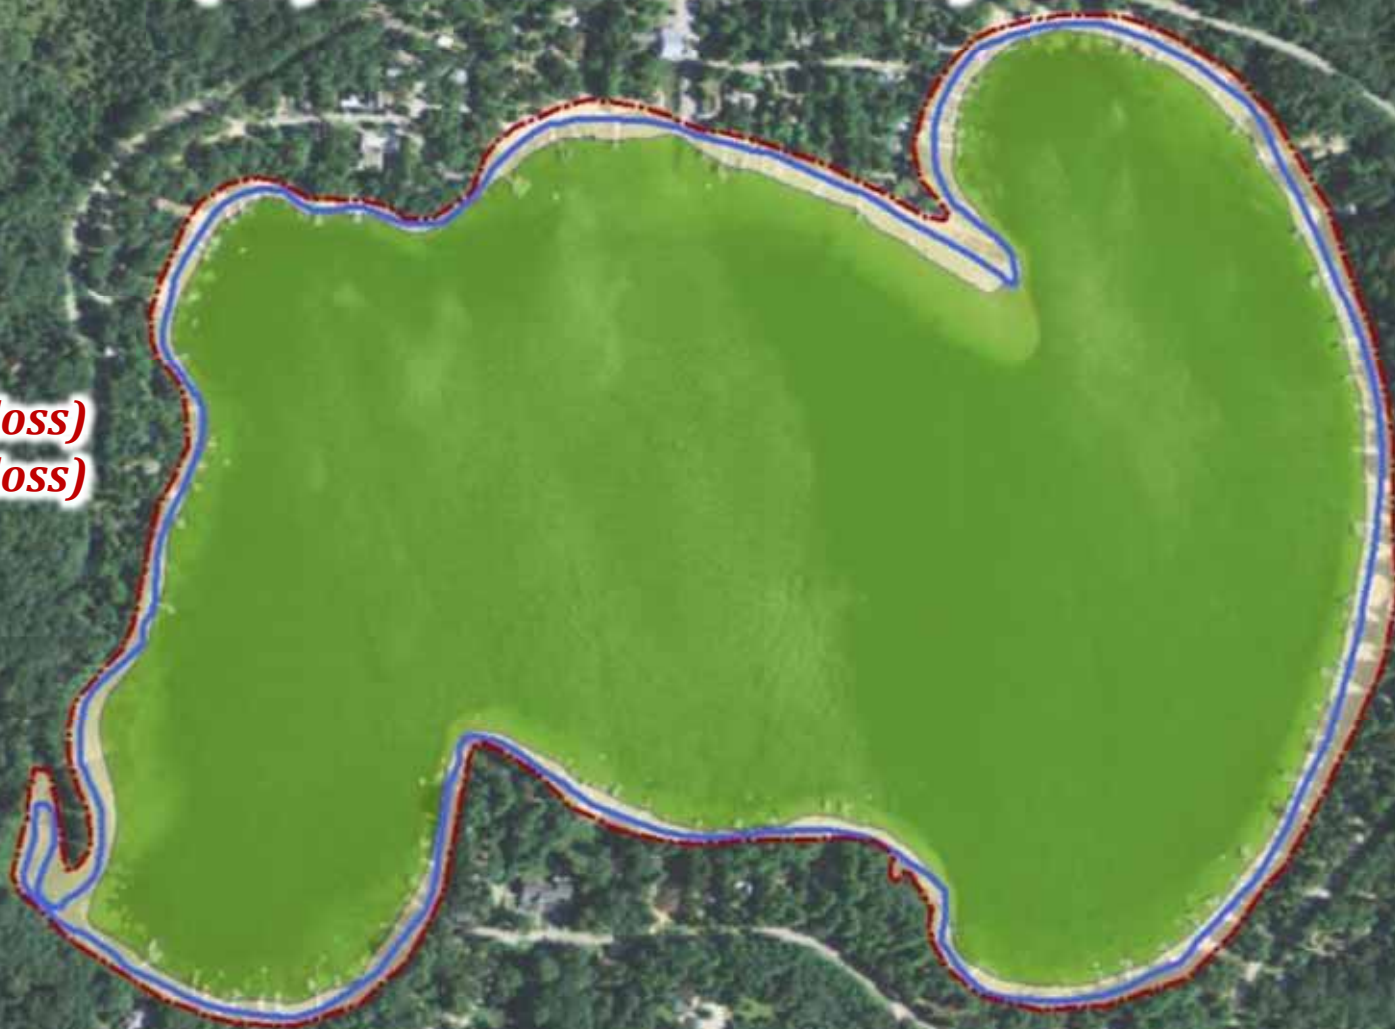
**2' Below 2013 Water Line
(6.4 feet Below 1993 Water Line)**

2' Decline: 123 (8 net loss)

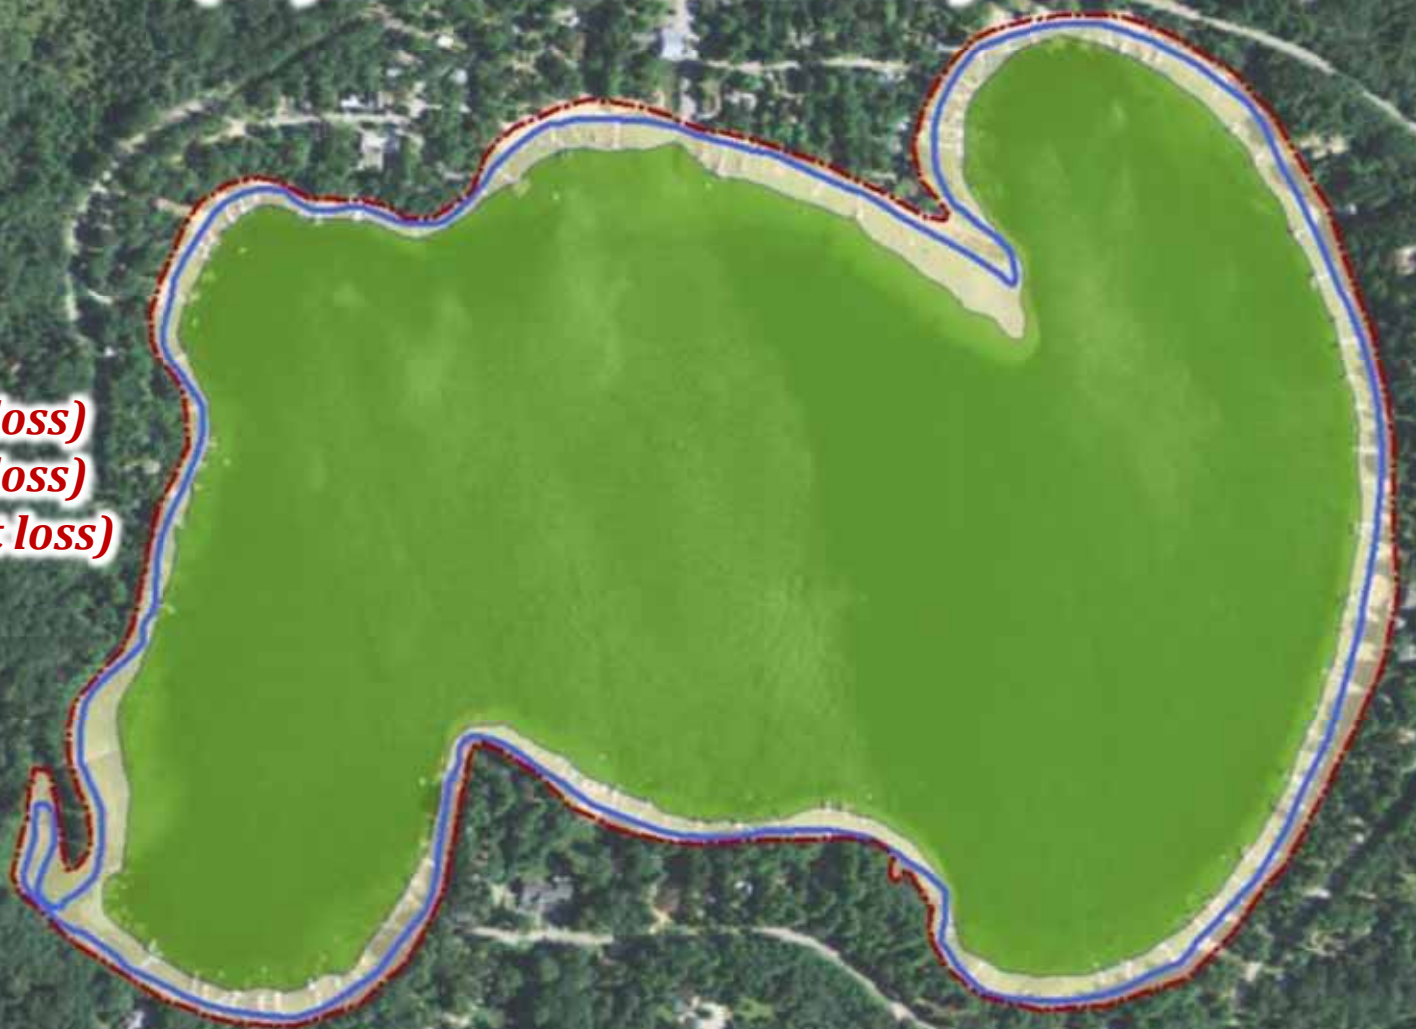
*3' Below 2013 Water Line
(7.4 feet Below 1993 Water Line)*

3' Decline: 117 (14 net loss)

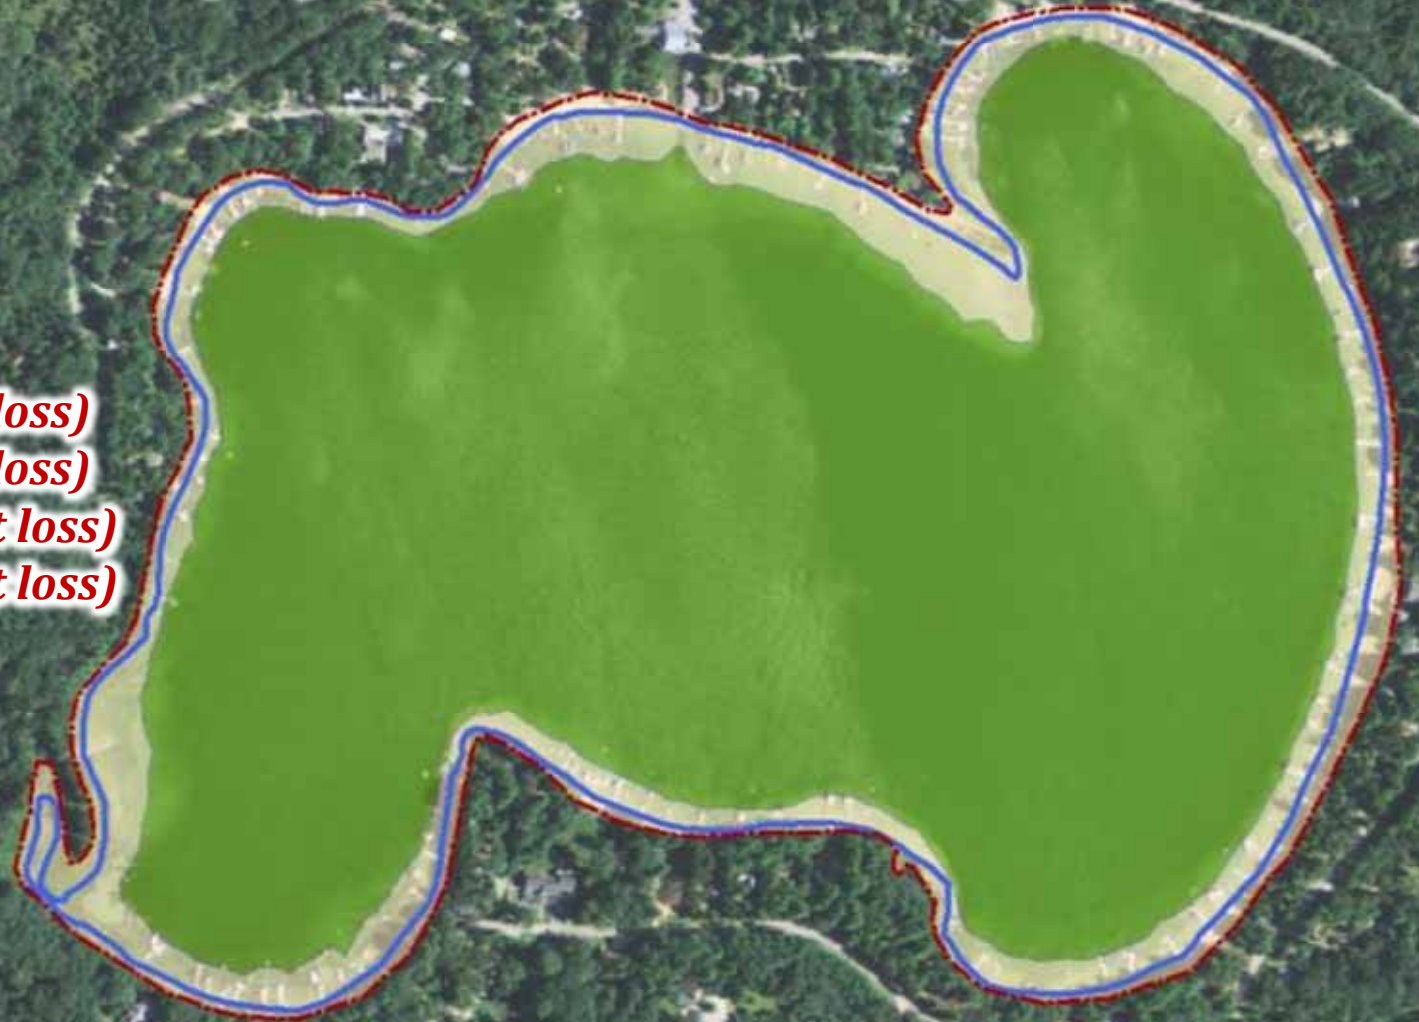
***4' Below 2013 Water Line
(8.4 feet Below 1993 Water Line)***

4' Decline: 112 (19 net loss)

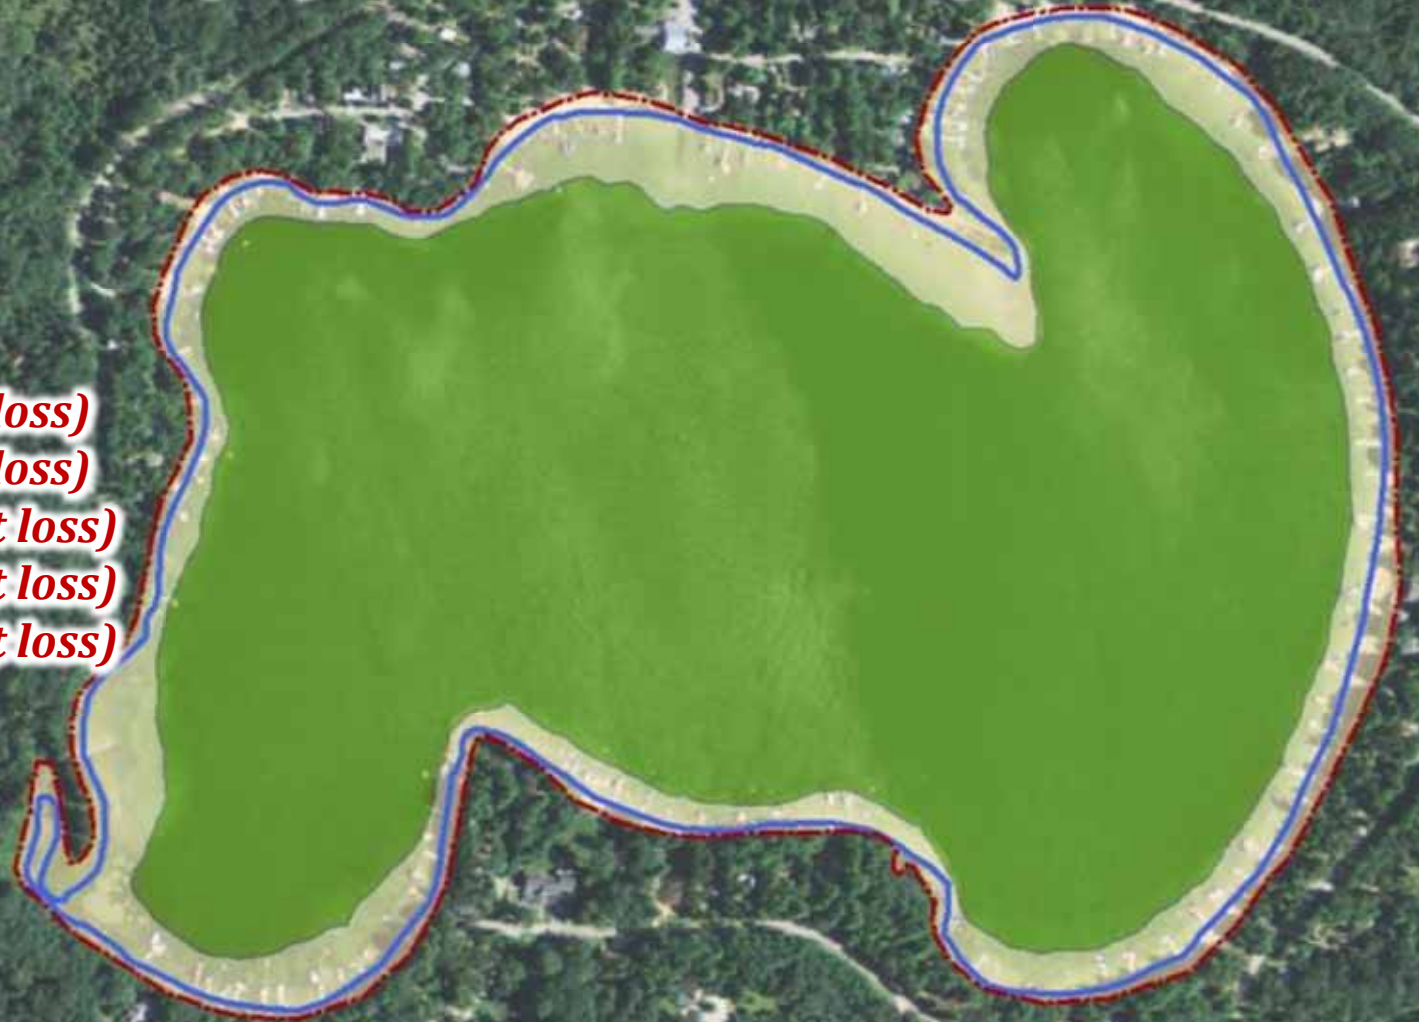
*5' Below 2013 Water Line
(9.4 feet Below 1993 Water Line)*

5' Decline: 106 (25 net loss)

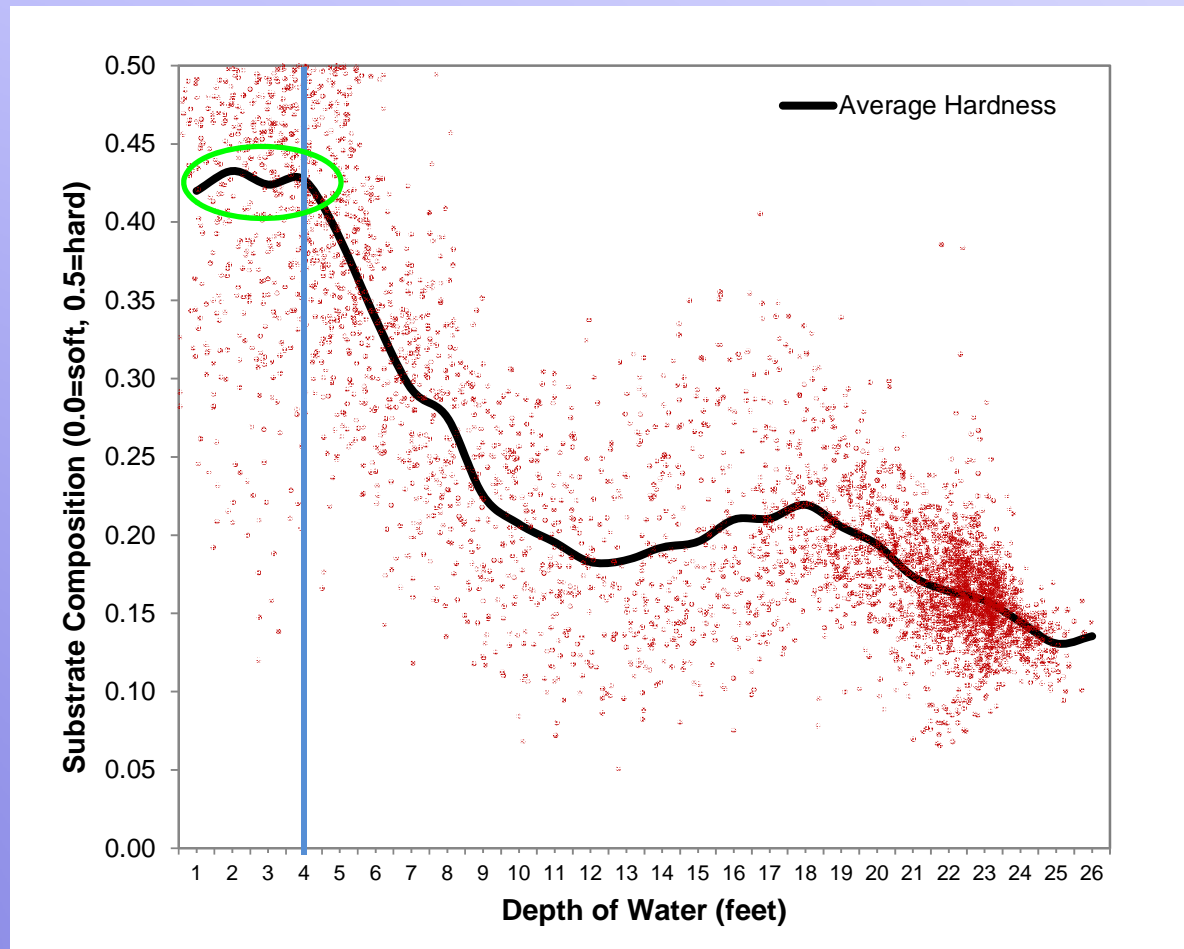
- Majority of hard substrates (sand/rock) located ≤ 4 feet of water
- Continued water level decline may reduce this habitat type

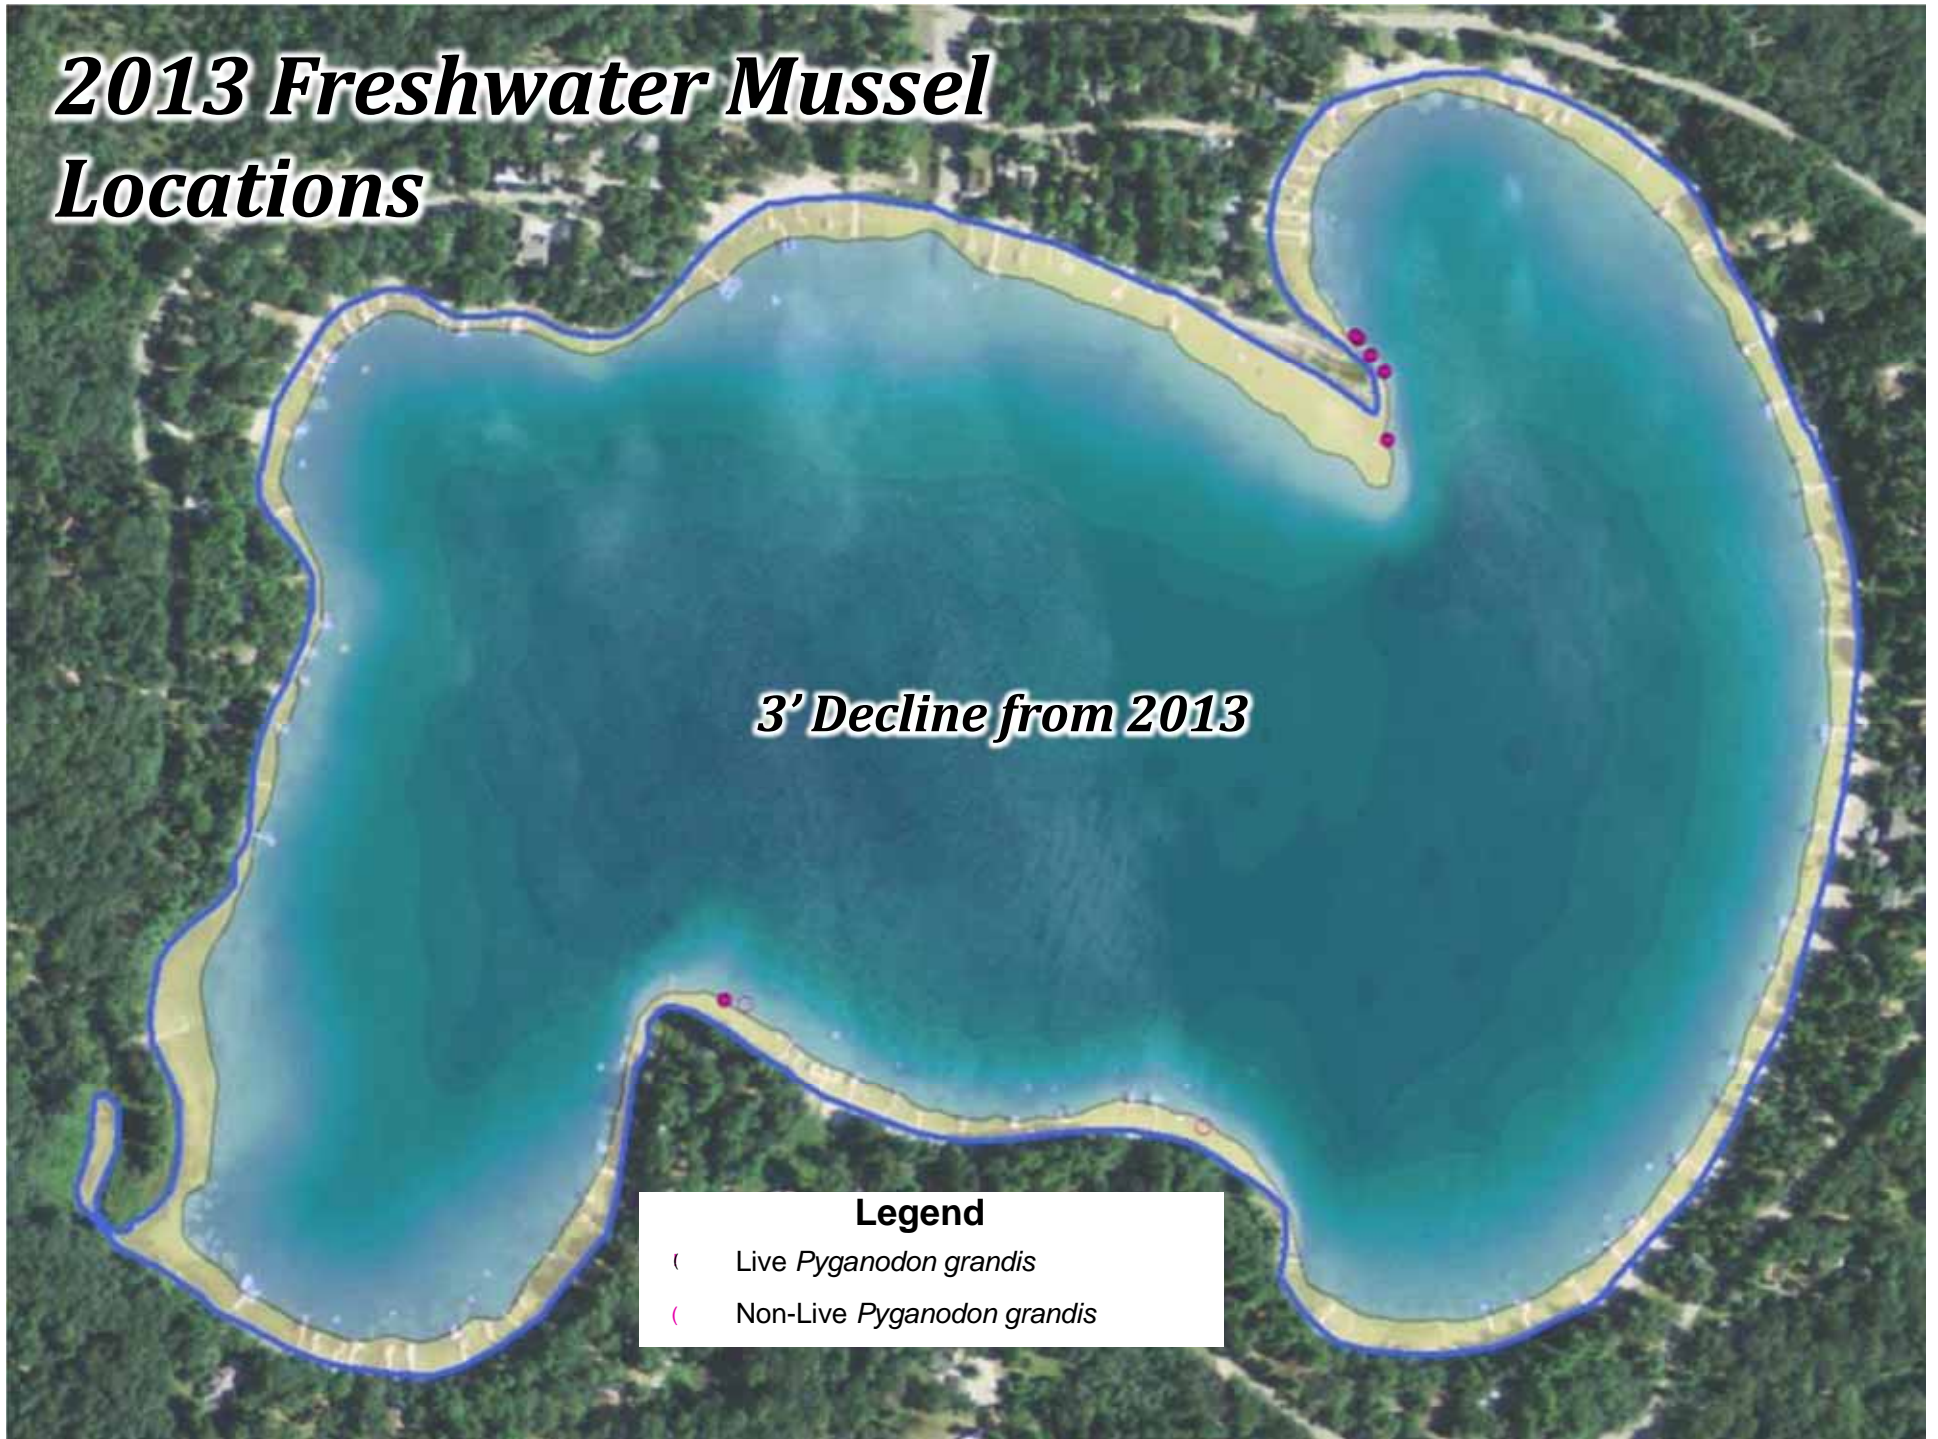
2013 Freshwater Mussel Locations

3' Decline from 2013

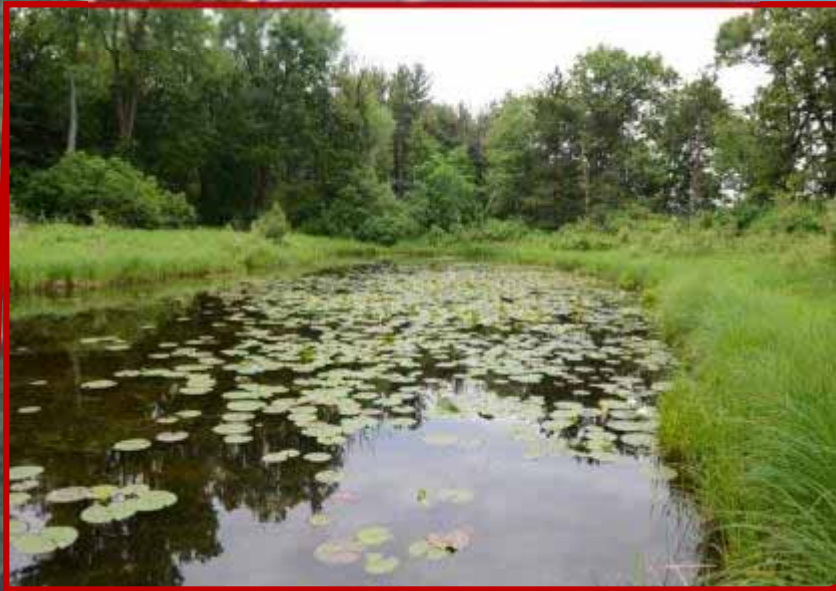
Turtle Bay Wetland

- Diverse amphibian & reptile populations (2 special concern)
- Diverse plant community
- Only location of common bladderwort within the lake

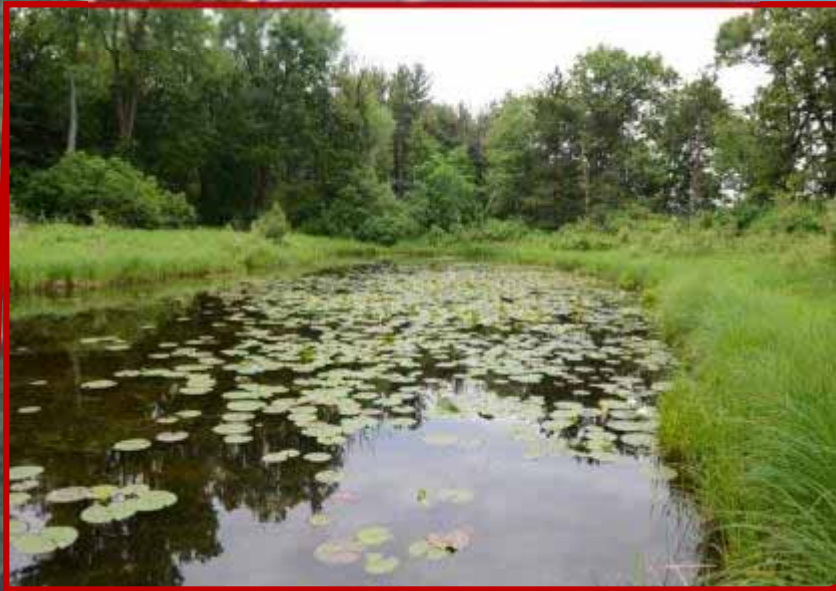
Turtle Bay Wetland

6 Anuran Species

- 2 Special Concern (American bullfrog & Northern Leopard Frog)

2 Reptile Species

- Snapping & Western Painted Turtles
