Porters Lake Eurasian Watermilfoil Monitoring and Management

Porters Lake Facts

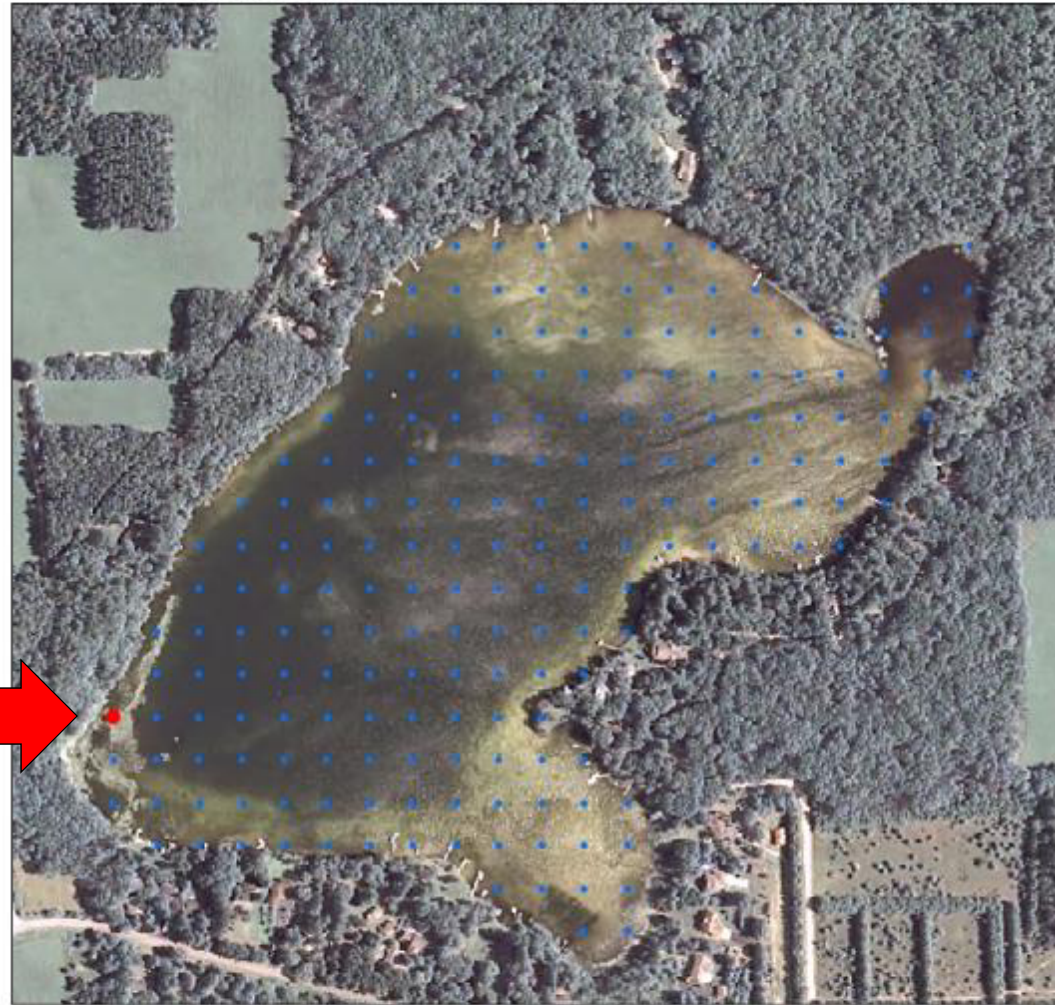
June 23rd,
2012

Porters Lake 2012 Aquatic Plant Survey:
Eurasian water-milfoil (*Myriophyllum spicatum*)

**EWM
Detected**

Occurrence of Eurasian water-milfoil
(*Myriophyllum spicatum*)

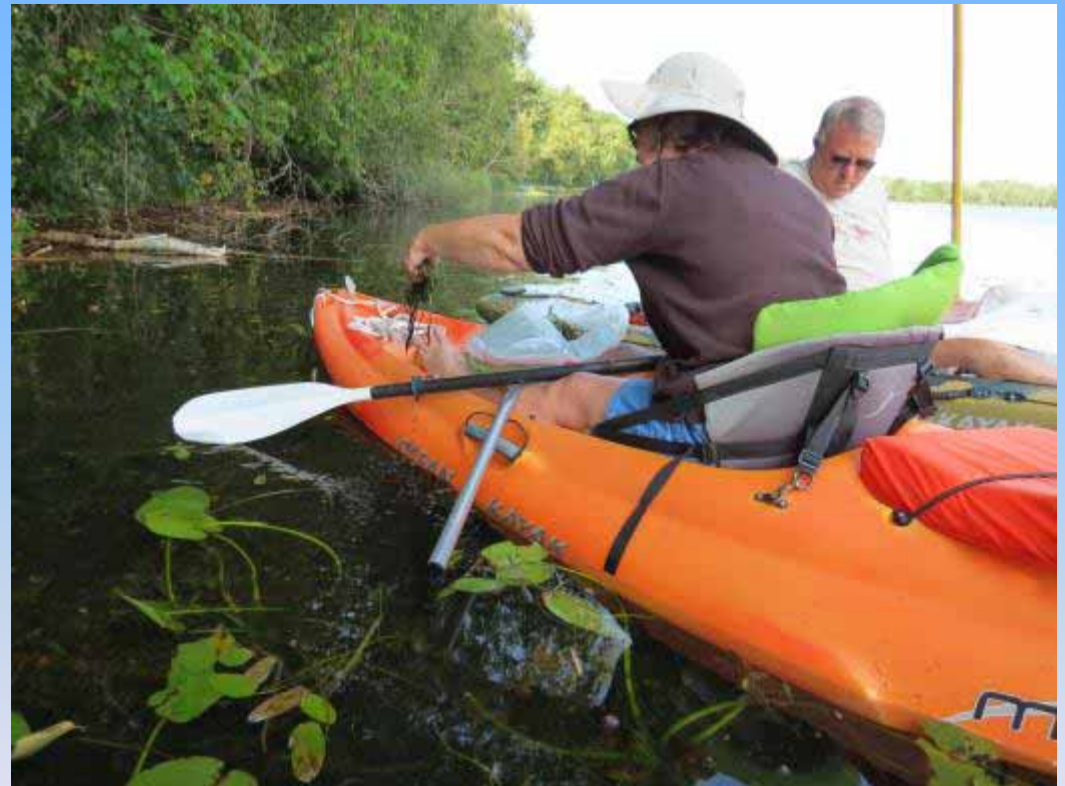
Granular 2,4-D application – May 15th, 2013

Treatment was effective at killing nearly all remaining EWM

A few plants remained and were removed by hand in June

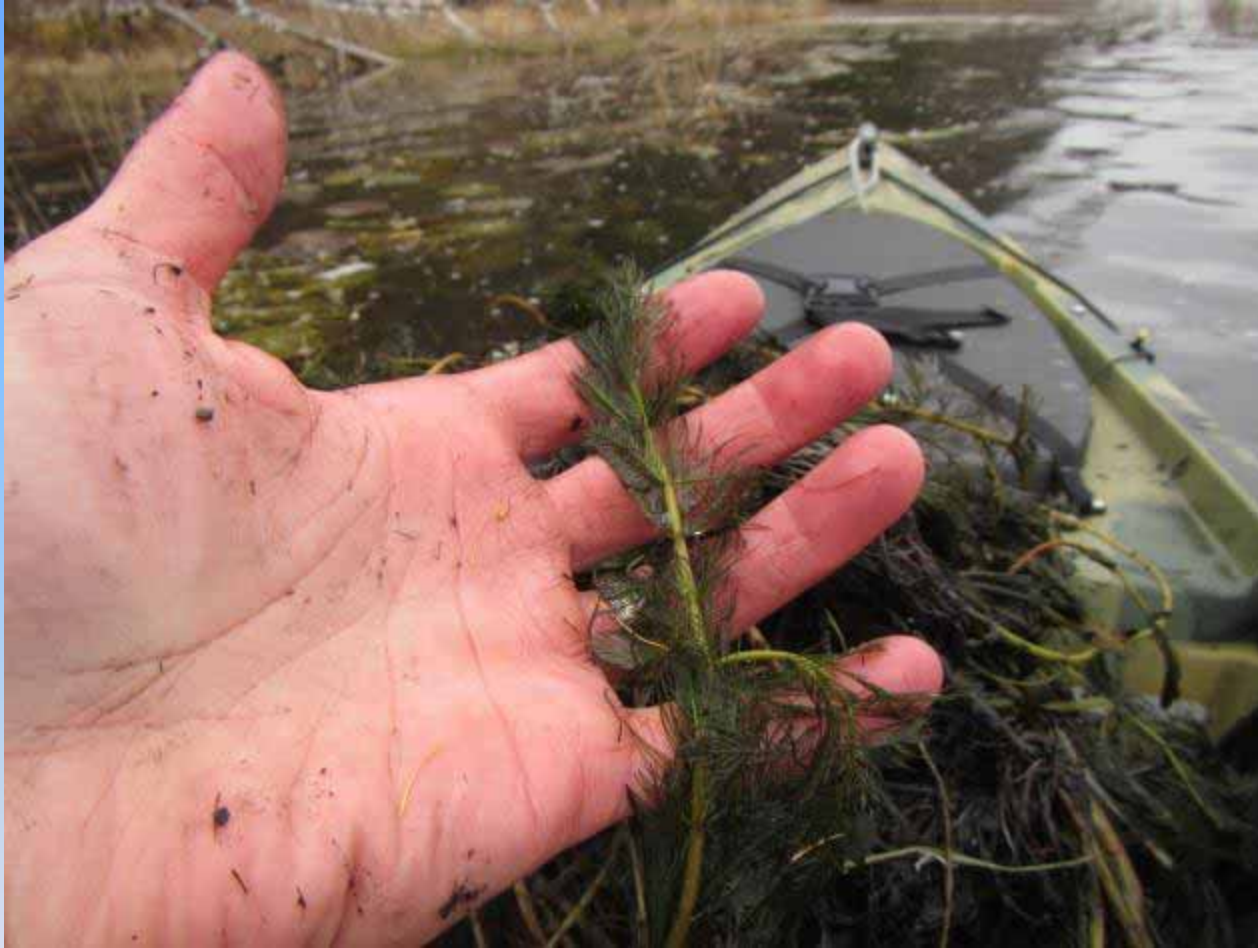
October 27, 2015

Small # of EWM found within 2013 treatment area
