Building a “Health Lakes” Rain Garden

Garden address: W11254 Lake Road, Randolph, WI 53956

DNR Lake Protection Grant #LPT52416 (4/15/16 – 6/30/18)

Beaver Dam Lake Improvement Association

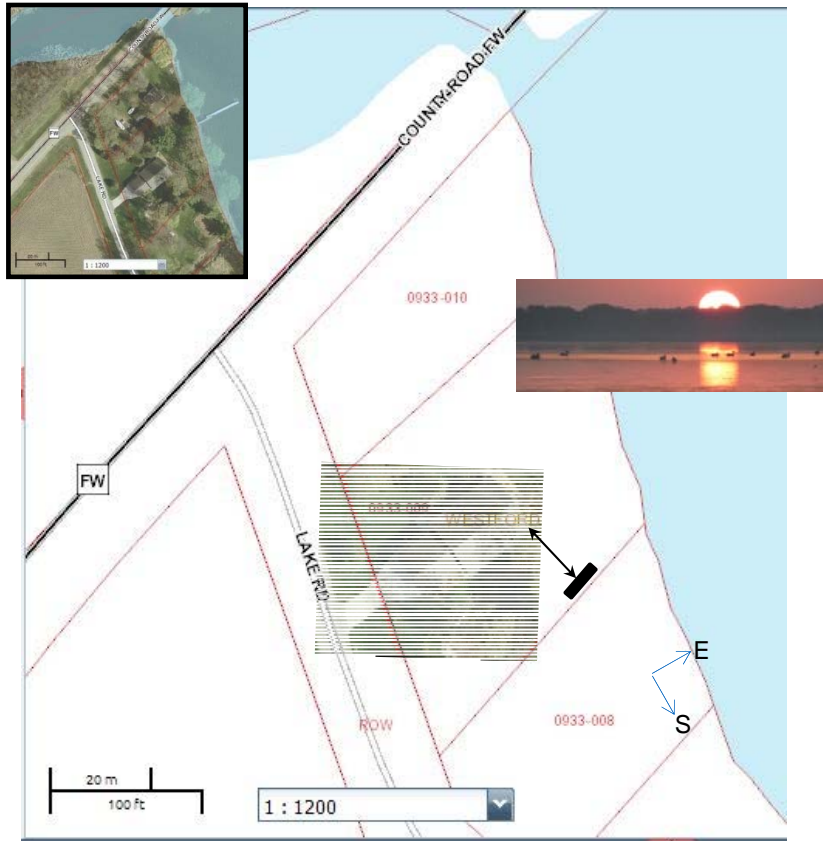
Plan of W11254 Lake Road and environs (insert).
Rectangle at southeast end of property indicates rain garden. Arrow indicates distance (40 ft.) from water source, a downspout at southeast corner of house.

1. 40 ft from the house, precluding foundation damage.
2. Remote from the septic system.
3. In a spot that is low & flat, but in which water does not pool.
5. Away from the canopy of deciduous trees.
6. In a sunny area, receives at least 6 hours of morning/noonday sun.

Soil type and distance from downspout support* a maximum size of 255 sq. ft. (Actual garden is ~25' x 10').

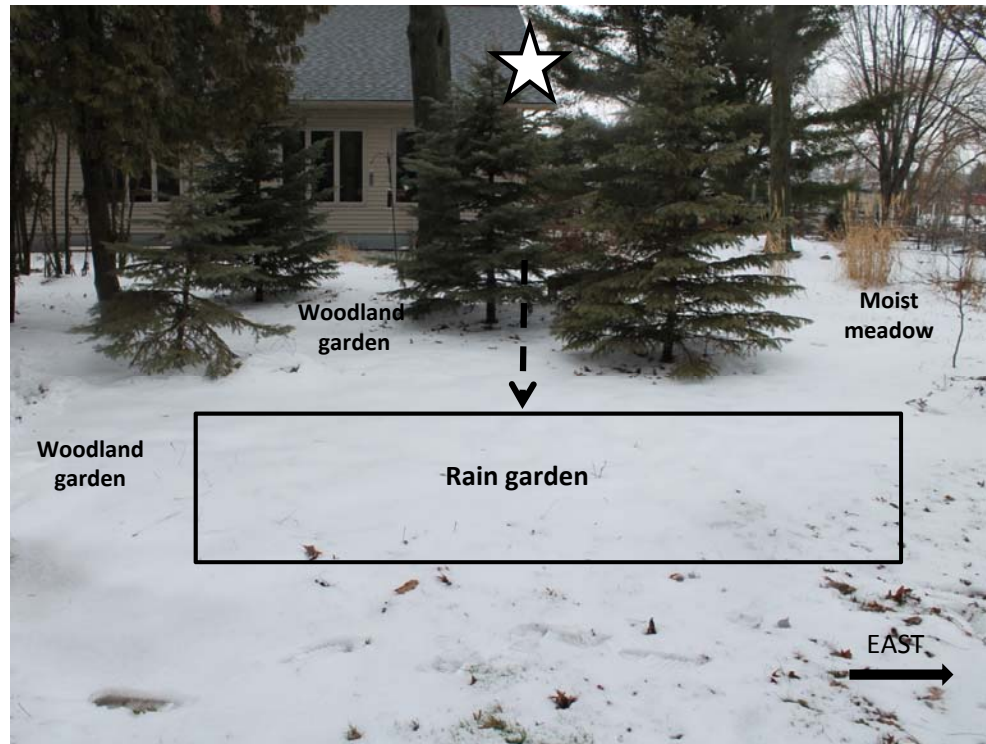
RAIN GARDEN SITE DECEMBER 2015

Location of rain garden viewed due north from south property line. Star indicates downspout that provides water from roof. Dashed arrow shows route of water, transported at ground level through buried PVC pipe. Three existing nearby gardens are indicated.

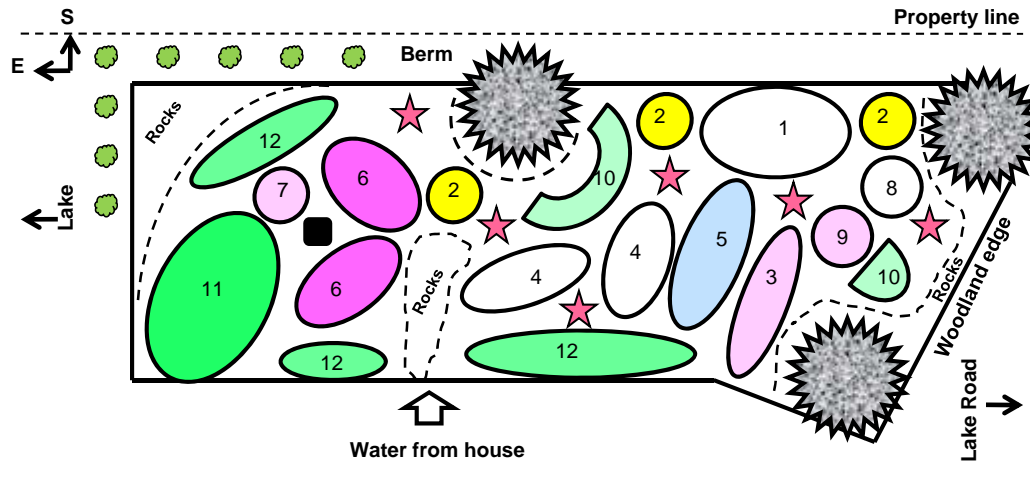
Rain Garden Species*

1.	Virginia mountain mint (5) <i>Pycnathemum virginianum</i>	8.	Culvers root (1 stand) <i>Veronicastrum virginicum</i>
2.	Wild senna (4) <i>Cassia hebecarpa</i>	9.	Obedient plant (1 stand) <i>Physostegia virginiana</i>
3.	Marsh phlox (9) <i>Phlox glaberrima</i>	10.	Bur sedge (10) <i>Carex grayii</i>
4.	Wild quinine (12) <i>Parthenium integrifolium</i>	11.	Palm sedge (7) <i>Carex muskingumensis</i>
5.	Great blue lobelia (10) <i>Lobelia siphilitica</i>	12.	Fox sedge (15) <i>Carex vulpinoidea</i>
6.	Marsh blazingstar (6) <i>Liatris spicata</i>

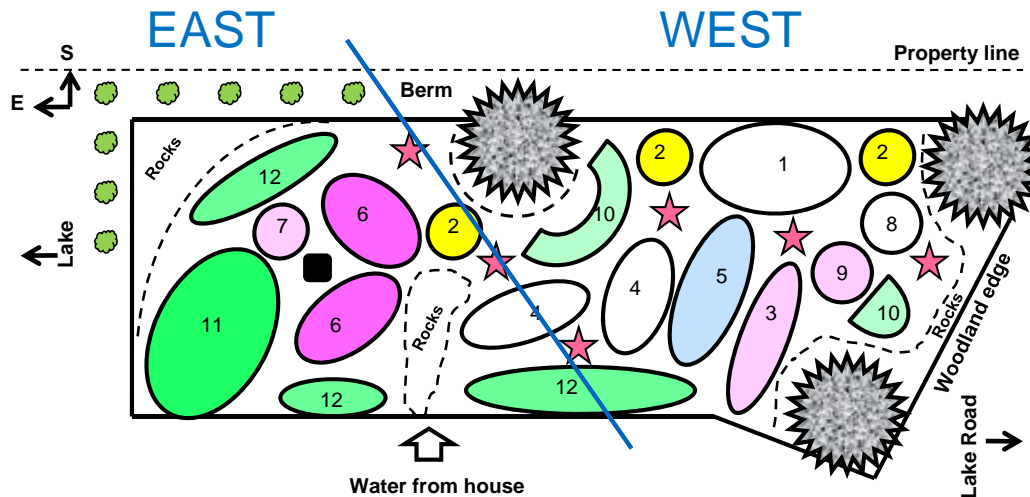
SITE CLEARING and SUBSOIL ASSESSMENT

Turf and weed removal : Lawn grass and annual and perennial weeds removed by hand exposing the topsoil within ~ 250 sq. ft area whose perimeter had been marked with water soluble spray paint.

Subsoil assessment: “Trial digs” into subsoil showed clay-loam containing increasing amounts of clay with increasing depth in west section. However, soil in east section contained gravel mixed with clay-loam.

Conclusion: To achieve a topography with good drainage after backfill throughout the garden, subsoil in east and west sections needed to be worked differently.

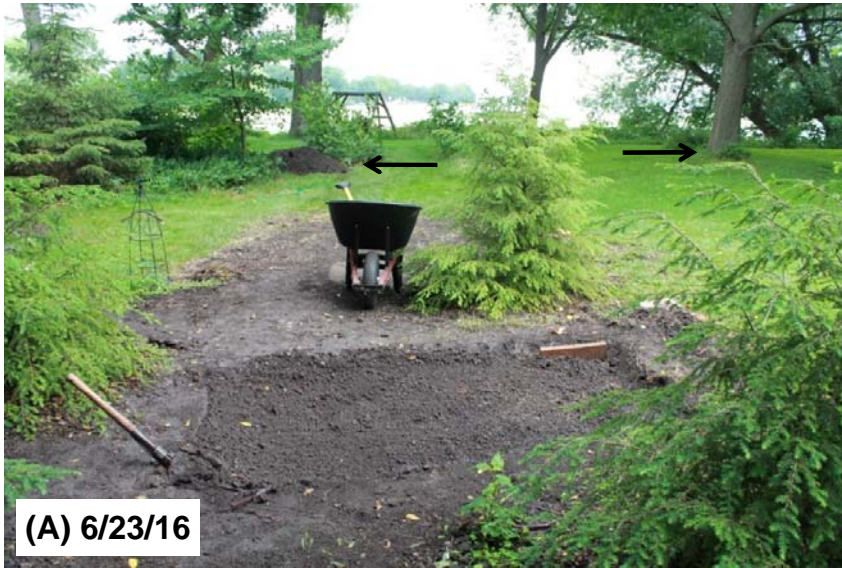
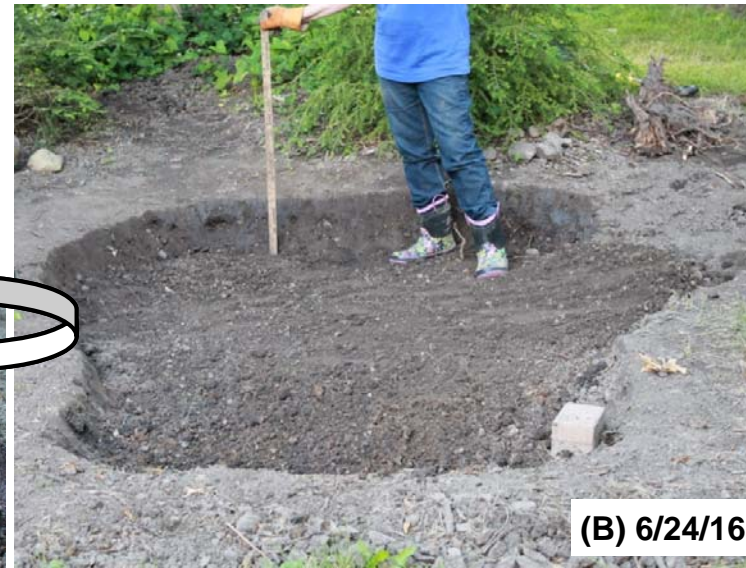
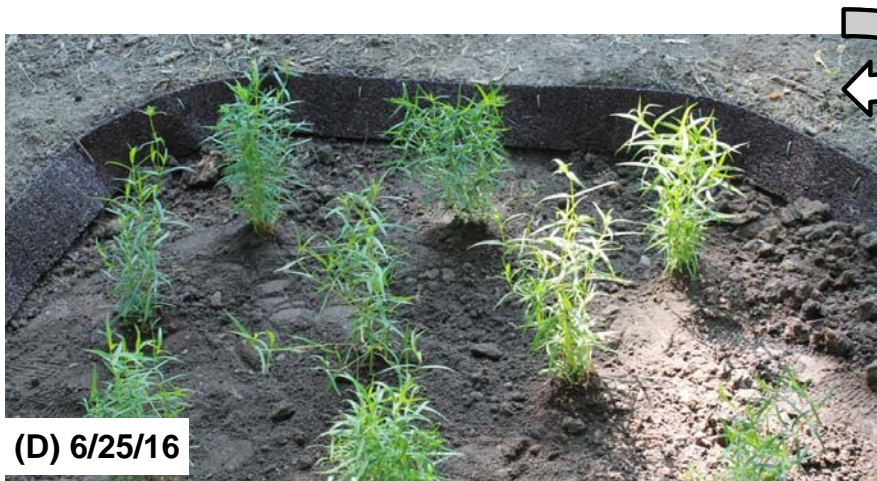
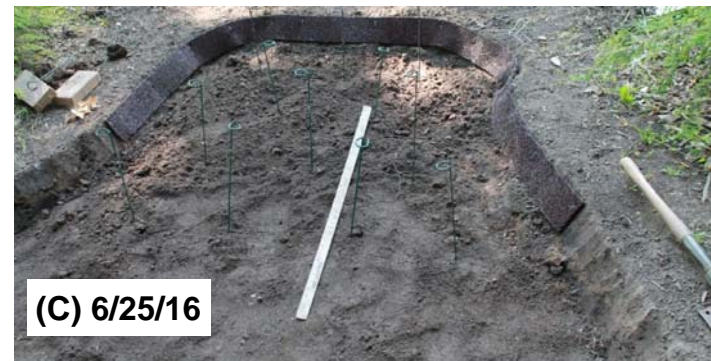
BUILDING THE WEST SECTION

(A-C) Excavating, soil saving and amending, wall reinforcing.

(C,D) Backfilling, laying grid, planting
(↑ marsh phlox).

1. Excavated to ~10 inches.
2. Walls reinforced with rubber tape held by landscape staples.
3. Excavated soil containing lowest clay content set aside and amended with peat moss to achieve porosity.,
4. Excavation backfilled to a depth of 4" below ground.
5. Plants with 3" and 4" root systems planted in amended soil.
6. Two inches of shredded hardwood bark mulch brought garden surface up to 2" below ground level.
7. Watered with gentle, soaking sprinkle.

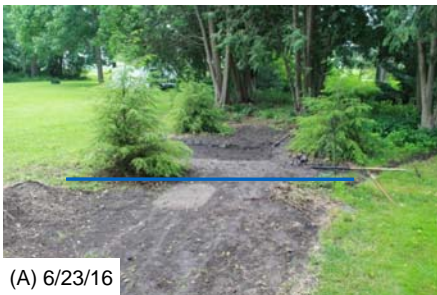
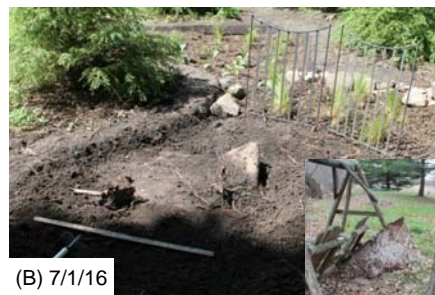
BUILDING THE EAST SECTION OF THE RAIN GARDEN

Challenge - A previous owner buried several large metal plates, assorted hardware, and other debris near the ground surface (photo A) in soil containing a large amount of gravel.

Photo B - Plate being removed. A movable fence was used to protect already-planted west section . Note removed plate's size in relation to the swing it leans against.

Photo C – Buried kitchen items.

Good news - Soil below plates was porous because of gravel component. Deep digging was not necessary. Once foreign objects were removed, east section floor was leveled, backfilled with amended soil, planted, and mulched.

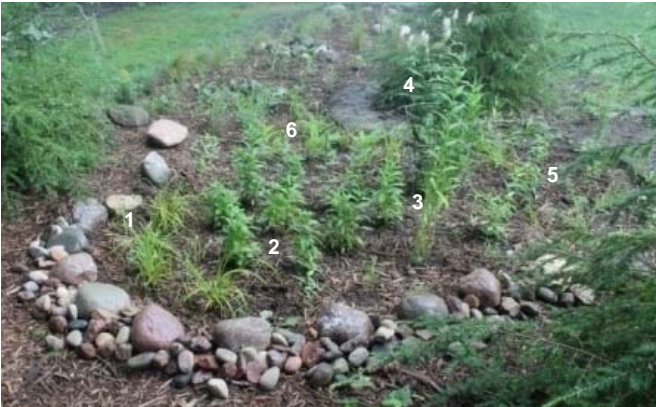
BERMS AND HARDSCAPING

(A) Bermed west end on 7/23/16 after a violent rainstorm showing good drainage. 1-burr sedge; 2-great blue lobelia; 3- obedient plant; 4-Culver's root; 5-mountain mint; 6-wild quinine; 7-marsh phlox.

The east, west, and south borders of the garden were bermed to retain rain water entering a conduit on the north side.

We researched berms to understand their construction and found that a height-to-depth ratio of 1-to-4 was desirable adjacent to forbs and sedges. A height-to-depth ratio of 1-to-7 was required for healthy tree establishment. We bermed accordingly.

The underlayer consisted of excavated soil containing a large clay content, over which we put layer of amended soil. The entire berm was mulched with shredded bark.

Large rocks intermixed with smaller stones were placed in some places on the berm. Their purpose was to decoratively define an edge and to deter mulch erosion from the berm into the garden.

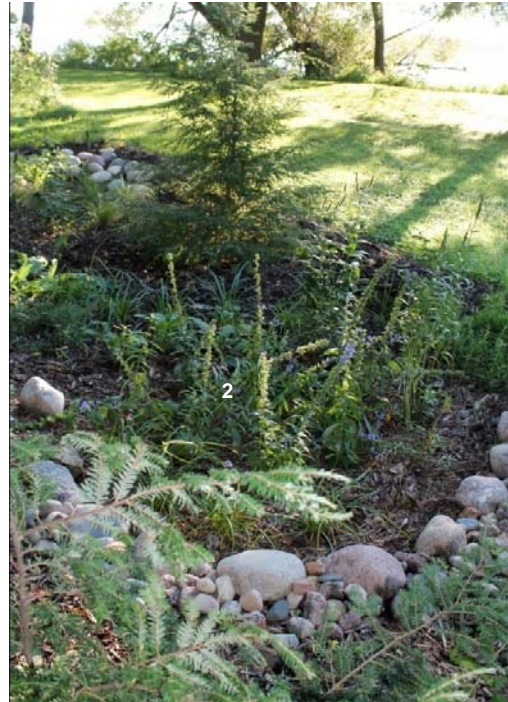
(B) Same area on 9/11/16, looking southeast. In foreground, great blue lobelia (2) is at the end of its bloom. Note berm on south border in back of hemlock.

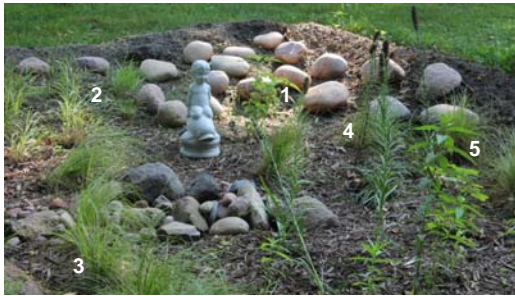
BERMS AND HARDSCAPING

(A) East end of rain garden, 8/3/16, planting continuing and berm and hardscape being developed.

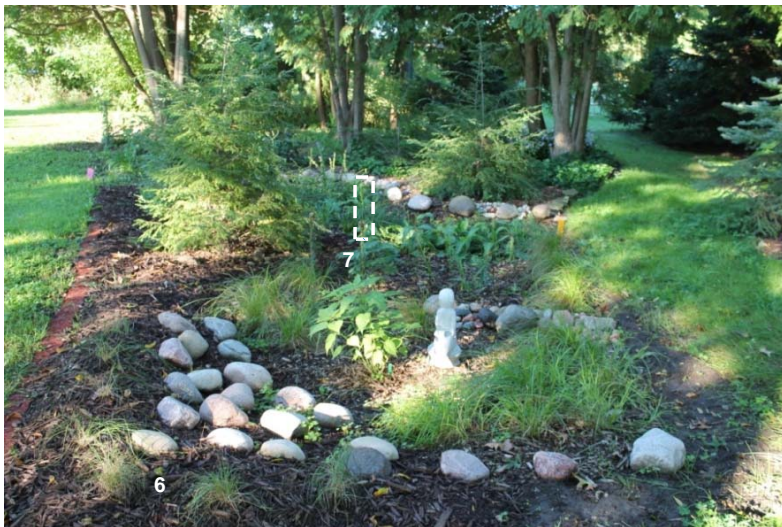
(B) Same area, 9/11/16, with contiguous woodland to the west.

1. rose mallow
2. palm sedge
3. fox sedge
4. dense blazingstar
(*liatris spicata*)
5. swamp milkweed

6. prairie dropseed on berm
7. wild senna
