Shoreland and Shallows Habitat Monitoring Protocol

Katie Hein & Scott Van Egeren

Measuring Elements of a Healthy Lakeshore Survey Scope

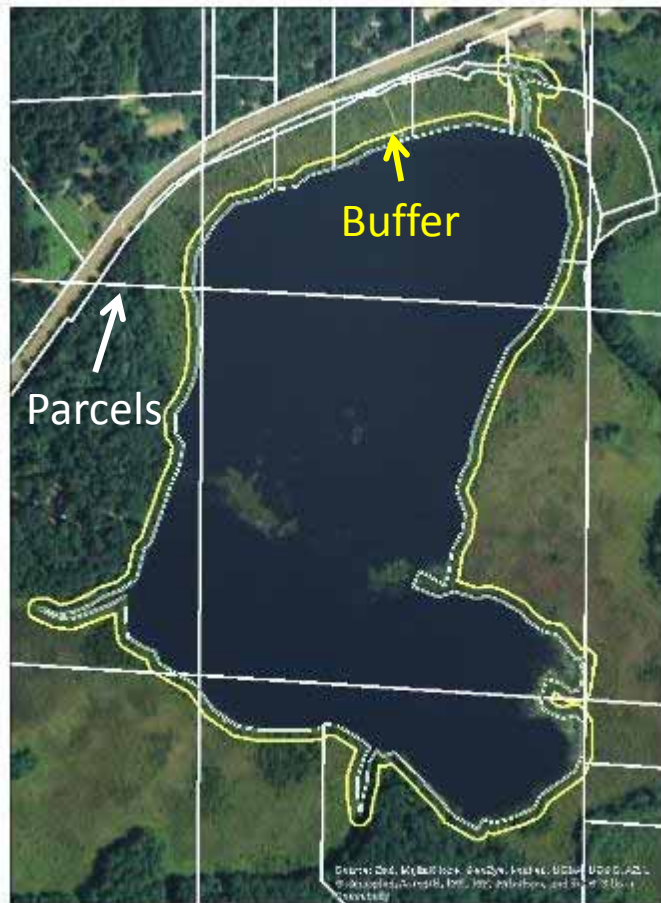
Pre-Fieldwork Mapping

- Parcel ID number
- Shoreline Length
- 35 foot buffer

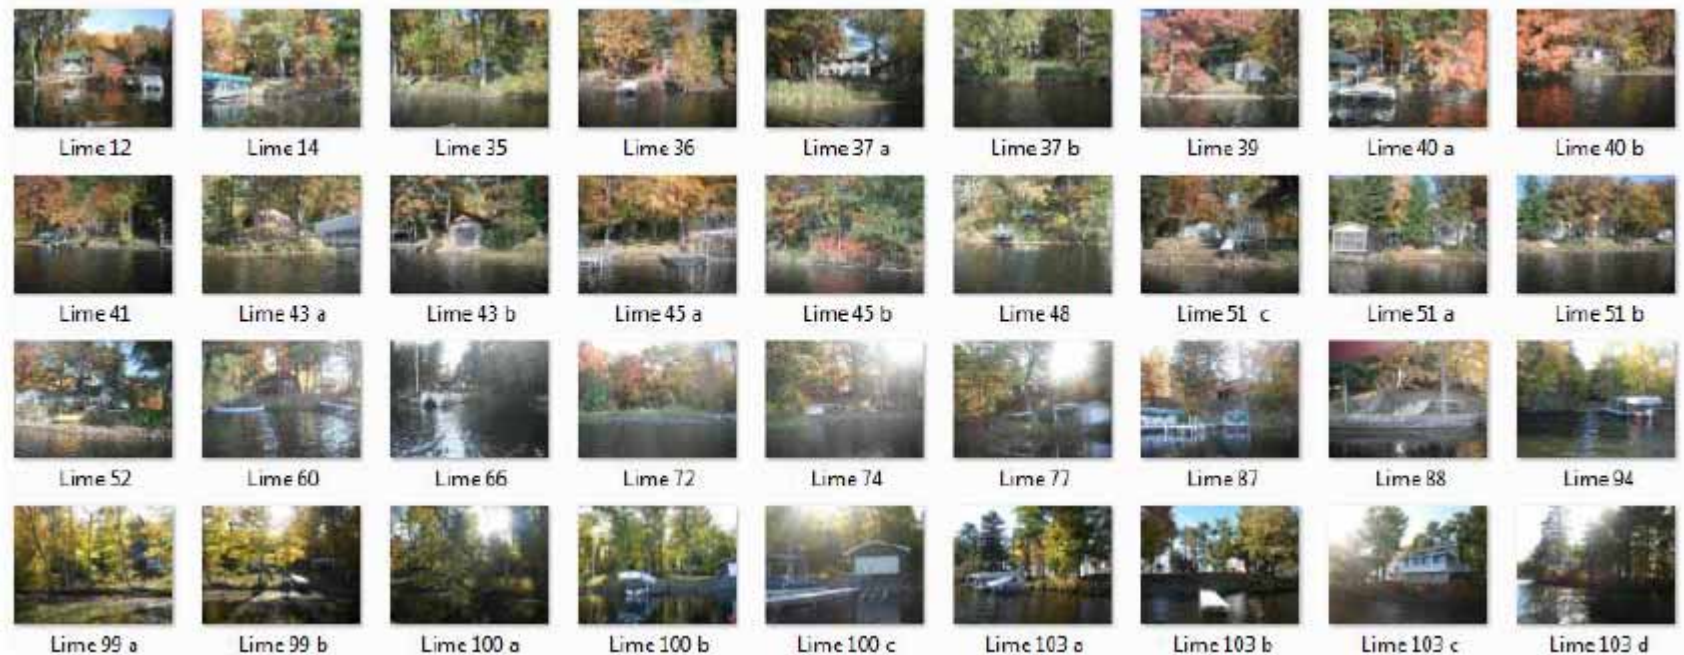
Loop 1: Photos of Entire Shoreline

- X,Y coordinates for each photo
- Overlapping images
- Publicly available data
- Check with your lake association before doing

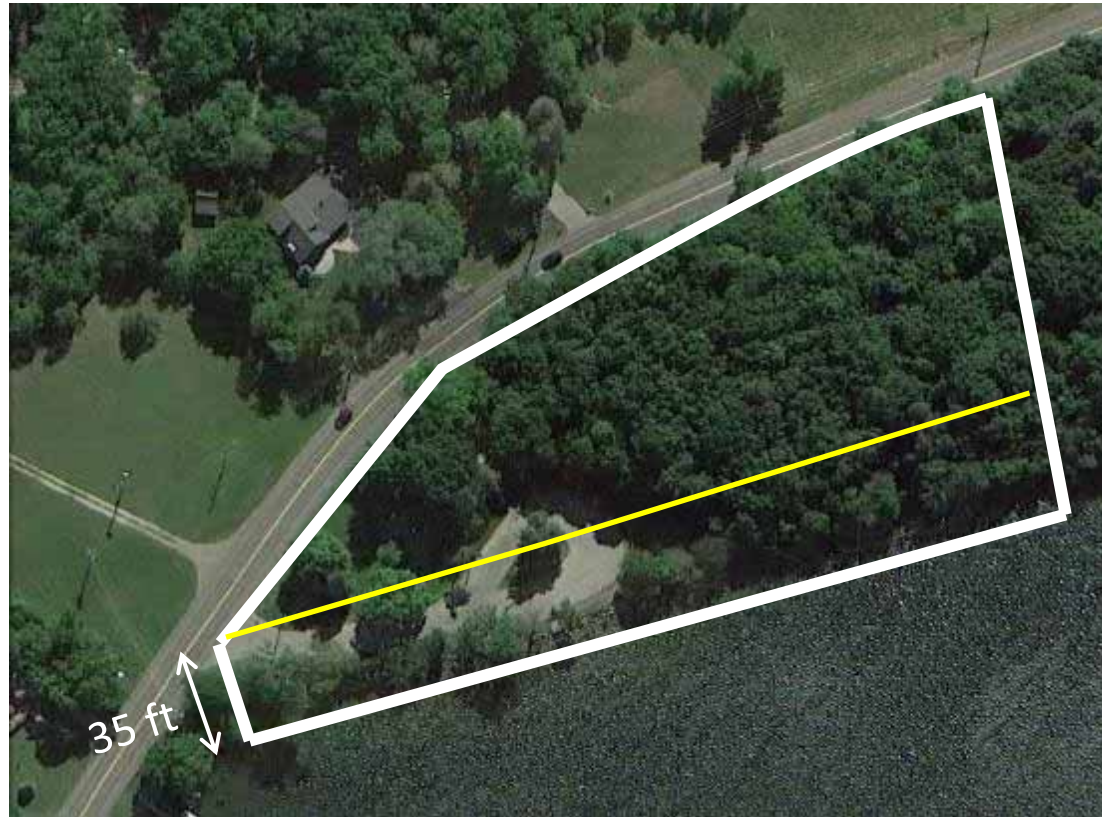
Loop 2: Riparian Assessment of Parcel

1. Find parcel boundaries
2. Determine 35 ft buffer

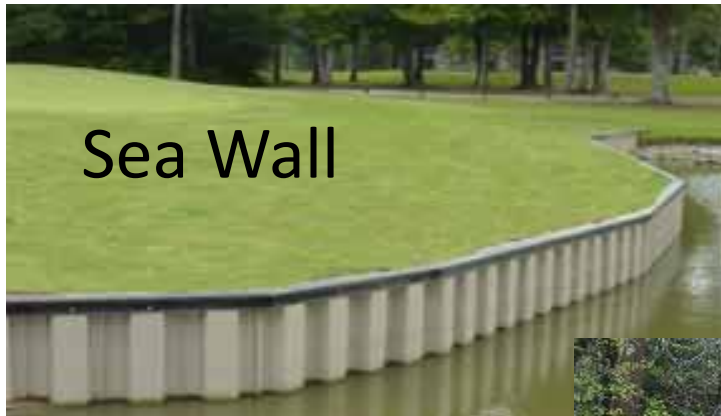
Sea Wall

Loop 2: Length of Modified Banks

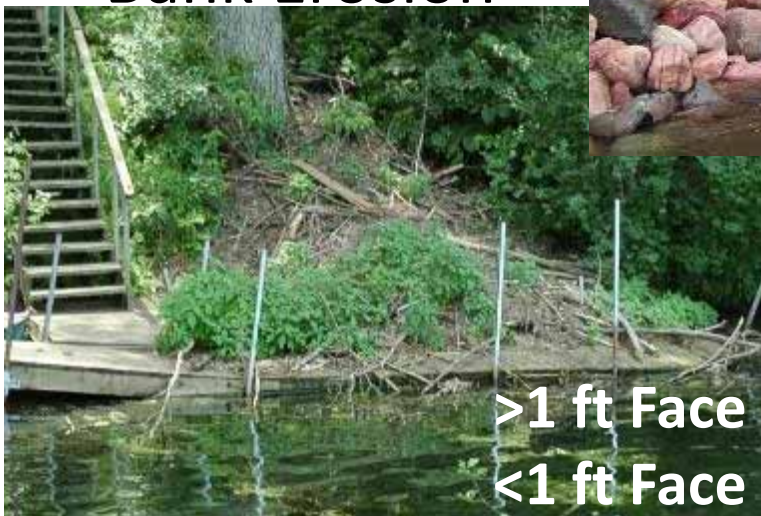
Bank Erosion

>1 ft Face
<1 ft Face

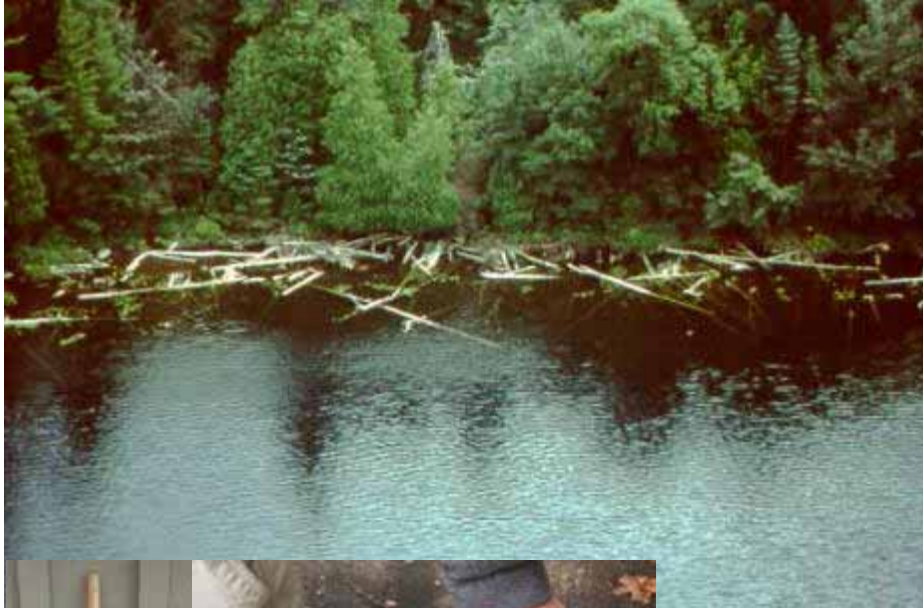
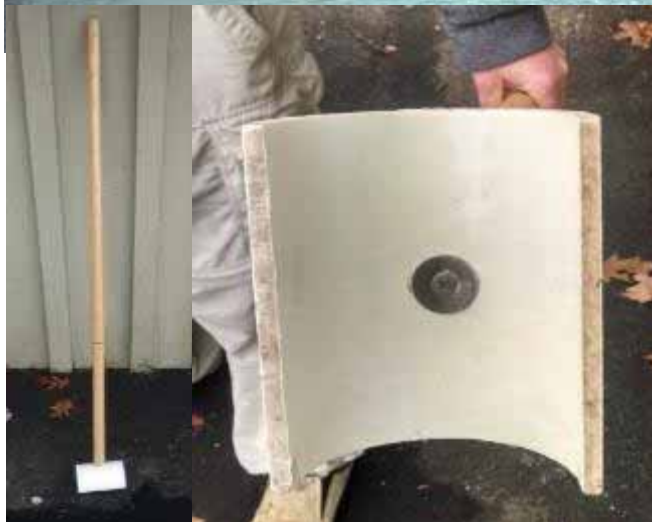
Loop 3: Map Coarse Woody Habitat

- > 4 inch diameter
- > 5 feet long
- XY coordinates per log
- Branchiness
 - No branches
 - Few branches
 - Full crown
- Connected to Shore
- Out of Water

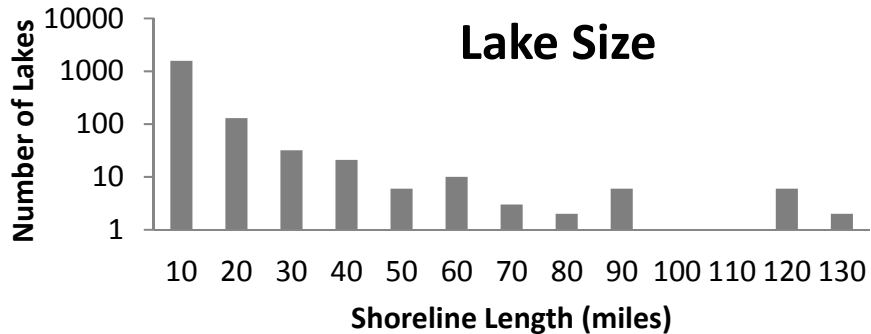
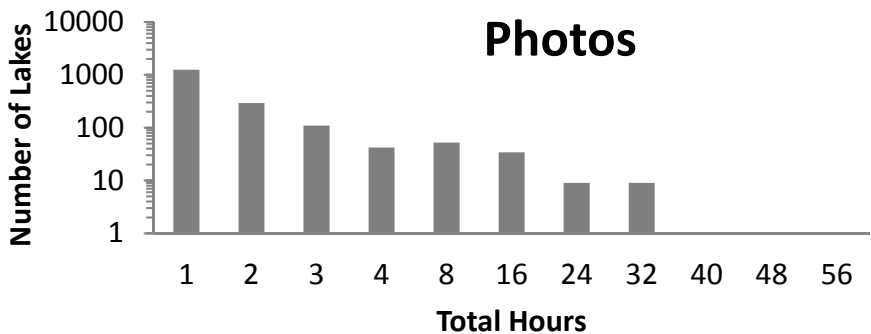
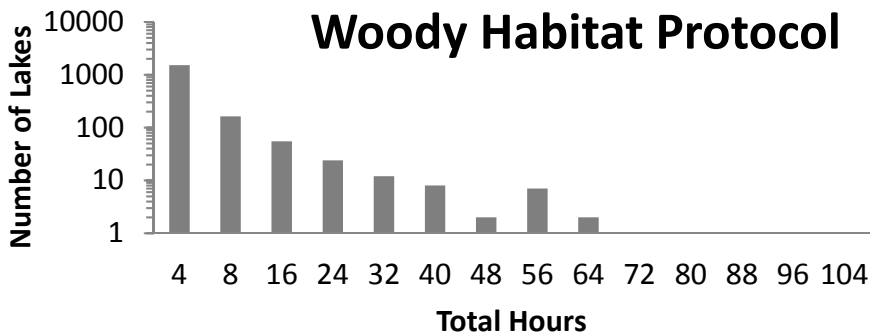
Time Estimates Given Lake Size

Lake	Area (acre)	Shoreline length (mi)	Parcels	Total Hours – Photos	Total Hours – Parcels	Total Hours – Wood	Total Hours
Green	7433	23.6	~1000	5.5	58.3	11.4	75
Rock	1364	11.2	341	2.6	17.5	5.4	26
Buffalo	105	2.1	26	0.5	1.5	1.0	3

Most lakes are small and could be completed in a “reasonable” amount of time

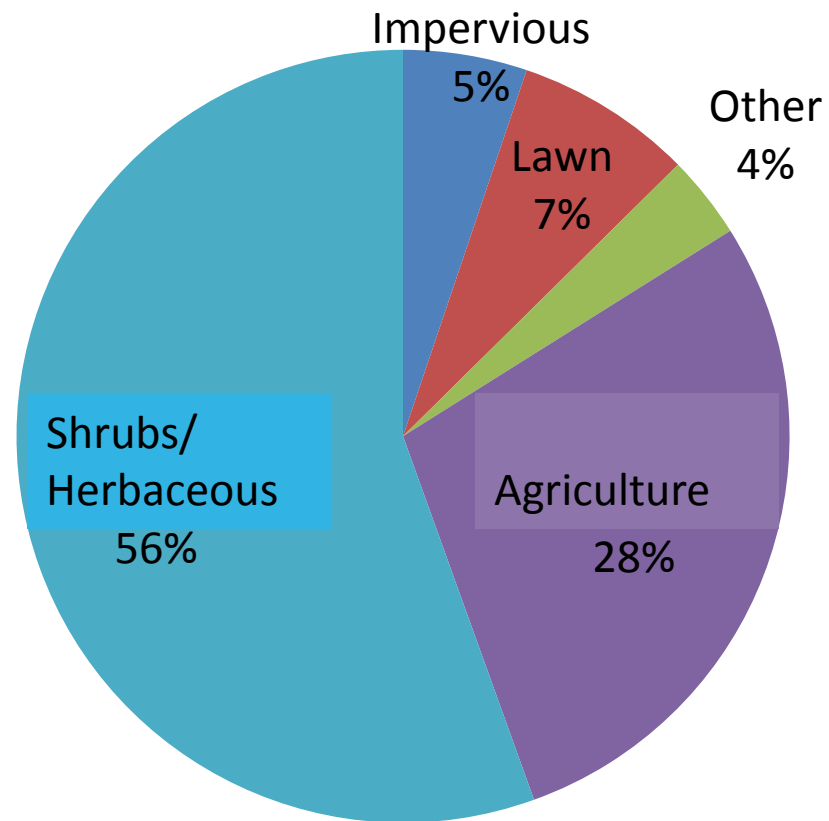
Percent Land Cover in Riparian Zone

10 parcels

Shoreline Length = 1910 ft

Riparian Area = 1.5 acres

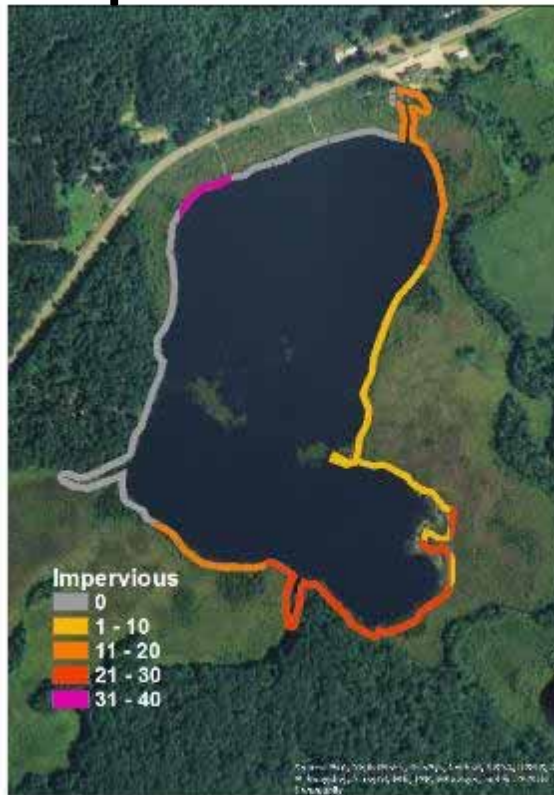
Impervious surface = 0.08 acres

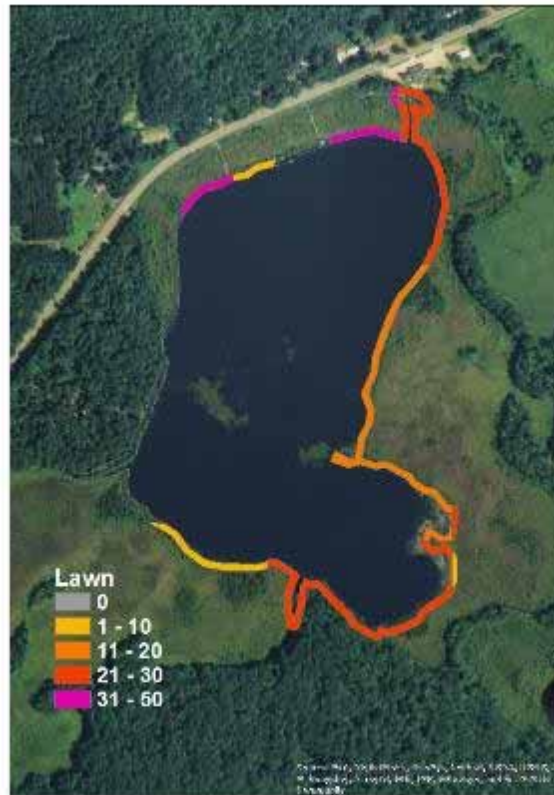
Lawn = 0.11 acres

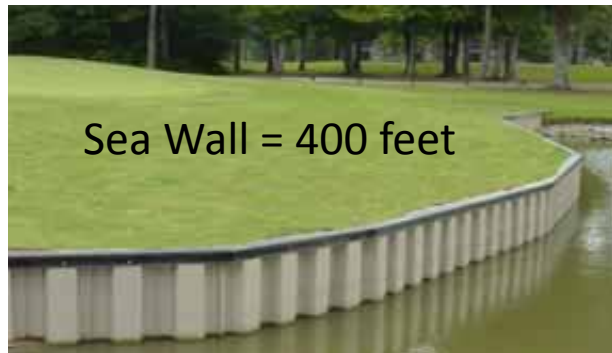
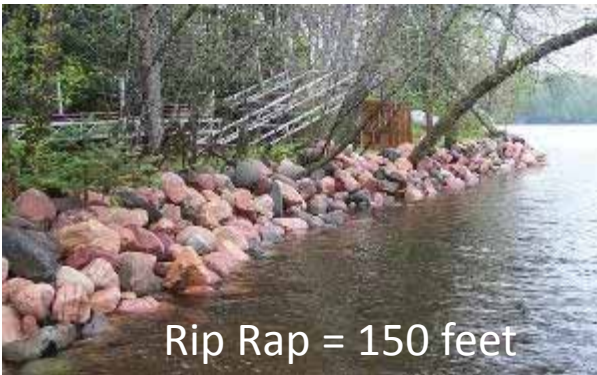
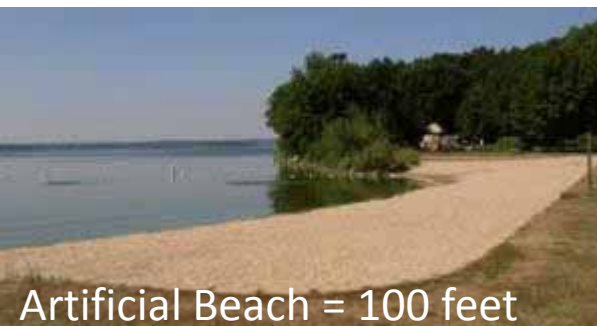
Total Length of Modified Banks

20% of shoreline is modified
