Restoring Ecological Landscapes in “High Profile” AIS Sites

Stephanie Boismenu, AIS Coordinator, Oneida County Land & Water Conservation Department
Thomas Boisvert, AIS Program Assistant, Oneida County Land & Water Conservation Department
Wisconsin Lakes Partnership Convention, April 20, 2018

Phragmites Restoration Site Highway 8 West, Rhinelander

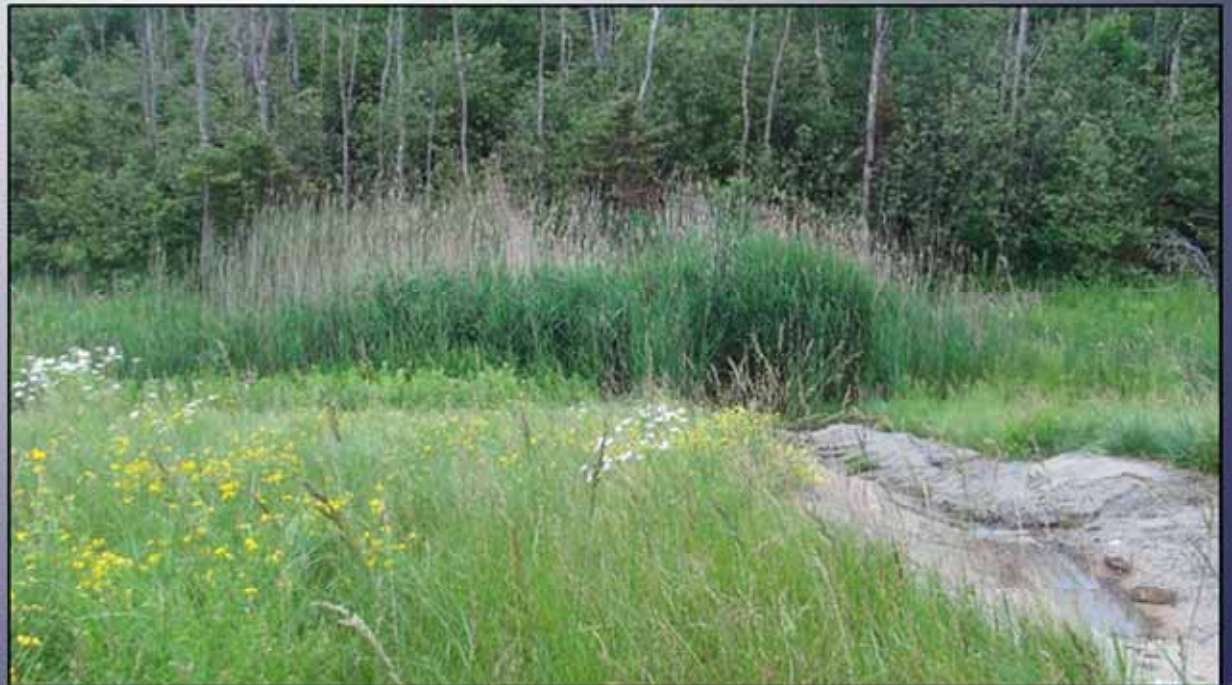
2013, Identified a 0.05-
acre pioneer population
of the non-native
Phragmites australis.

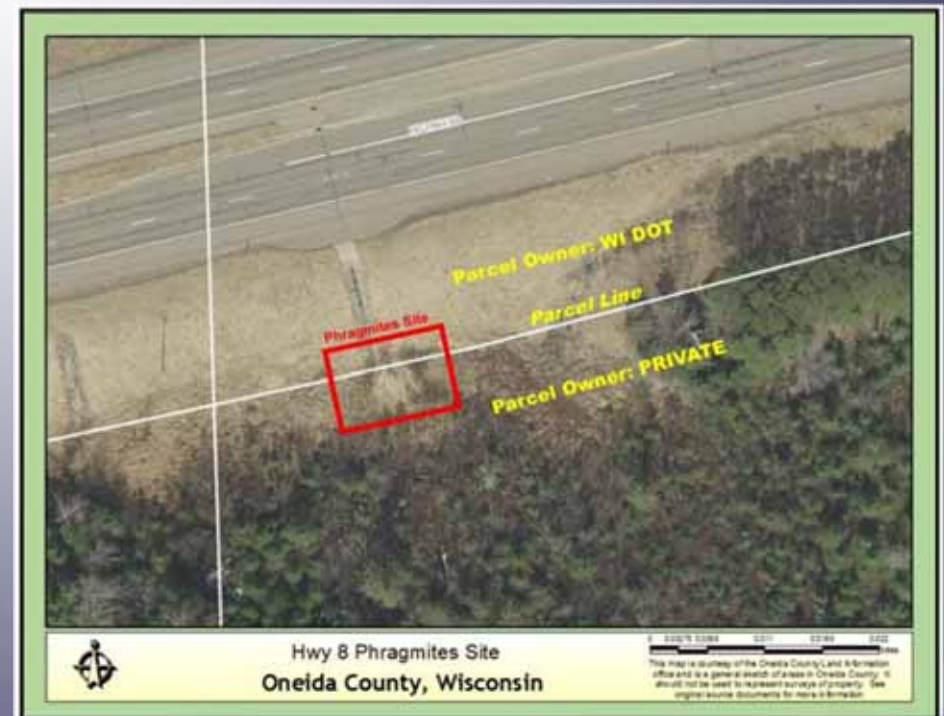
- The site is located in a wetland habitat at the bottom of a concrete run-off ditch, along Highway 8 just west of Rhinelander.
- The site extends across both WDOT highway right-of-way property and private property.

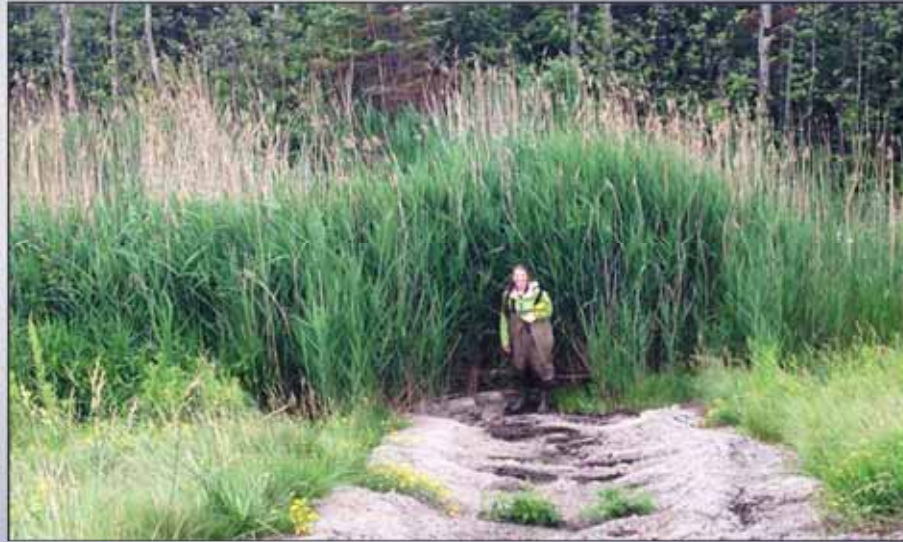
Post-herbicide treatment.

Herbicide applied 9/22/14.

(Boismenu 4/15/15)

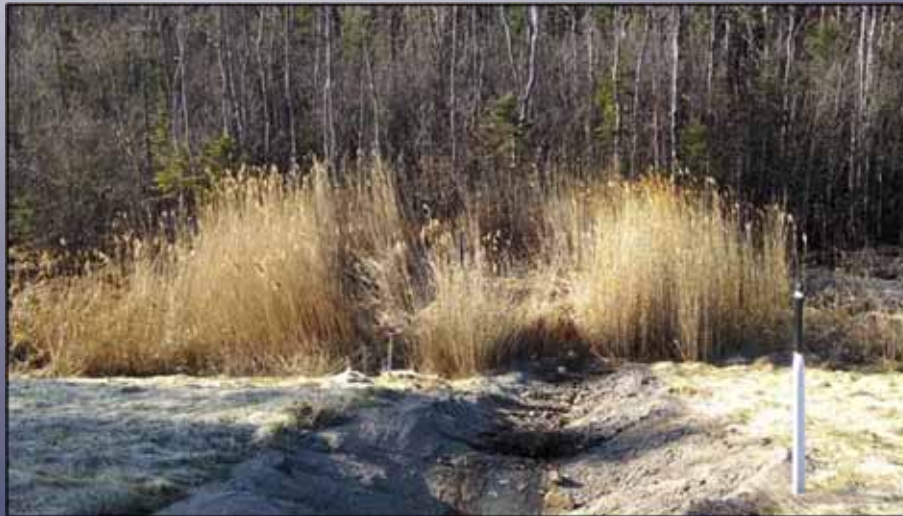
4/27/15 Phragmites manual
removal project.

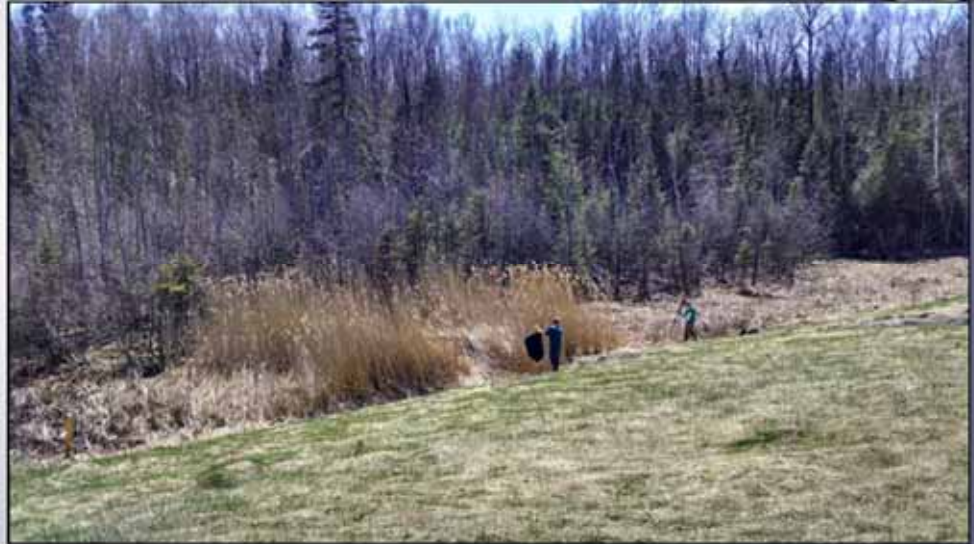
4/27/15 Phragmites manual
removal project.

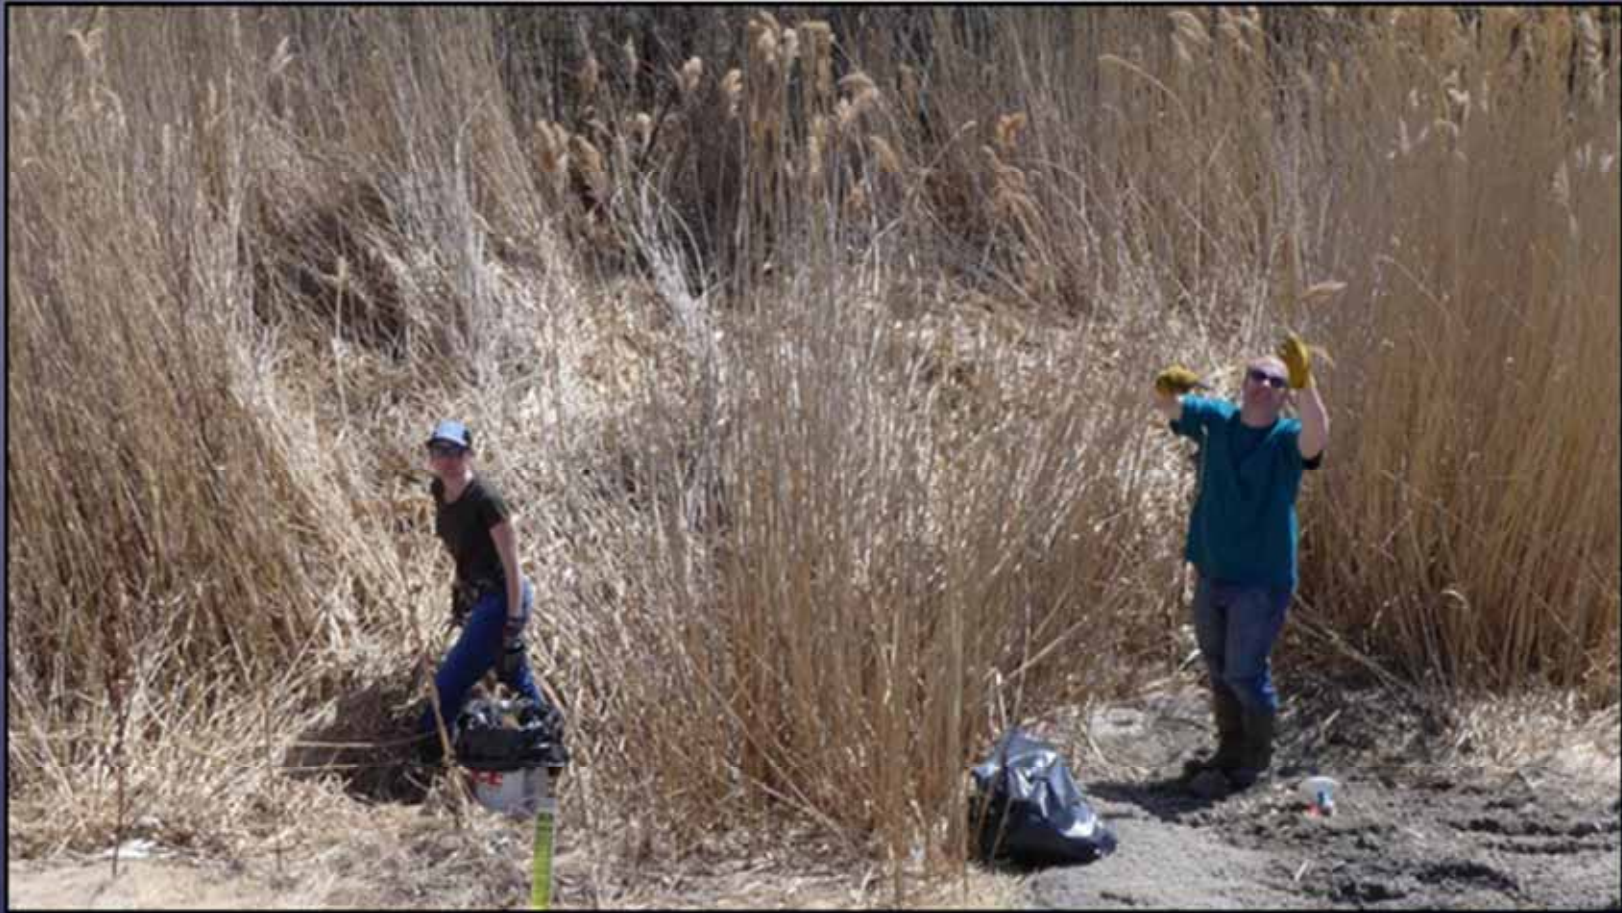
Cutting and bagging seed heads. (Photo by Michele Sadauskas)

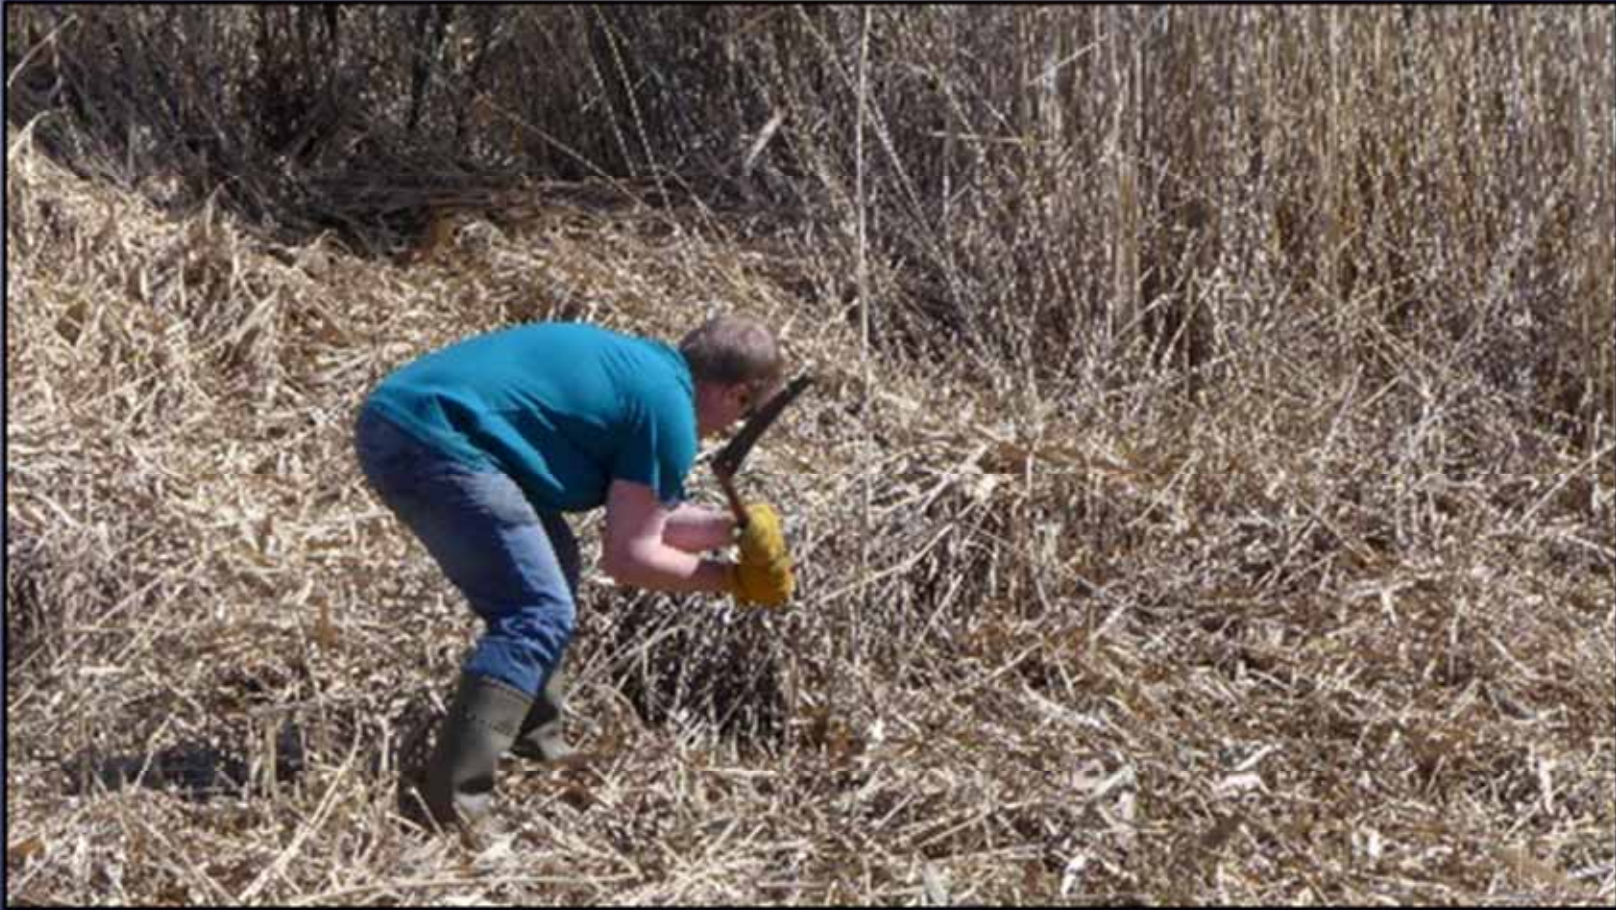
John is using a garden a sickle to cut the stalks at their base.

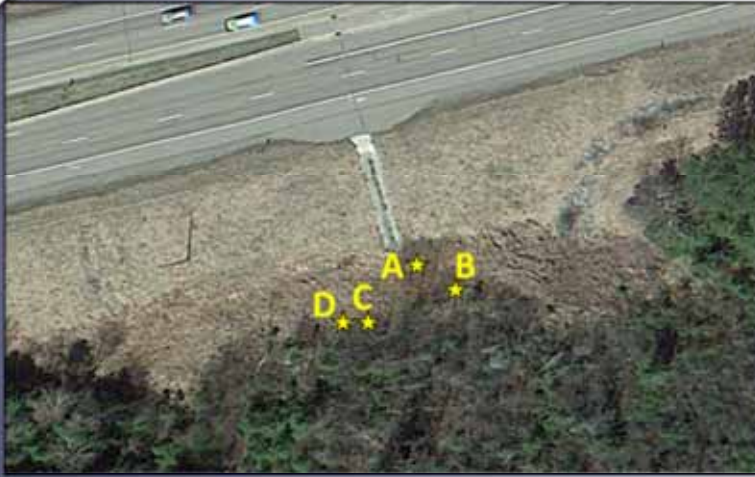
- Site visit 6/23/15: New growth and plots labeled.
 - Plot A: 0 live plants. (45.61942657, -89.48020553)
 - Plot B: 5 live plants, max height of 4 feet, 4 inches. (45.61939439, -89.48012274)
 - Plot C: 9 live plants, max height of 4 feet, 6 inches. (45.6193422, -89.48023085)
 - Plot D: 9 live plants, max height of 5 feet, 7 inches. (45.619344, -89.480374)
- Second herbicide treatment applied 8/18/2015
