**A Tale of Two Gardens:
Mini-Wetlands That Are Paying It Forward**

DNR Healthy Lakes Initiative Grants

Rain Garden (2016-2018) and Lakeshore Native Plantings (2017-2019)

Liaison: Beaver Dam Lake Improvement Association

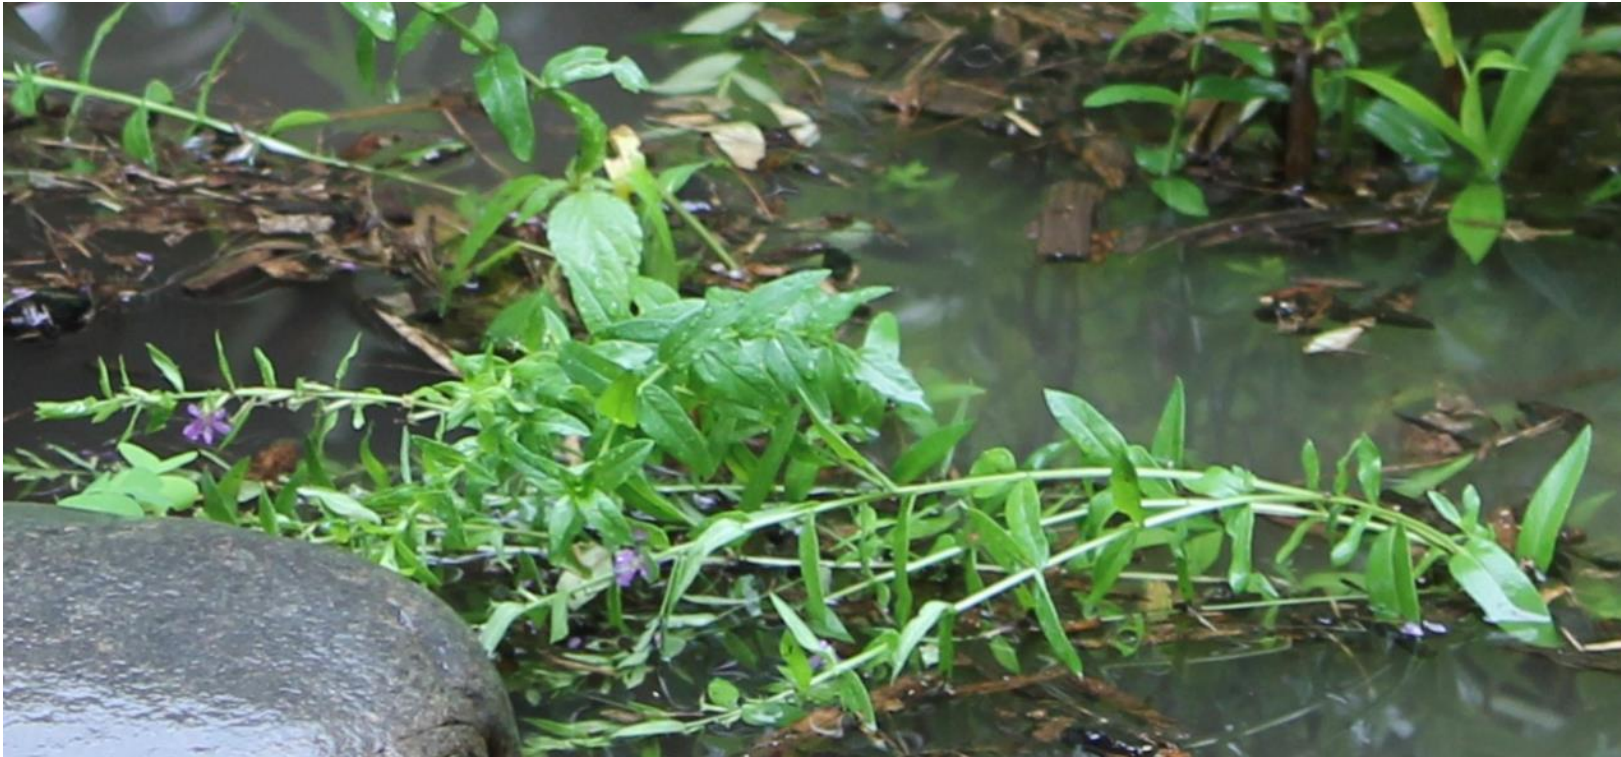
July 20, 2018: RAIN! 5.5" in 12 h! Winged loosestrife in standing water immediately after rainstorm and influx of water from flooded lawn on neighboring property.

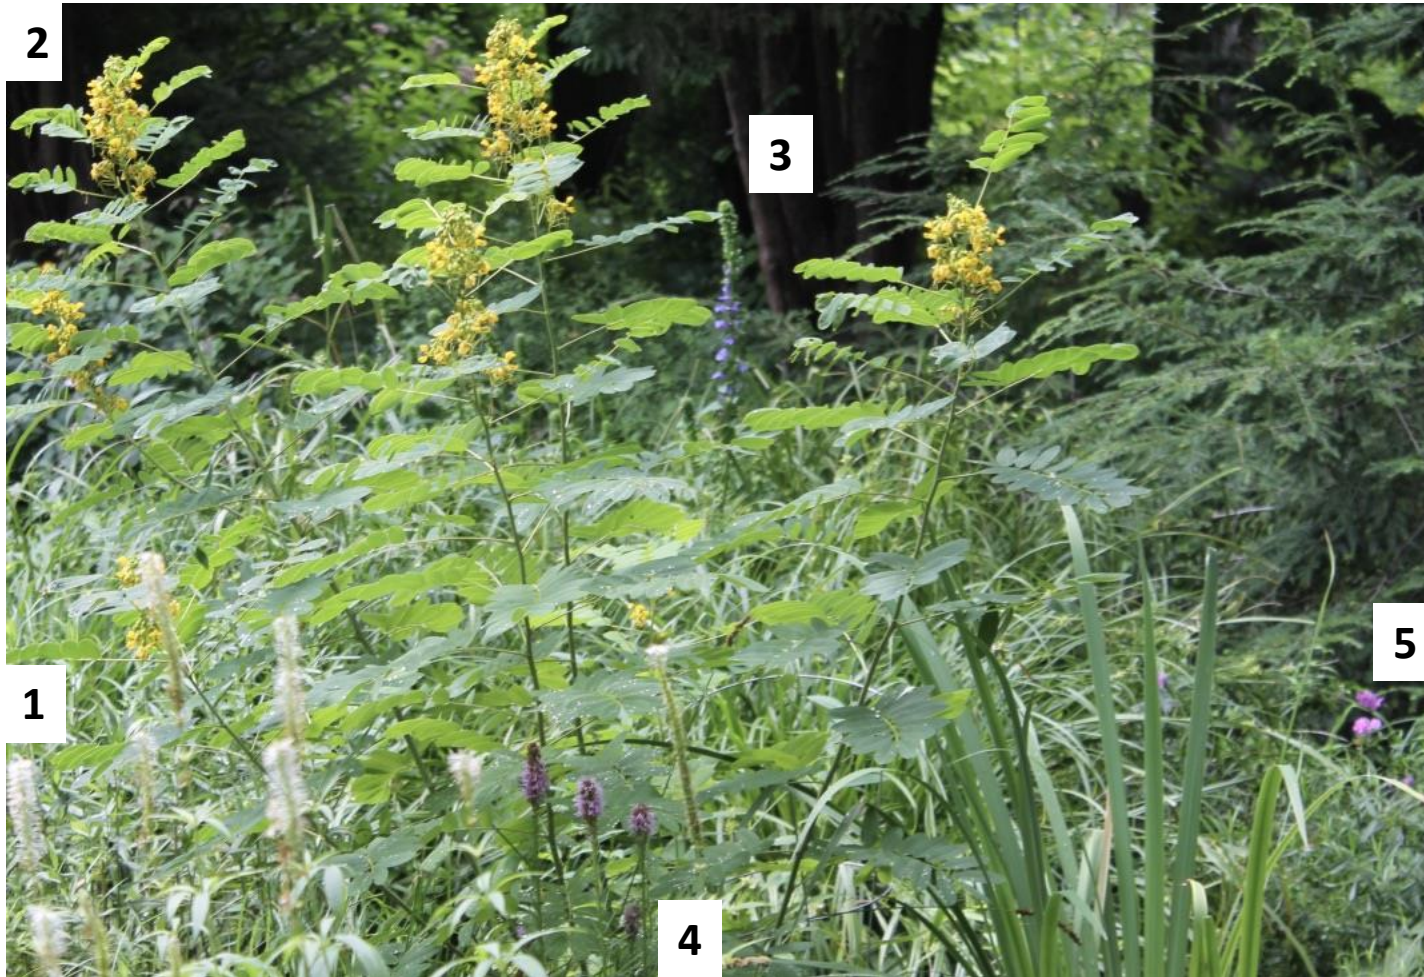
August 6, 2018

After doing hard infiltration work in late July, the rain garden dries and thrives in early August.

1. Culver's root
2. Wild senna
3. Great blue lobelia
4. Dense Blazingstar
5. Marsh phlox

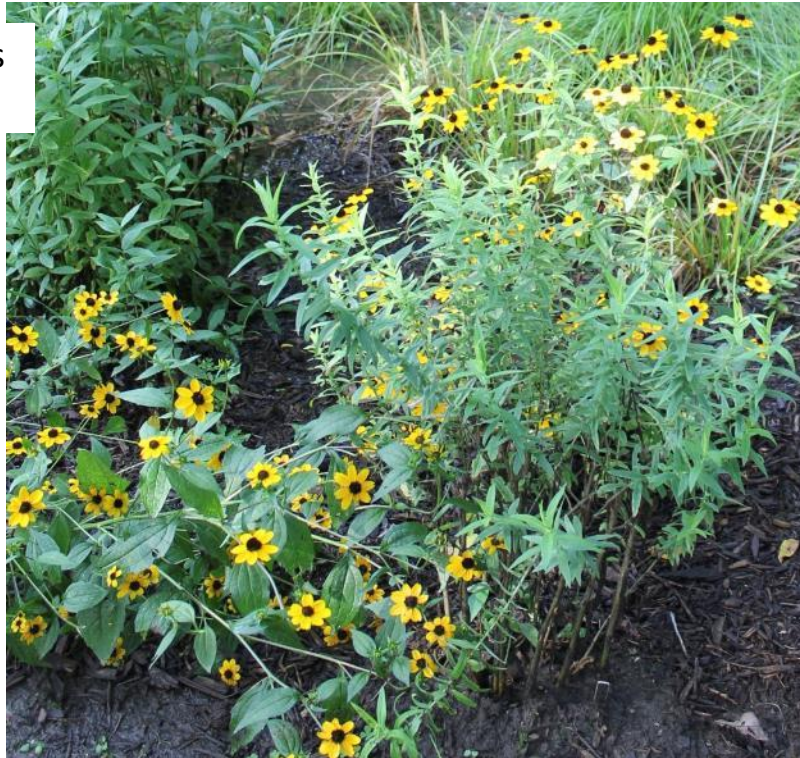
Late August-early September 2018 brought record-breaking rain. 14" of rain fell between August 26-29 and an additional 2" rainfall on September 2. Two vignettes after 9" rainfall on August 28.

Saturated soil but robust plants

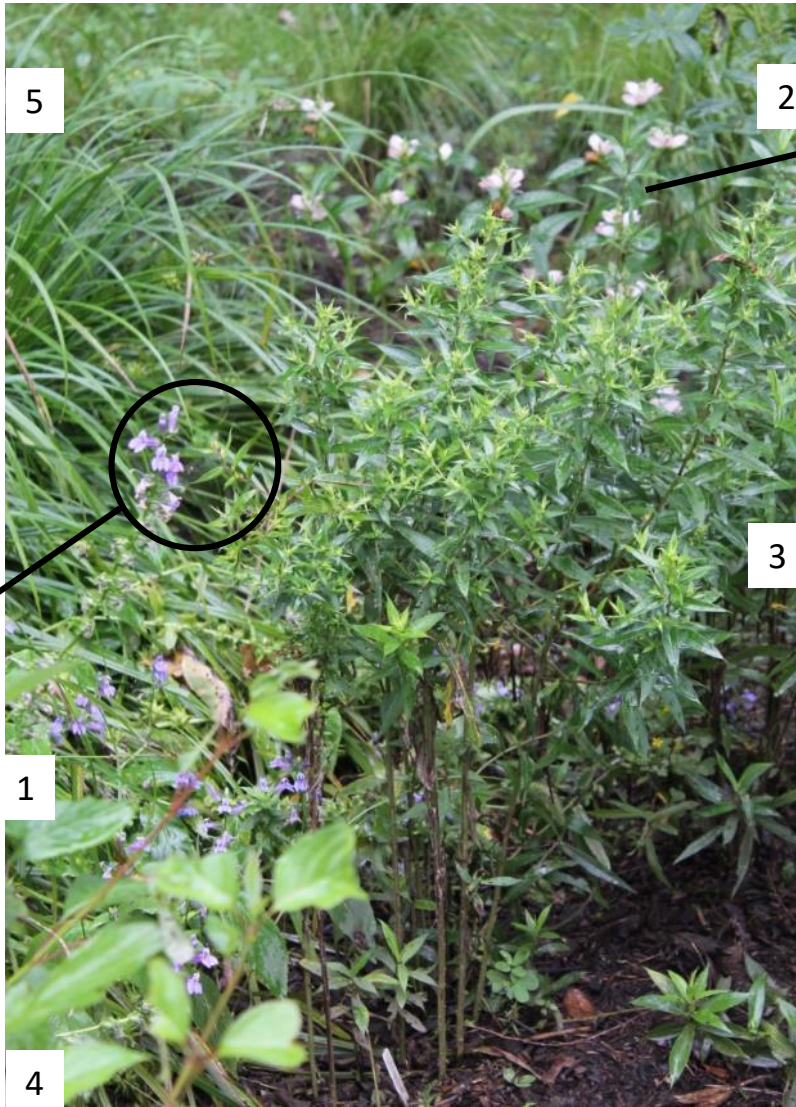
September 3, 2018

Undeclared RG after record 16" rainfall since August 26.

1. Great blue lobelia
2. Turtlehead
3. Swamp (red-stemmed) aster
4. Red osier dogwood
5. Burr sedge

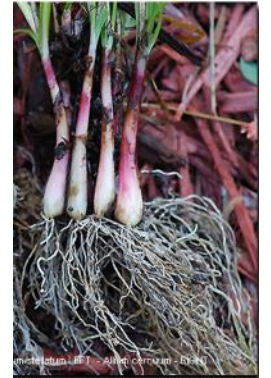
- Large deep rhizomatous and/or fibrous root biomass provides water access to deep soil:
Fox sedge, porcupine sedge, swamp aster (a). Dense blazingstar, swamp milkweed (b).
- Deep taproot (live or dead) provides conduit:
Culver's root, wild senna (c).

- Large shallow root biomass anchors soil in first 6" below surface.
Culver's root, great blue lobelia (a). Burr sedge, marsh phlox, nodding pink onion (b).
Note: On slight slope, e.g. lakeshore garden, occasional deep root "anchor" species are necessary.
- Large shoot biomass near soil surface diffuses flowing water movement, reduces drag on plants.
Fox sedge, porcupine sedge, swamp milkweed (a).

*Published data for 11 of 14 rain garden species.

(a) UW Arboretum Leaflet 15; (b) minimum root depth, USDA; (c) USDA fact sheet.

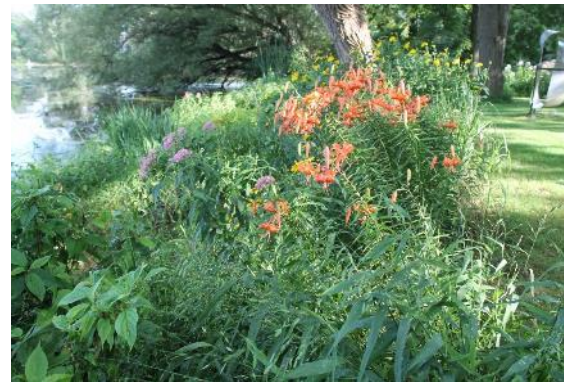
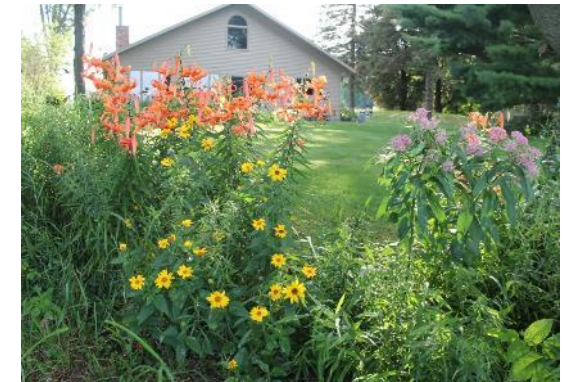
A. Colored shapes indicate plantings retained after removing exotics and undesirable volunteers. Black-outlined white shapes indicate position of new plantings that were added during first two growing seasons, 2017, 2018. Photos show retained plantings thriving in late **July 2017**.

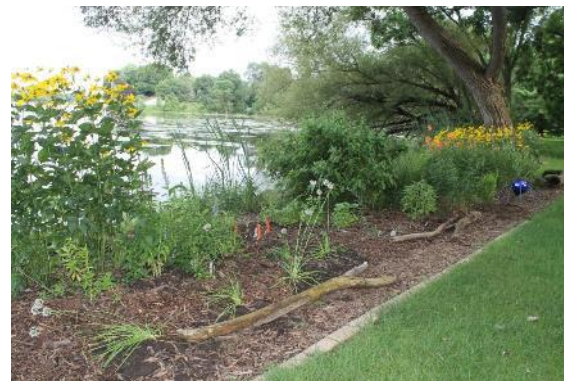
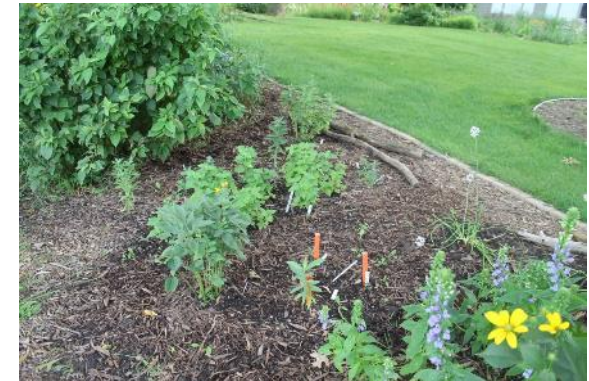
B. Retained and new plantings in early **August 2018**.

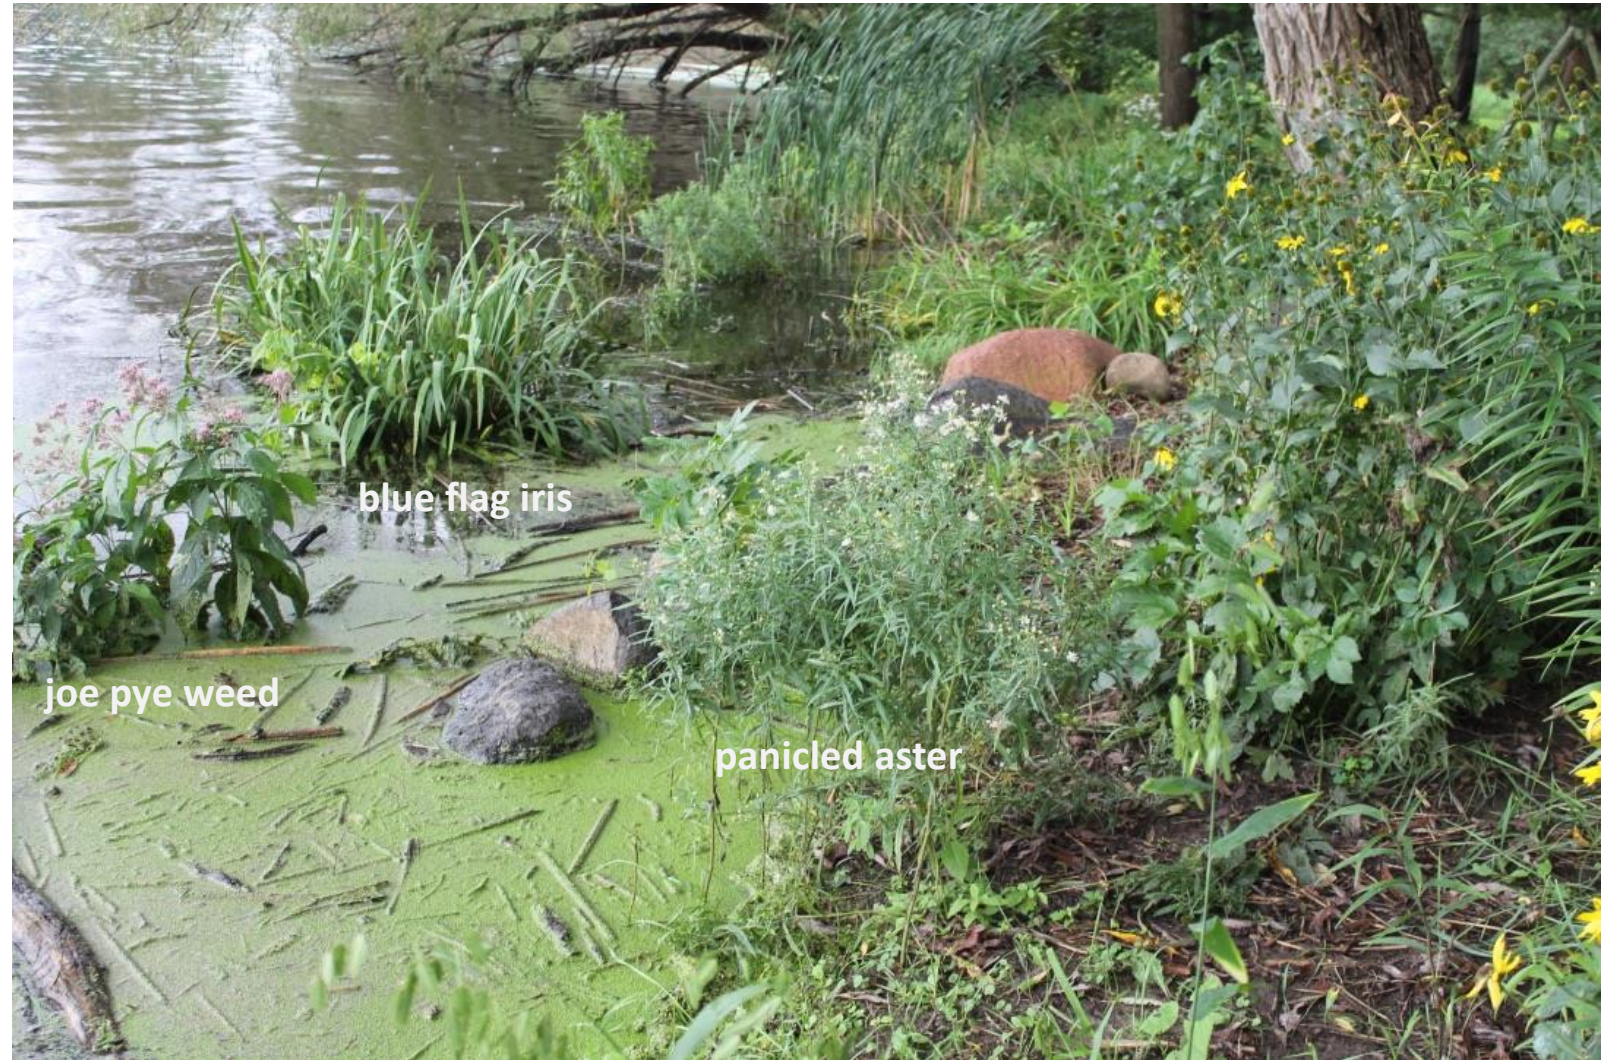
SEPT. 3, 2018: 16" of rainfall since 8/26 + influx of water from Beaver Creek caused major flooding of part of the lakeshore garden.

- (1) Acknowledge changing habitat of flooded region.
- (2) After assessing damage, take cue from Mother Nature. Replace plants that disappeared with species related to survivors.
