P O R T A G E C O U N T Y

EURASIAN WATER MILFOIL ASSESSMENT

**Springville Pond  
Thomas Lake  
Lake Joanis**

Summary: 2003 - 2006

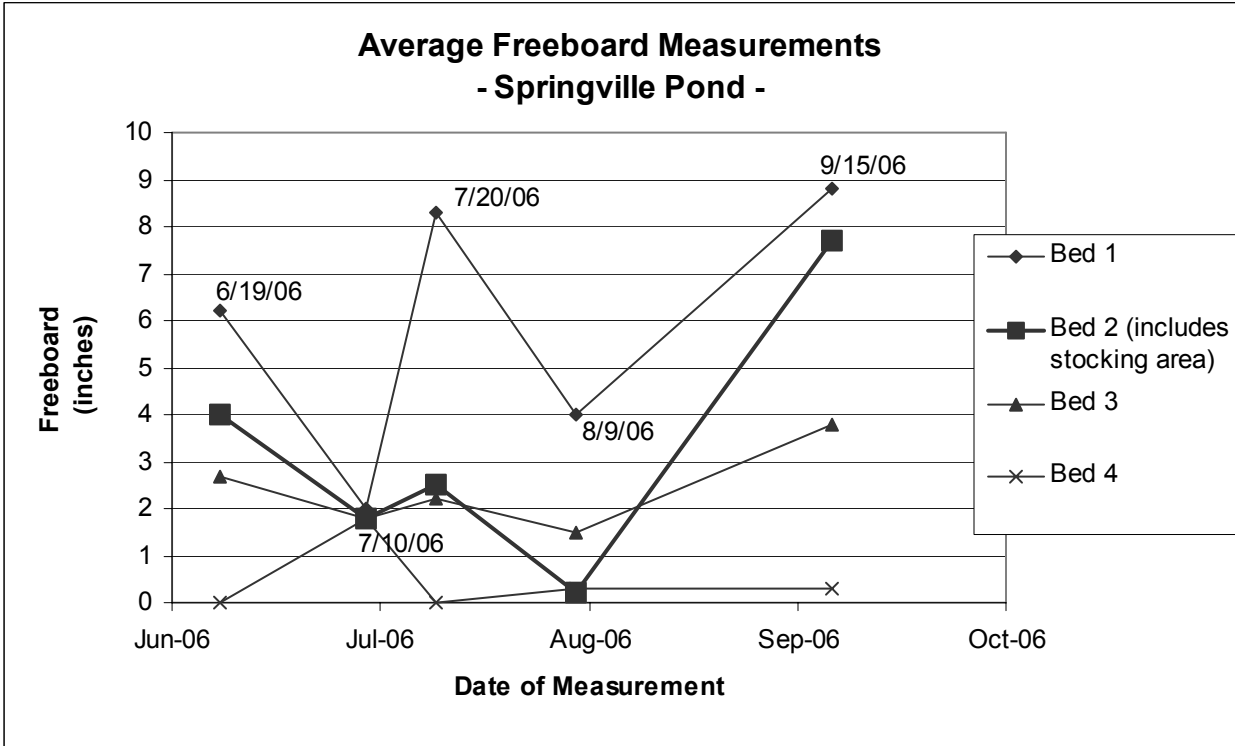
Chart 4. Average Freeboard Measurements – Springville Pond

Freeboard and temperature measurements did not indicate discernable trends. (See Section II for detail on survey methods. Note that survey freeboard surveys avoided the immediate stocking area.) Freeboard is the distance from the surface of the water to the top of the EWM stem. A freeboard of zero inches indicates that the EWM was reaching the surface. Weevil impacts usually cause a loss of stem buoyancy, therefore, heavy weevil activity would be likely to result in a higher average freeboard.

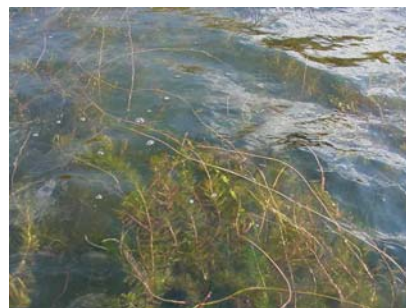
A closer view of dense EWM growth in Thomas Lake.

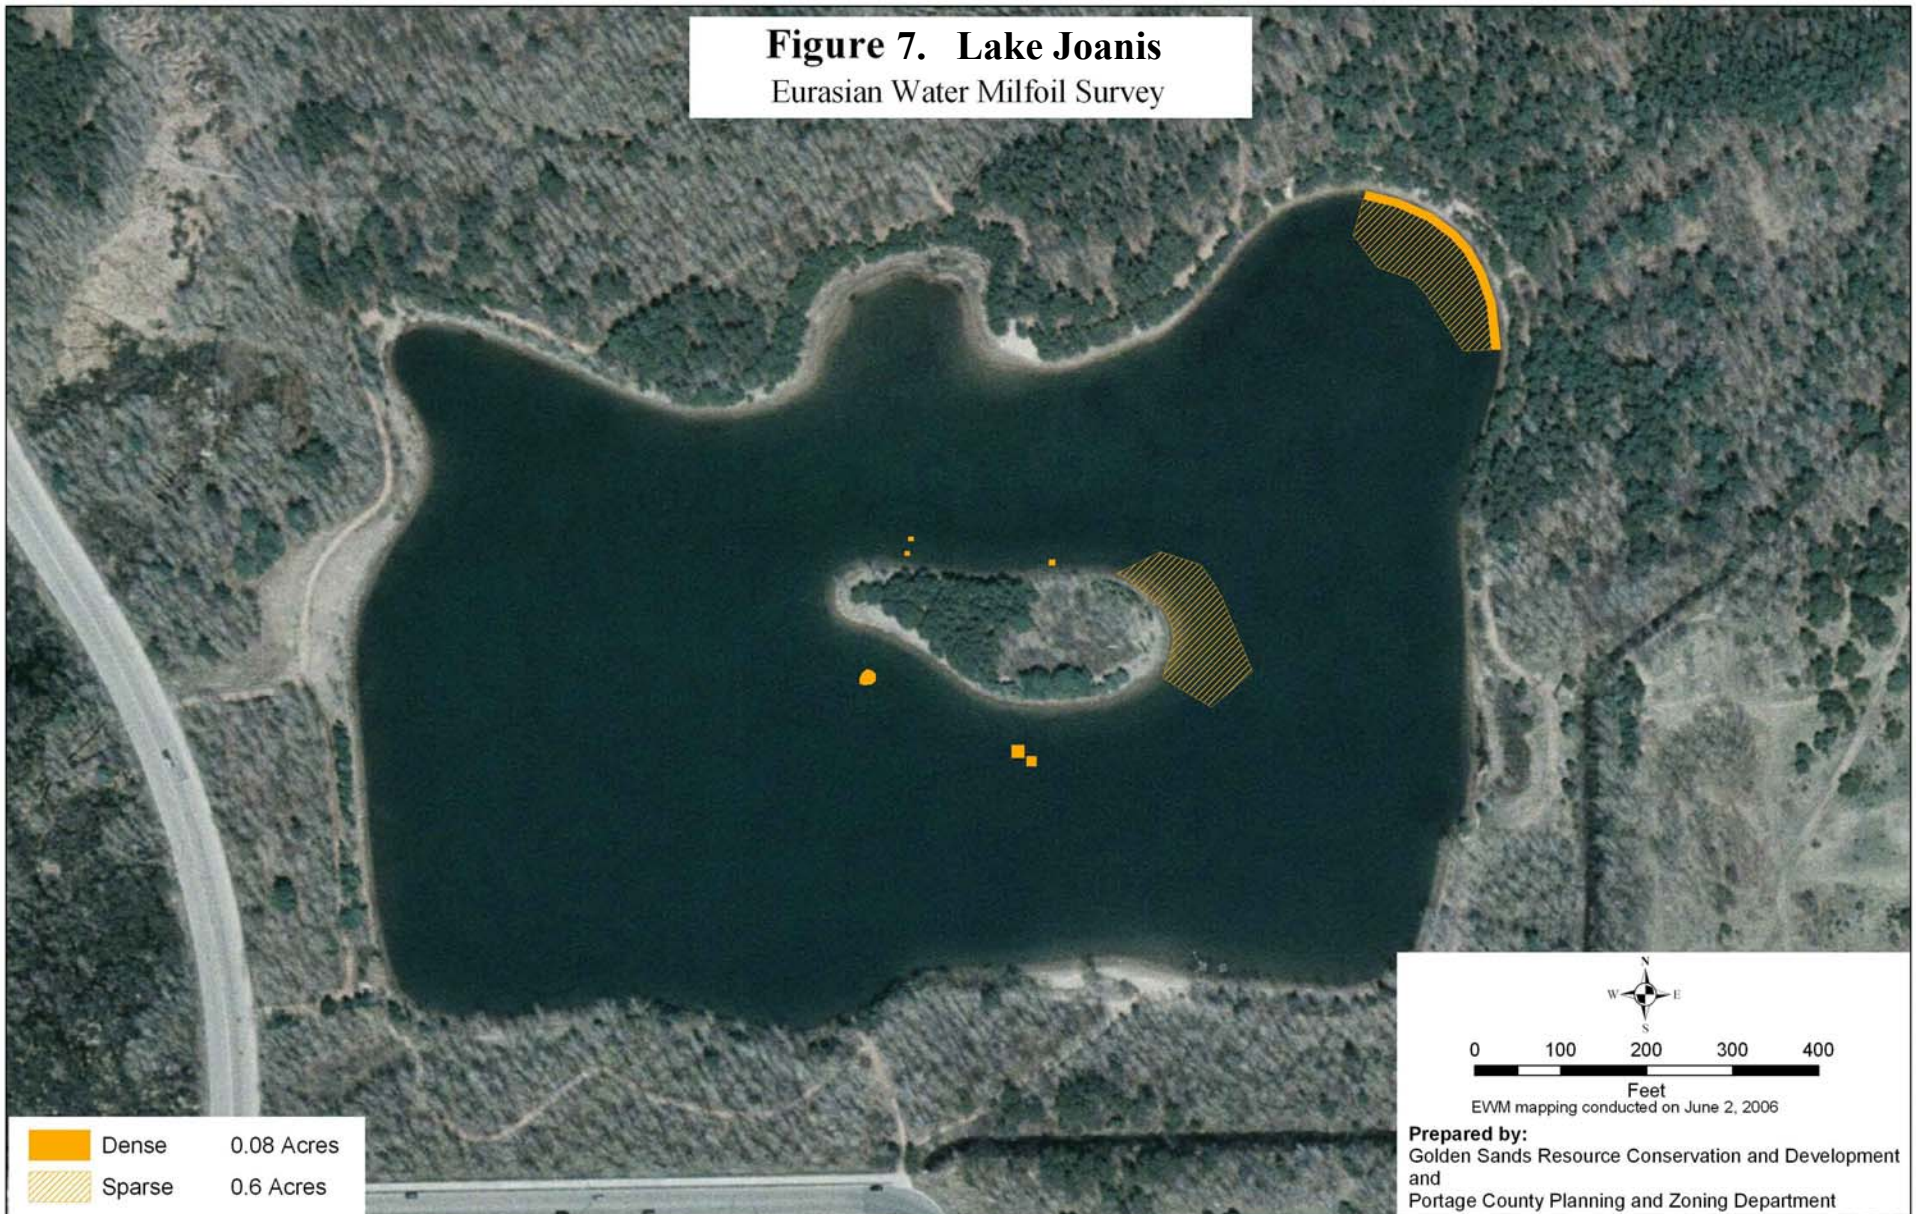
Field mapping on June 2<sup>nd</sup>, 2006, found only a few, isolated EWM colonies. Dense acreage totaled approximately 0.08-acres, and sparse growths totaled 0.60-acres. Depth contours not available. Note that this mapping was done early in the season. Early-season mapping reduces confusion with native vegetation, but EWM beds may have expanded over the season. Updated mapping in 2007 is recommended to assist with EWM control planning.
