Wisconsin Lakeshore Restoration Project - Advanced Lake Leaders Session

September
2009

Found Lake, Vilas County, Wisconsin, USA

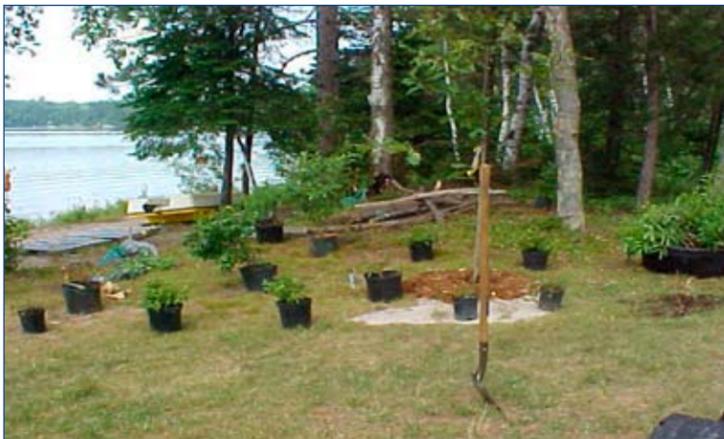
Figure 9. Example 1: pre-installation and planting.

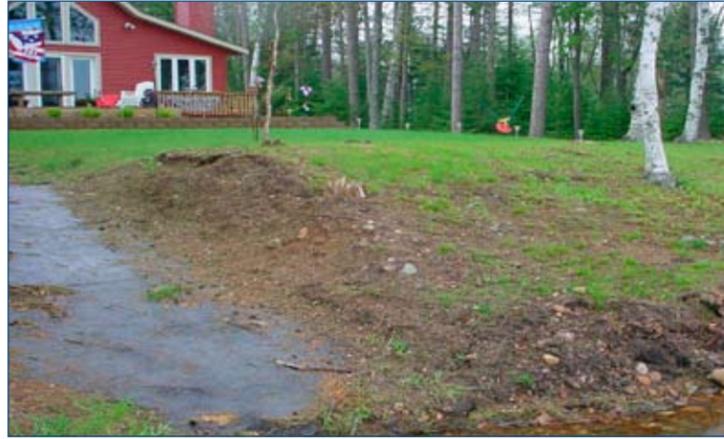
Figure 11. Example 2: pre-installation and planting.

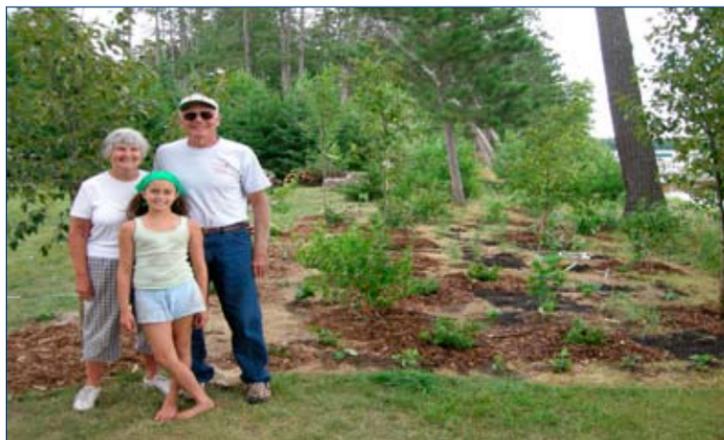
Figure 10. Example 1: post-planting shoreland restoration.

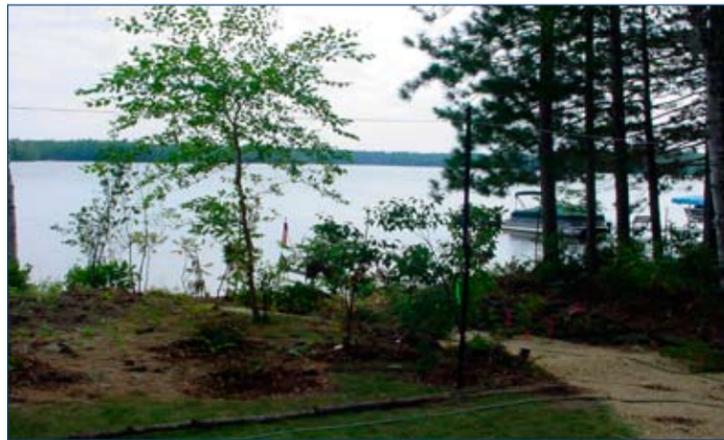
Figure 12. Example 2: Post-installation with straw matting and native plantings.

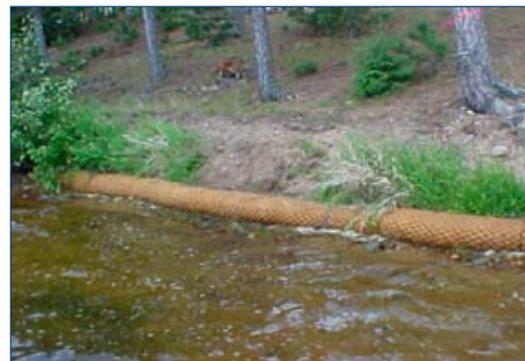
Figure 2. Biologs.

Assorted shoreland erosion control techniques are being compared and contrasted on Found Lake sites including the following examples:

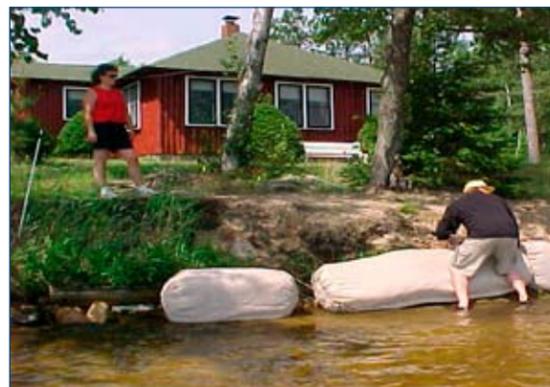
Figure 4. ShoreSox®.

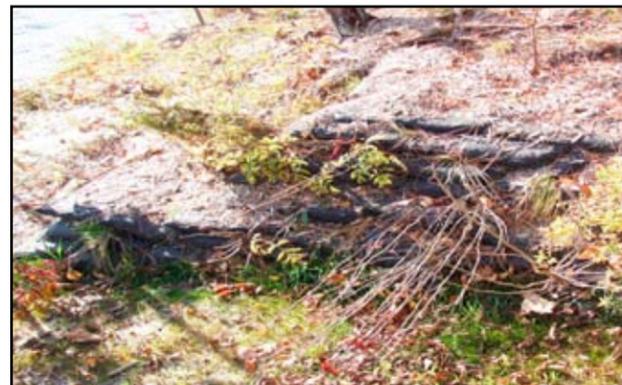
Figure 6. EnviroLok® bags.

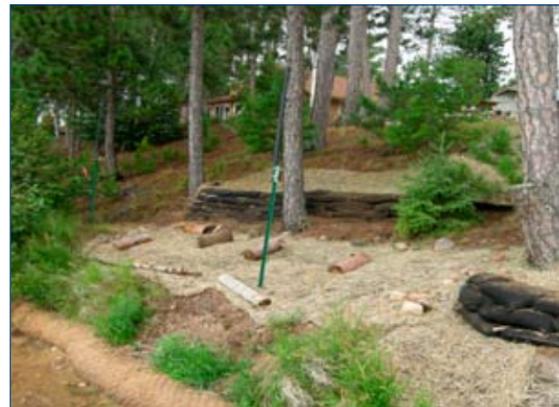
Figure 1. Soil lifts.

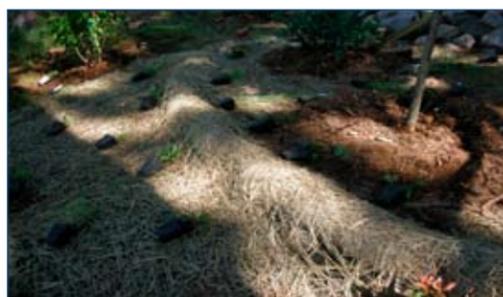
Figure 3. Straw matting with plantings.

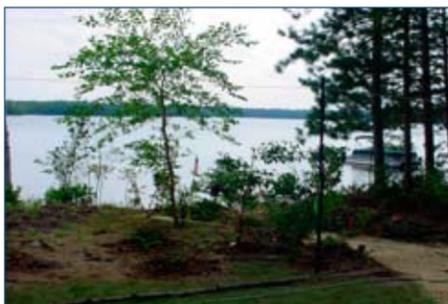
Figure 5. Straw matting replaces an asphalt boat landing.

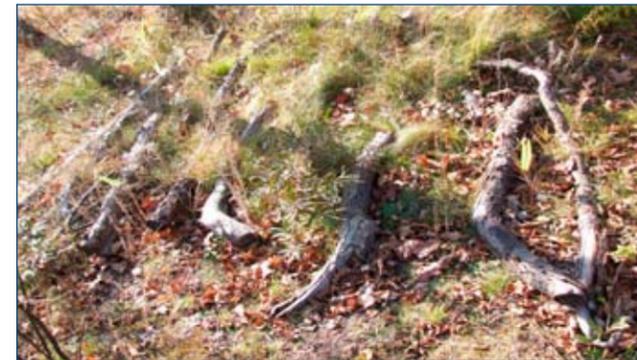
Figure 7. 25 % down woody material.

The project examines the use of down woody material (DWM) on restored plantings. Researchers monitor changes in soil temperature and moisture between sites with no wood on the ground, 25% DWM, and 50% DWM. To date, the mean maximum soil temperature, temperature variation, and change in soil moisture content were significantly lower in the 25% and 50% DWM plots. No difference in plant survival was identified, but snowberry (*Symphoricarpos albus*) and barren's strawberry (*Waldsteinia fragarioides*) growth was significantly greater in the DWM plots.

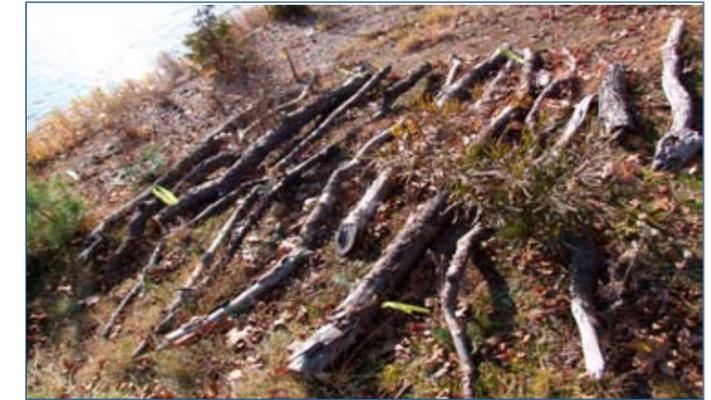
Figure 8. 50 % down woody material.
