Wisconsin Lakeshore Restoration Project

Preliminary Findings

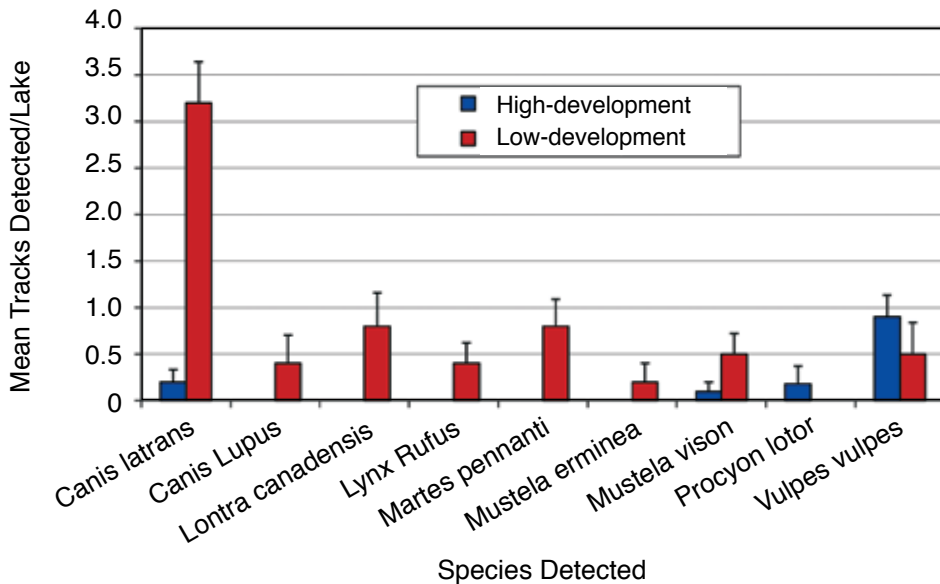
Figure 1. The mean and standard error of individual species detected by snow track surveys within pairs of ten lakes each pair containing a low- and high-development lake, in Vilas County, Wisconsin, USA. Data was collected in January and February of 2008 (Haskell et al. 2013).

We calculated Shannon's index of species diversity for each lake. We documented 83 encounters of tracks of nine carnivore species across all lakes sampled. Five of the nine species were detected exclusively on low-development lakes (see Figure 1). Coyotes (*Canis latrans*) were the most encountered species (n = 34) across all lakes. Red foxes (*Vulpes vulpes*) and raccoons (*Procyon lotor*) had the highest encounters on high-development lakes (Figure 1). Shannon's index of species diversity was significantly higher ($t = 3.547$, $df = 9$, $P = 0.006$) on low-development (mean = 1.974 ± 0.438 SE) than on high-development lakes (mean = 0.277 ± 0.113 SE). Overall, there were twice as many carnivore species on low-development lakes (n = 8) than on high-development lakes (n = 4). For non-carnivore species, white-tailed deer were abundant on all high-development lakes, but were detected on only 50 percent of low-development lakes. Our results suggest that high-development lakes are having a negative effect on the carnivore community in this region. The absence of apex carnivores in an ecosystem can have a significant effect on the relative abundance of herbivores and small carnivores. This trend can lead to further reductions in biodiversity because of overgrazed native vegetation and reduced nesting bird abundance (Haskell et al. 2013).

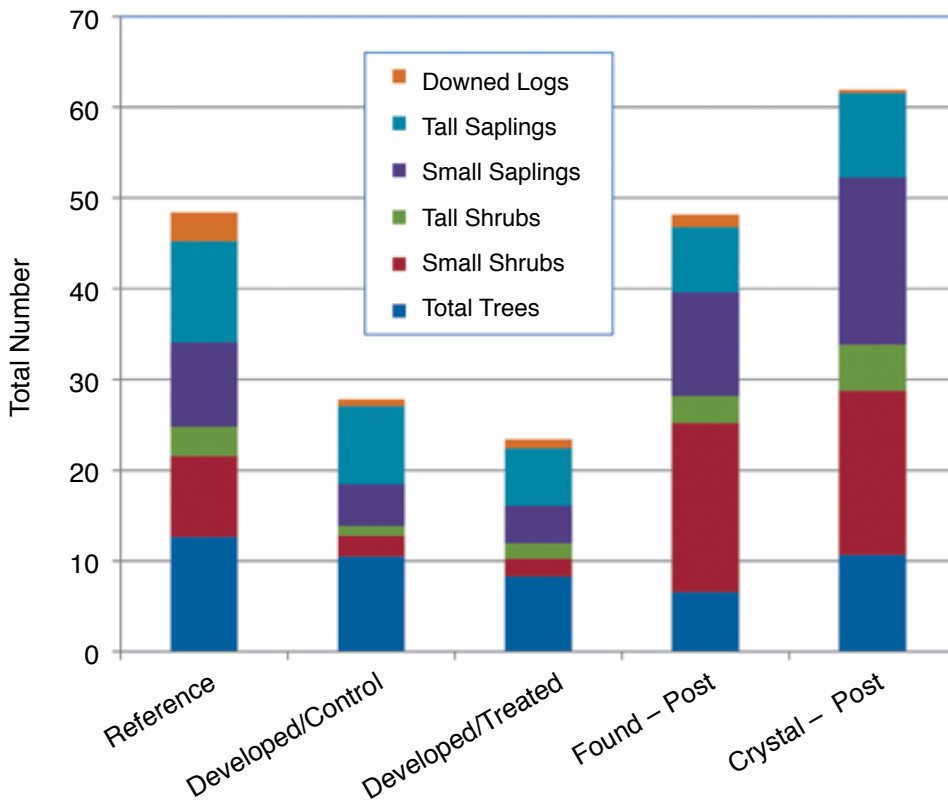
Figure 3. Initial habitat structure at vegetation plots along reference shorelines on undeveloped lakes (n=5) as compared to vegetation plots at control shorelines on developed lakes (n=5) and treated shorelines (shorelines selected for habitat restoration) on developed lakes (n=5). Also, conditions at 2 “treated” lakeshores, two to three years after planting (Found and Crystal).

with those at the Developed Lakes (see Figure 3). We also compared canopy openness using digital photography and WinSCANOPY software and counted and measured the amount of coarse wood (logs, snags, stumps) present (see

We found the total number of trees per plot and the tree species diversity index (SDI) were significantly greater at vegetation plots on Reference Lakes, however trees were larger (as indexed by average basal area measured at breast height) on Developed Lakes. The total number of small tree saplings (dbh <5cm at 1.37m height) per plot and SDI were significantly lower on Developed Lakes, however similar numbers of large tree saplings (dbh > 5cm at 1.37m height) and sapling SDI were measured on Reference vs. Developed Lakes. Similarly, the total number of small shrubs (<1.37m) per plot and SDI were greater at Reference vs. Developed sites, however the number and SDI of large shrubs (>1.37m) were similar. There was a greater number and larger diameter of downed woody material (DWM) present at plots on Reference Lakes vs. Developed Lakes, however there was no difference in the number of snags or stumps present in the two lake categories. Analysis of canopy openness indicated canopy openness was greater

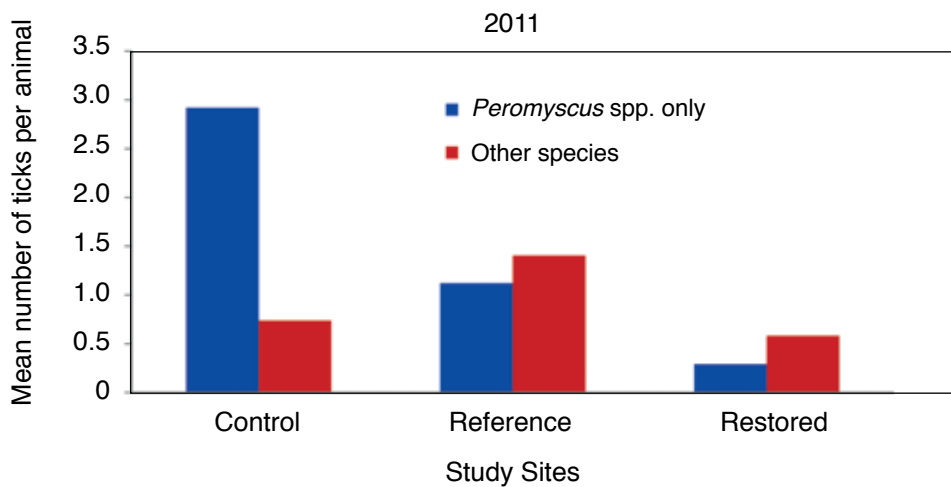
Figure 6. The mean number of ticks infesting *Peromyscus* spp. (white-footed and deer mice) and all other small mammal species captured at the lakeshore treatment sites during 2011.

areas. For instance, changes in small mammal communities and specifically the dominance of communities by the white-footed mouse are associated with habitat fragmentation in the eastern United States and are hypothesized to be important ecological drivers of human TBID risks (Ostfeld 2011). Our results indicate the probability of a small mammal harboring at least one tick at the Developed, Control sites was significantly higher than that found at the Reference Lake sites. Moreover, small mammals captured at the Restored sites had a significantly lower risk of harboring ticks compared to the developed sites and overall were infested with lower abundances of ticks (see Figures 6 and 7). These observations suggest there may be higher risks of

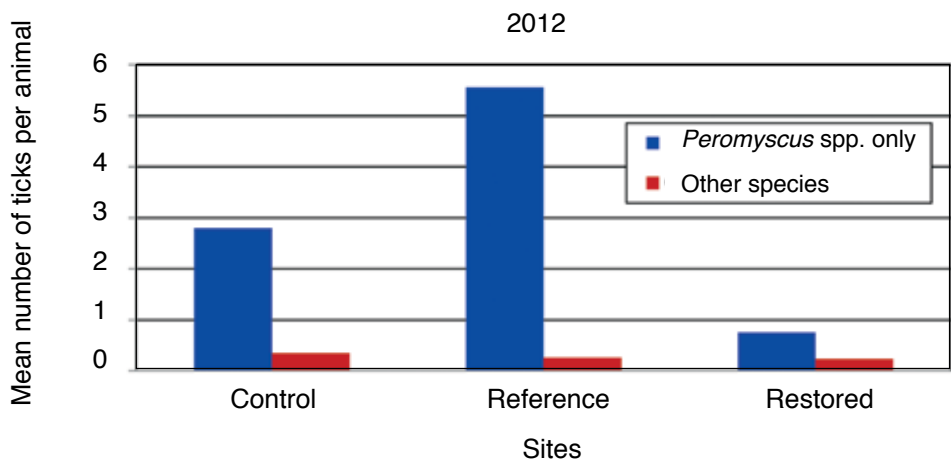
Figure 7. The mean number of ticks infesting *Peromyscus* spp. (white-footed and deer mice) and all other small mammal species captured at the lakeshore treatment sites during 2012.
