Restoration Stories

Many waterfront property owners in Wisconsin are restoring the buffer of native vegetation along the shoreline. These stories and pictures describe the experience and results of a few. Two of the sites are demonstration areas at public parks.

Seeded Prairie

Lake Wissota State Park, Chippewa County County Highway O, about 5 miles North of US Highway 29. Park signs at interchange of Highway 29 and County Highway X.

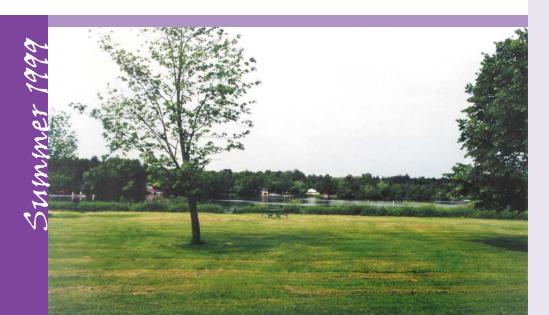
The prairie was seeded in the spring of 2000. Site preparation consisted of two herbicide treatments of glyphosate (Rodeo is a common trade name for the herbicide approved for use near water) five weeks apart, with shallow rototilling following the first herbicide treatment. Grass and flower seeds were seeded by hand five days following the second herbicide treatment. A few trees and shrubs were scattered in the prairie planting.

Wet soils are overlain with about 12 inches of sandy loam fill added in the early 1970's to create the park picnic area.

Site preparation: This seeded prairie buffer was a great success because of careful removal of the preexisting vegetation, mostly Kentucky bluegrass. Rototilling between the herbicide treatments along with the several weeks between the treatments favored germination and subsequent killing of the non-native seedbed before planting.

Variety of species: The large number of species in the seed mix assured a successful "take" for a range of wetness conditions. The site has variable moisture conditions, and it is easy to see that different species dominate in wetter and drier areas.

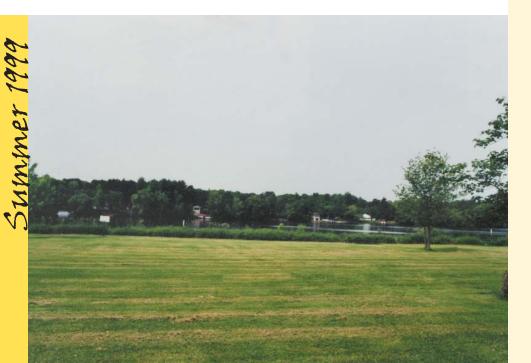
Bare-root trees and shrubs were planted in April 2000 into an area that was previously mown lawn.

Wet soils are overlain with about 12 inches of sandy loam fill added in the early 1970's to create the park picnic area.

Site preparation: While "no mow" approaches are typically confined to sites where lawns are not well established, at this site it proved to be very successful even with a well-tended lawn. Surprisingly, visitors perceived the unmown grasses as quite visually appealing. With "no mow" however, property owners need to keep a cautious eye open for non-native invasive plants such as reed canary grass and purple loosestrife.

As an experiment, during the second year of establishment, patches of sod, about 3-feet square were scalped off, and the bare soil planted with prairie flower and grass seedlings.

Progress: The trees and shrubs that were planted into the no-mow area are doing well, and created more variety on the site. Native plants are moving in along moist edges of the no-mow area. They may have been growing within the grasses all along, and have done well once the mowing stopped.

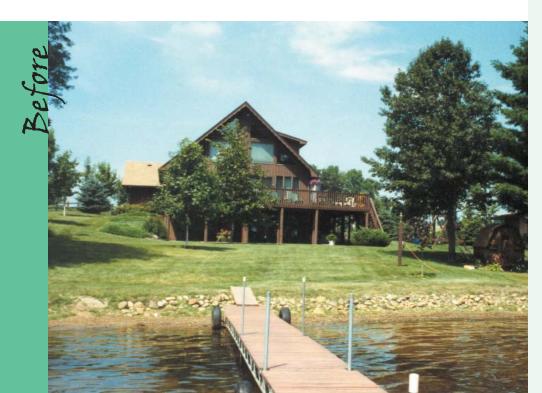
The soil is sand with just a bit of organic matter. Two methods were used to remove thick lawn vegetation. One side was covered with black plastic for 6 weeks, and the other side was sprayed with Round Up® (a glyphosate herbicide).

Site Preparation: The spraying killed existing vegetation more effectively than covering with black plastic.

Planting Techniques: Use of a bulb auger drill bit really made the planting an easy task.

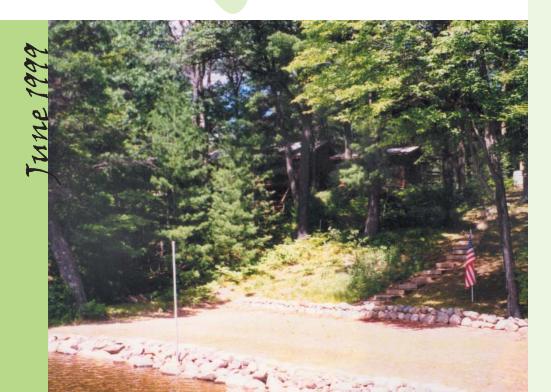
This project was completed as mitigation required for a land use permit. The main area planted was bare sand. The landowner completed the planting himself with help from the Burnett County Land and Water Conservation Department's consultant. Guidance included Burnett County's 30 page instructional booklet: Shoreline Buffer Restoration. A Guide for Landowners.

NOTE: Seedlings were planted at one per square foot. An organic soybean meal fertilizer with an N-P-K ratio of 6-0-6 was used. Native shrubs (serviceberry, hazelnut, grey dogwood, and bush honeysuckle) were also planted in the understory of the wooded area.

Planting techniques: Mulch was not initially used in the planting. When it was added, it greatly helped to conserve moisture and reduce weed germination.

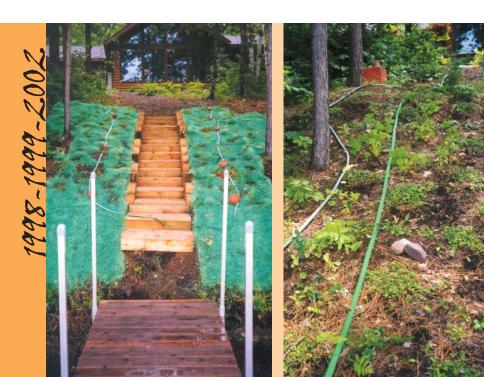
This site was planted following in-ground stair construction on an eroded, rather steep, (3:1) slope. Fifteen feet were planted on either side of the 30-foot long stairs to the lake.

The compacted subsoil was covered with peat moss then manually tilled to replicate the thin layer of acidic organic topsoil present in these forests. Excelsior erosion control mat was laid down on each side of the stairs to prevent erosion.

Site preparation: Loosening of the very compacted soil was believed to be important for establishment of plants.

Planting techniques: Transplanting from nearby woods helped to reduce planting costs. However, each square that was dug up was still empty after two growing seasons. This demonstrated the lengthy period required for natural regeneration of woodland plants.

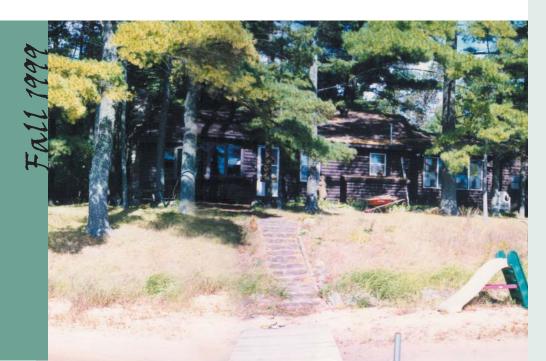
This sandy, dry hillside faces south. It is rimmed by red pine. Shrub plantings were added along the upper and side margins of the property. The area near the water's edge was allowed to grow. The water level is considerably higher in this picture in 2002 than when the site was planted in 2000.

This landowner is enrolled in Burnett County's natural shorelines program. The small white sign identifies the site as a "preserved natural shoreline." In addition to cost sharing plantings, the program pays an enrollment bonus and credits property taxes each year in return for a perpetual covenant on the property. The covenant requires that the shoreline buffer remain in place.
